WALKER UPPER ELEMENTARY SCHOOL
1564 DAIRY ROAD
CHARLOTTESVILLE, VIRGINIA

ECS PROJECT NO. 46:6713

CITY OF CHARLOTTESVILLE - FACILITIES DEVELOPMENT

Reference: Facility Condition Assessment Report for Walker Upper Elementary School, 1564 Dairy Road, Charlottesville, Virginia

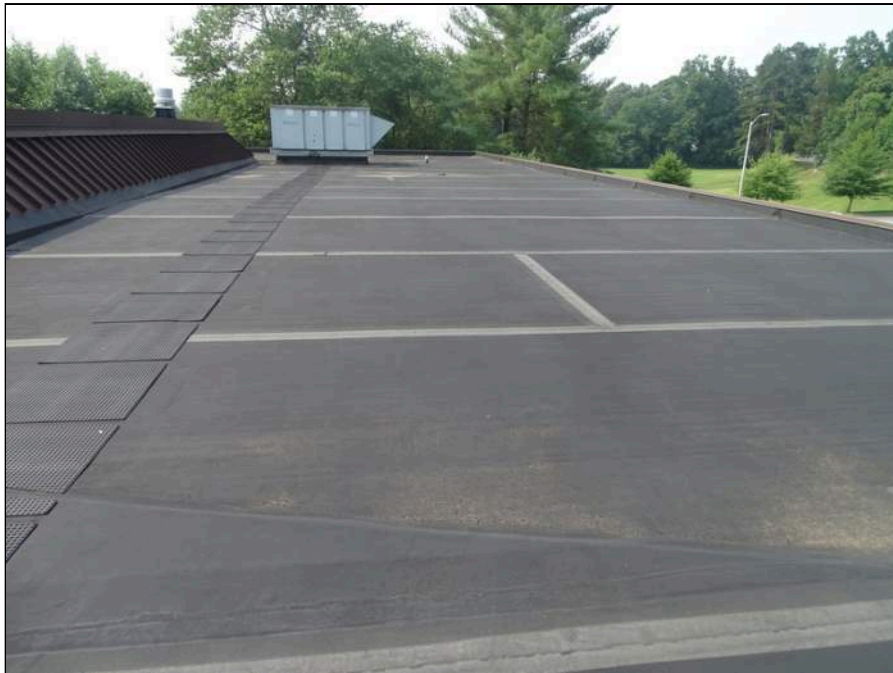
50 - Single-ply membrane roofing system main building looking north

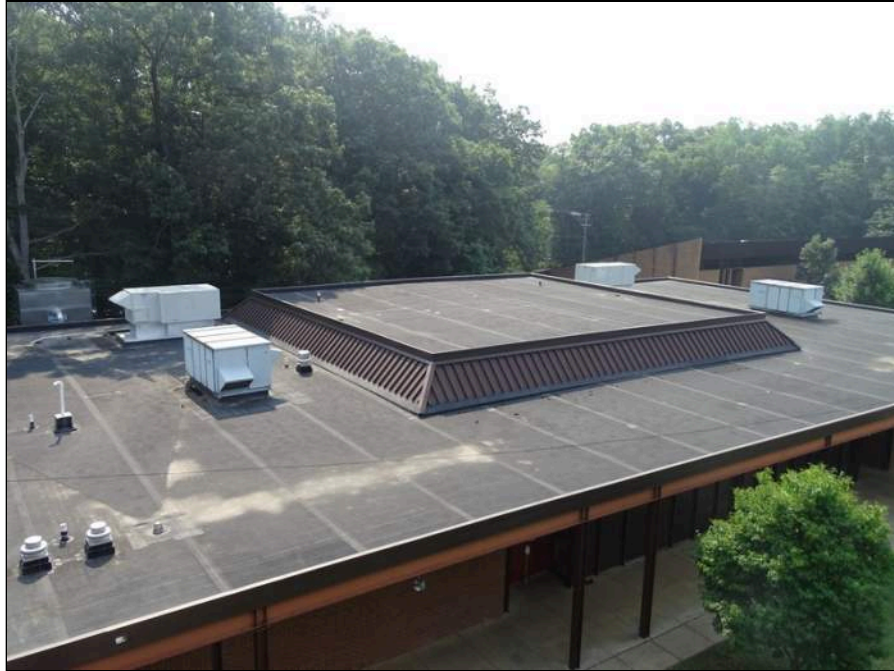
51 - Single-ply membrane roofing system secondary building looking south

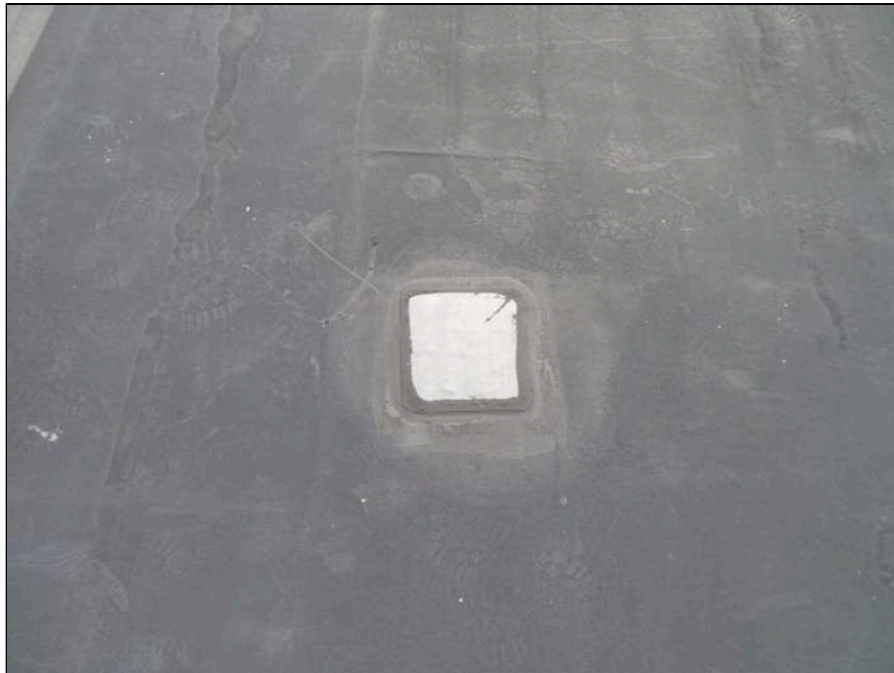
52 - Single-ply membrane roofing system - note patching

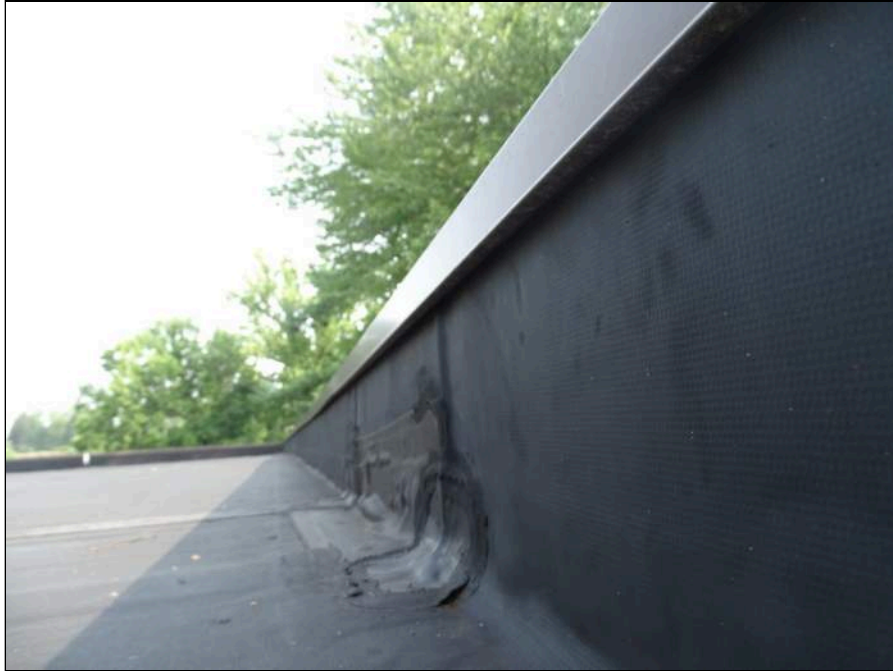
53 - Single-ply membrane roofing system - note patching

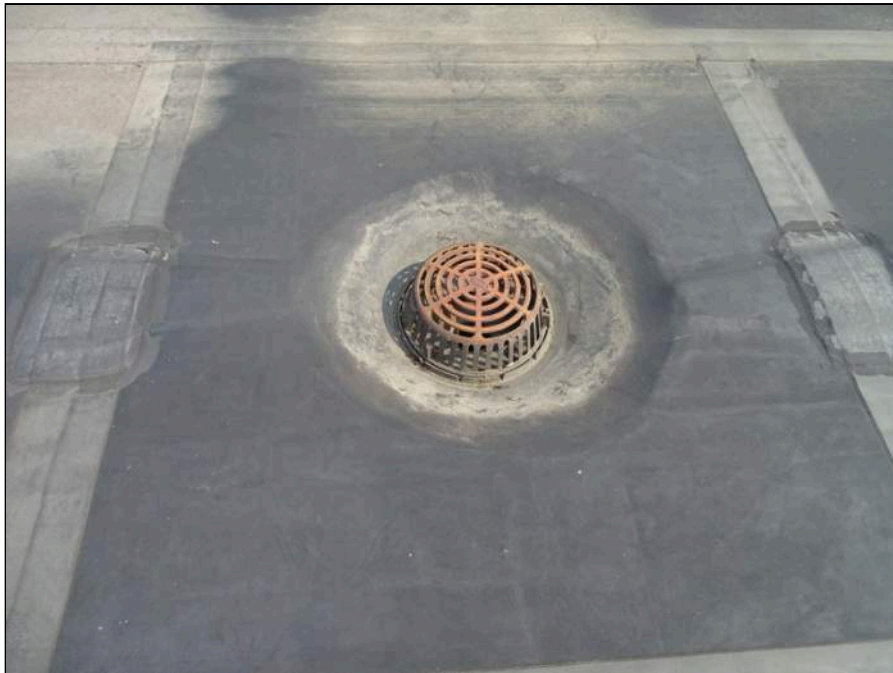
54 - Typical internal drain

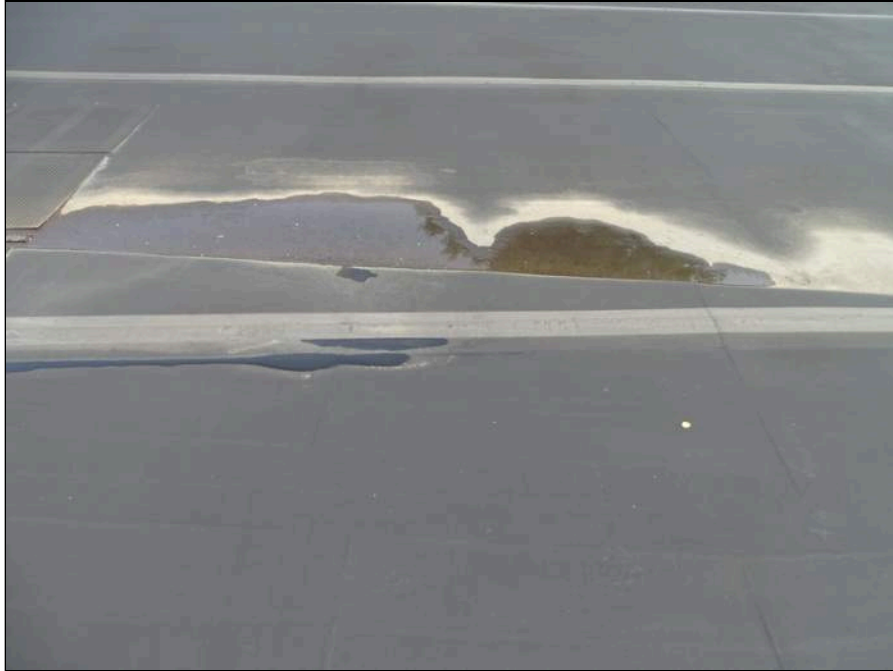
55 - Single-ply membrane roofing system - note ponding

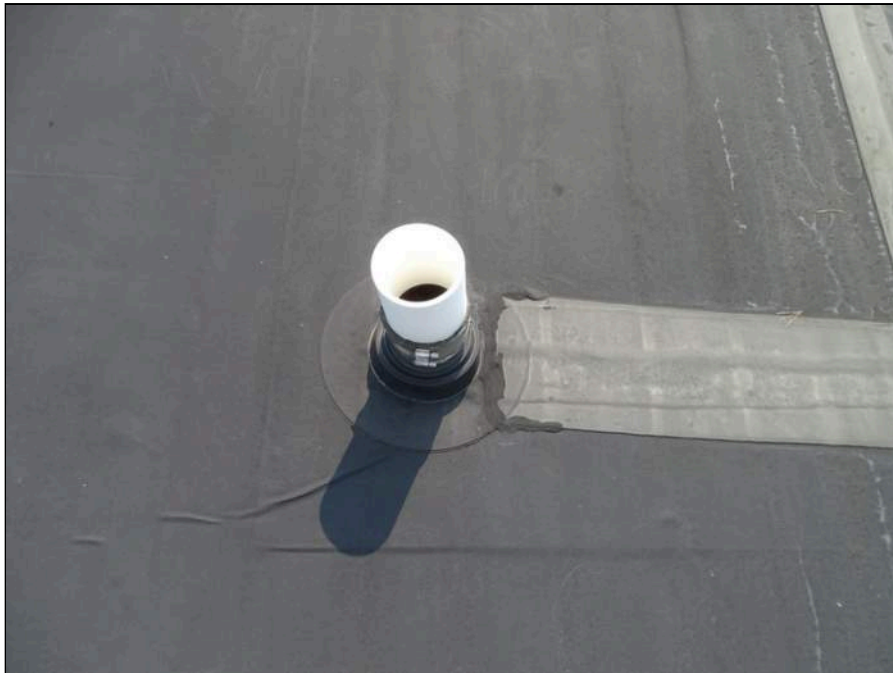
56 - Typical plumbing penetration

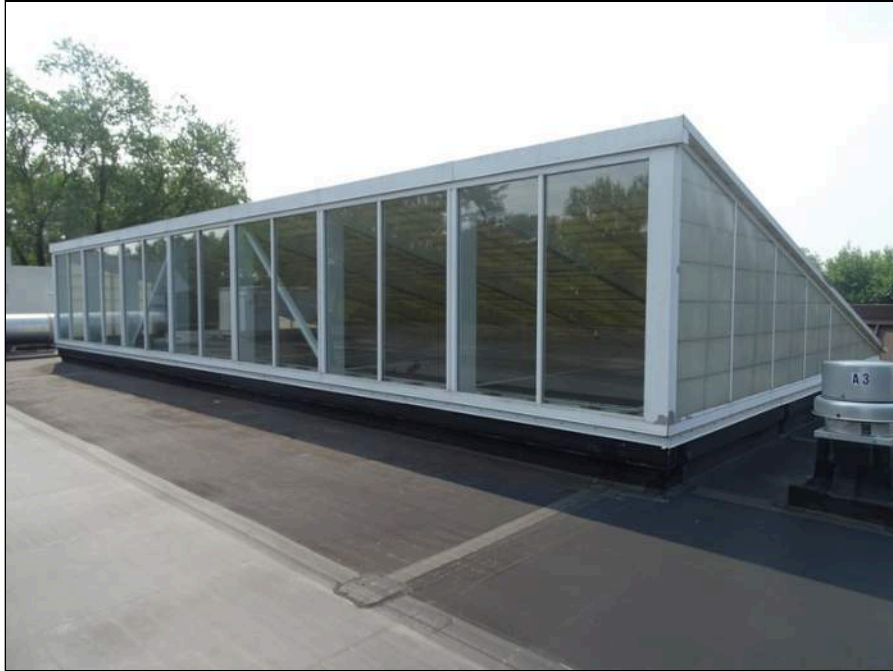
57 - Skylight located on main building

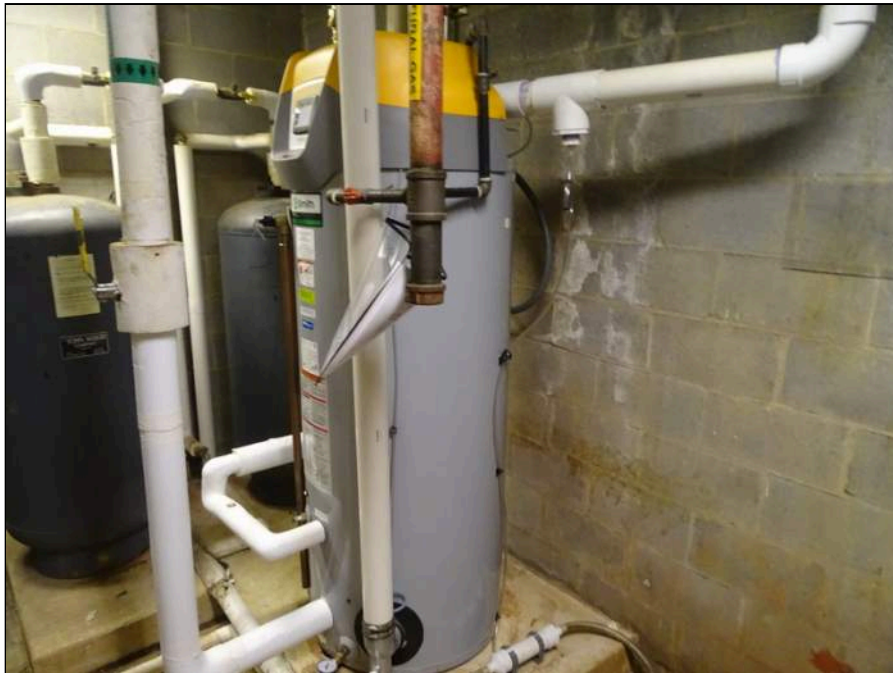
58 - Gas domestic water heater located in main building

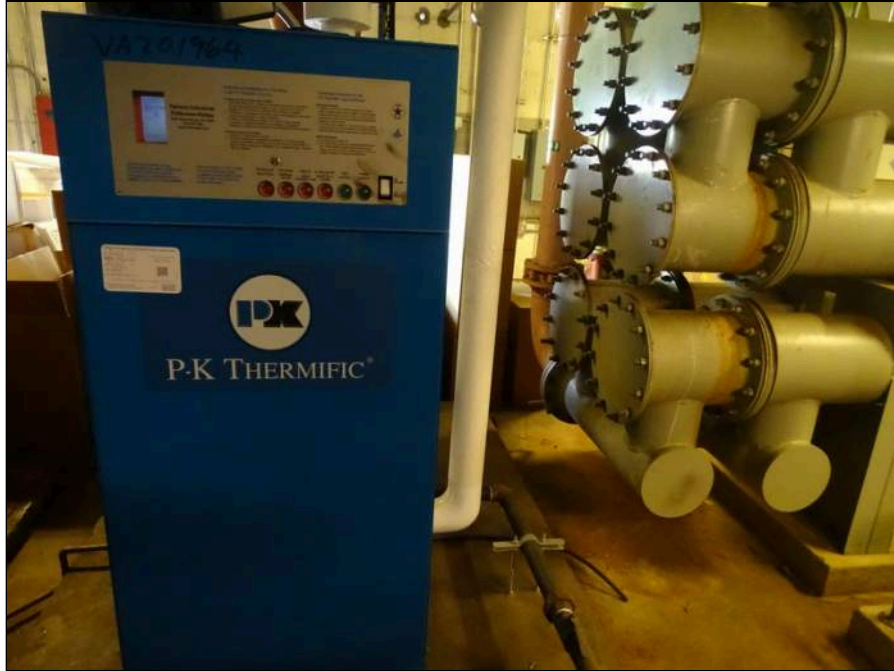
59 - Typical boiler located in main utility room

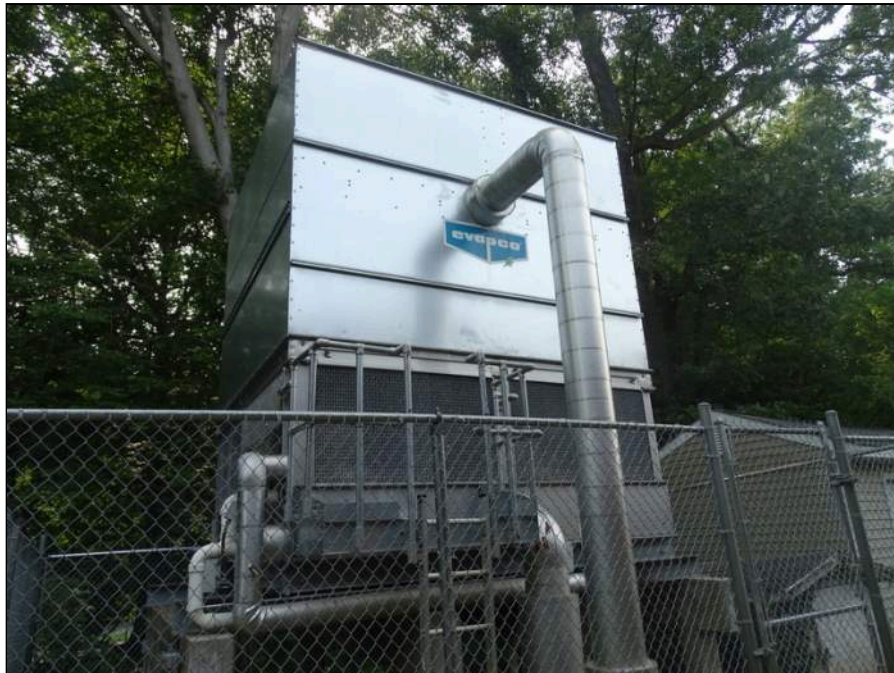
60 - Cooling Tower located on east side of the site

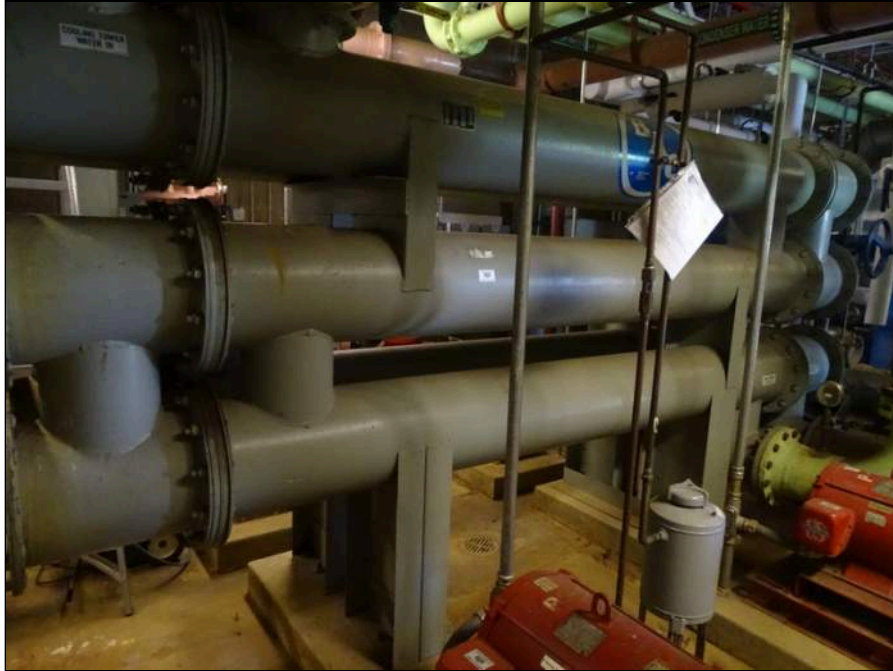
61 - Chiller located in main utility room

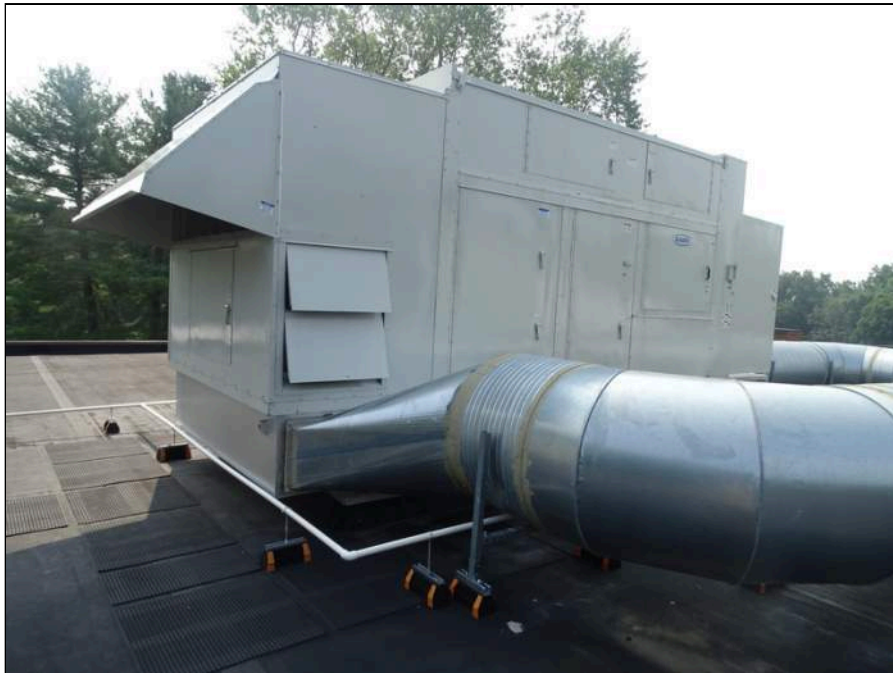
62 - Typical Make Up Air Unit located on roof

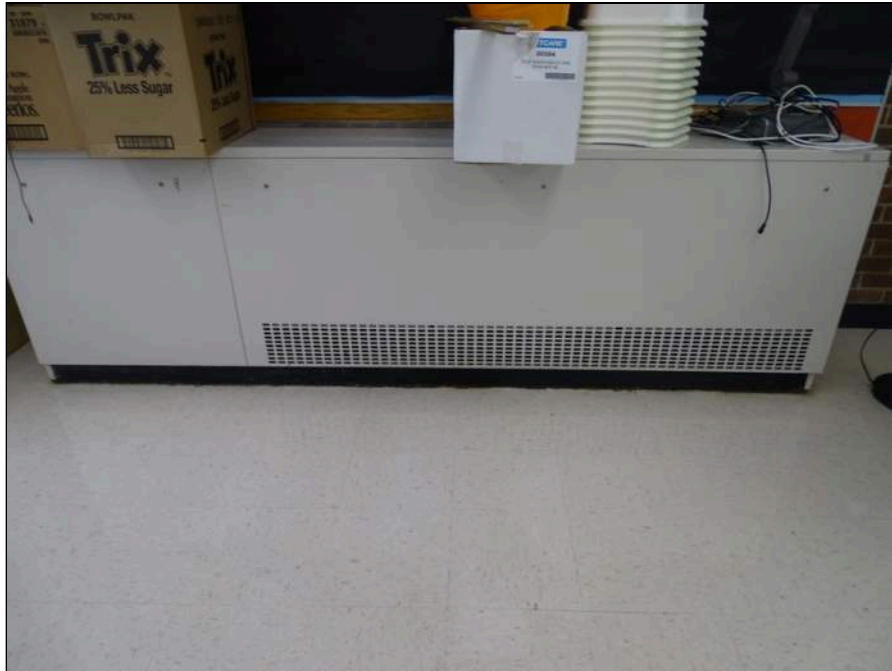
63 - Typical water source heat pump

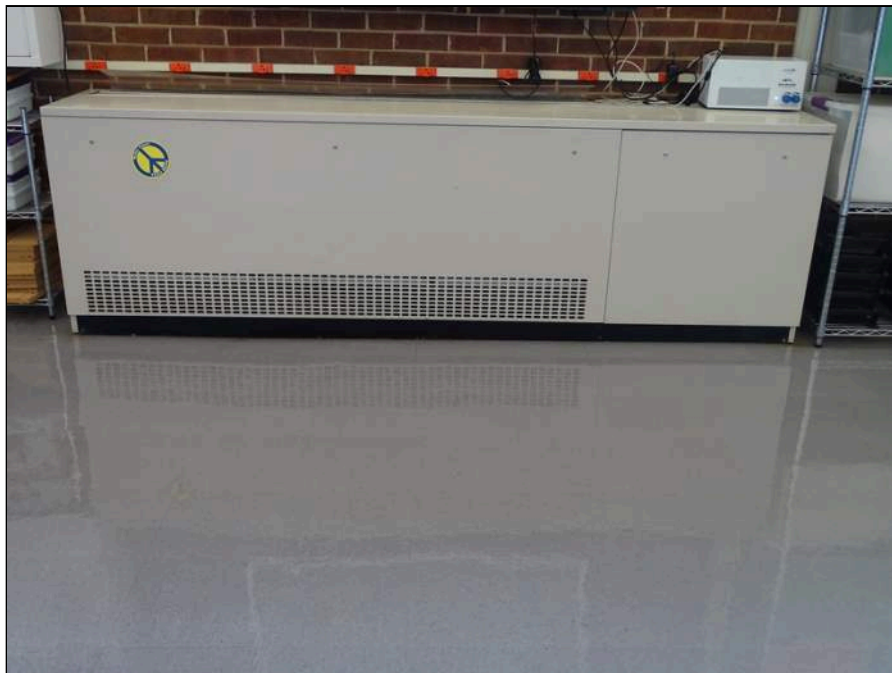
64 - Typical water source heat pump

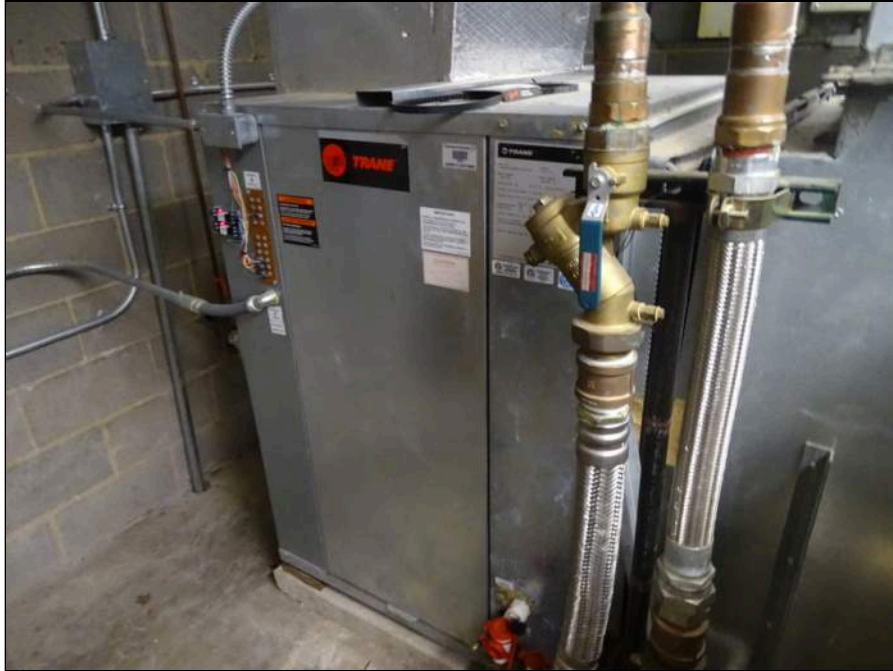
65 - Typical Air Handler Unit

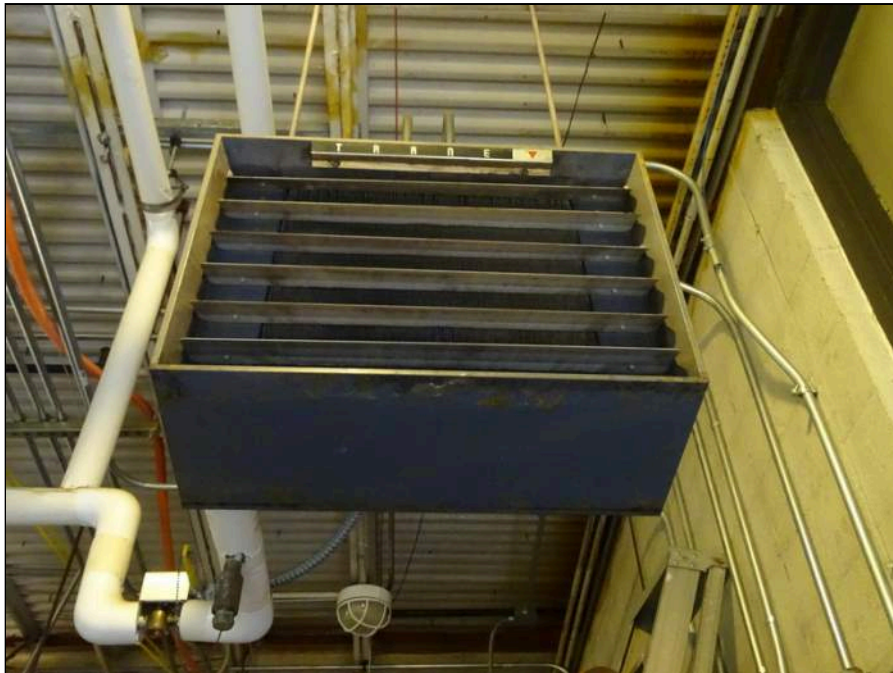
66 - Typical space heater

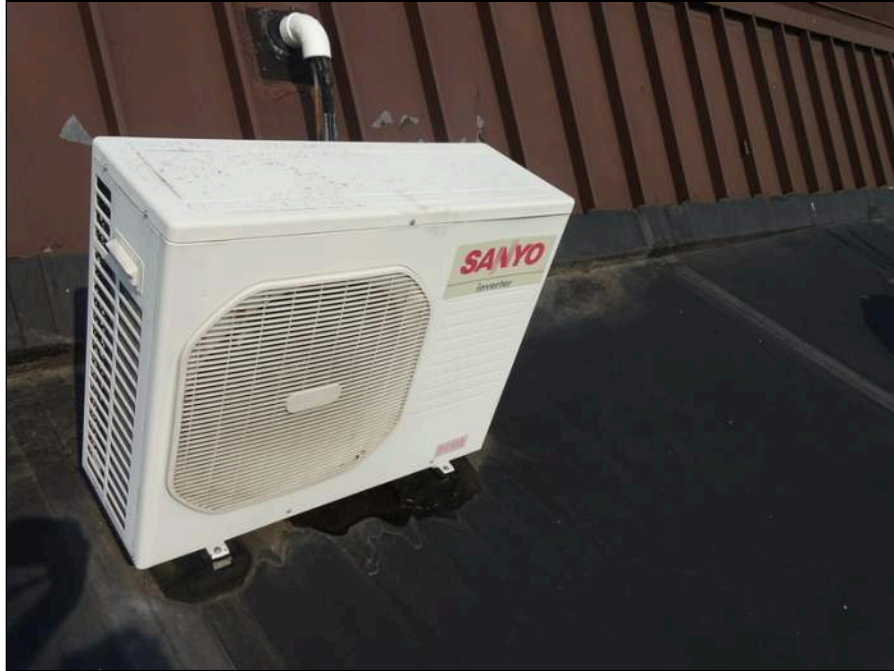
67 - Split system for IT room

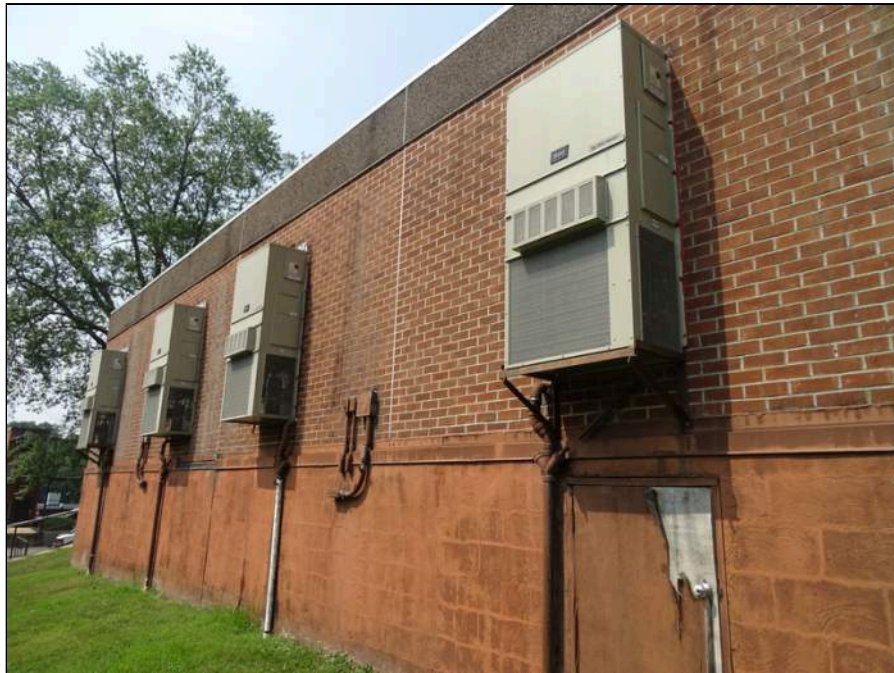
68 - Wall mounted air conditioner unit

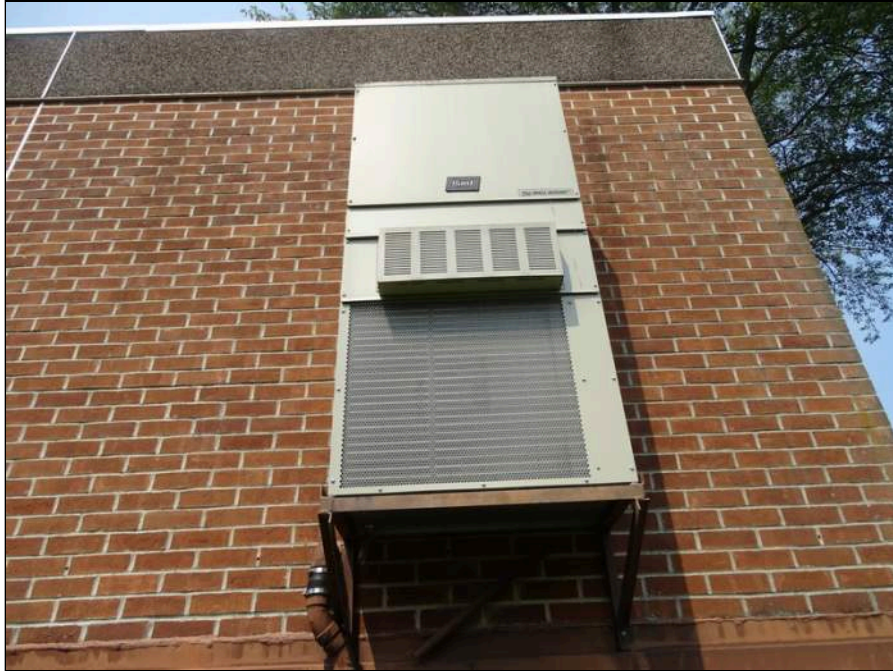
69 - Wall mounted air conditioner unit

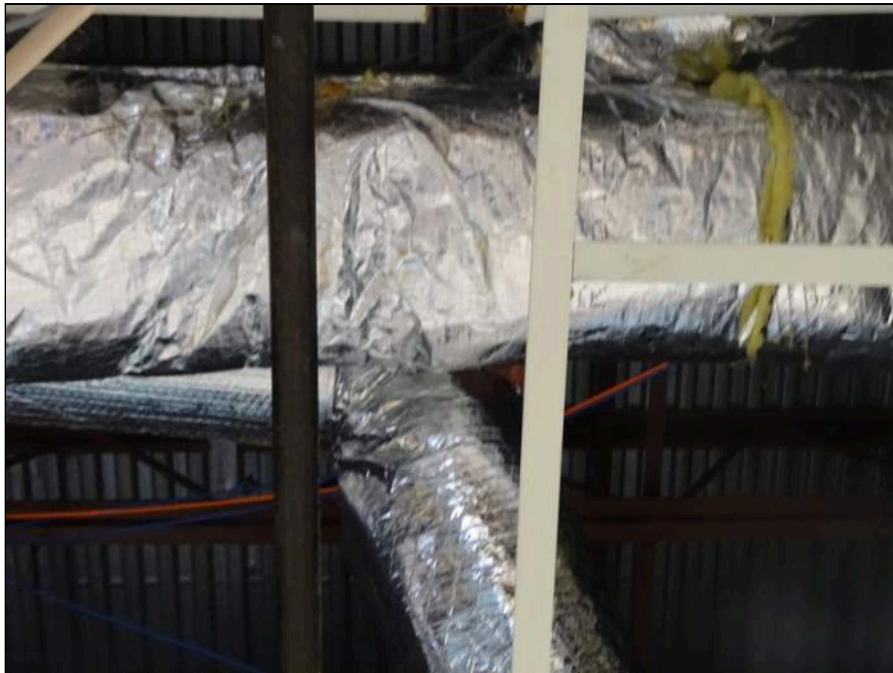
70 - Typical mechanical duct

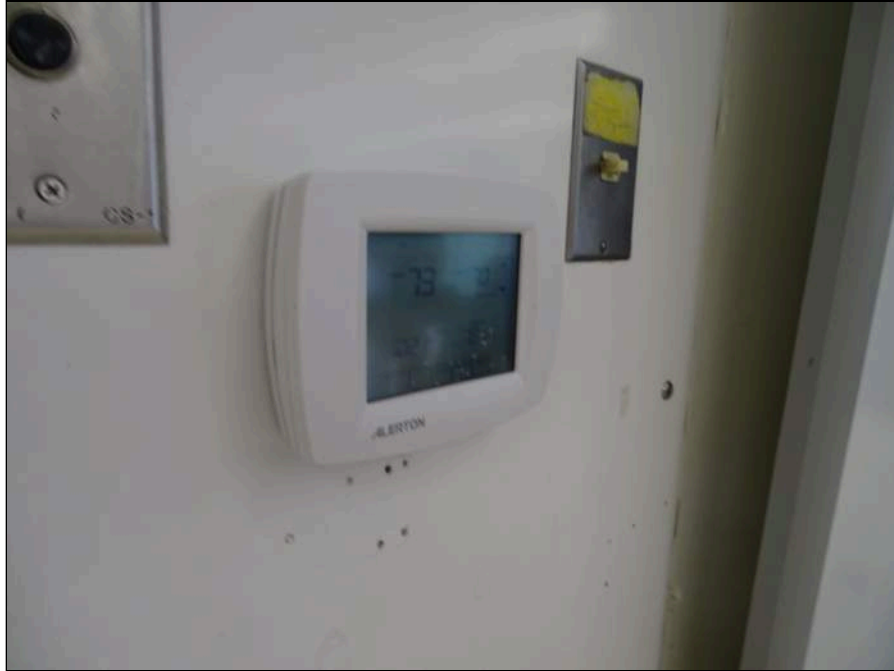
71 - Typical thermostat control

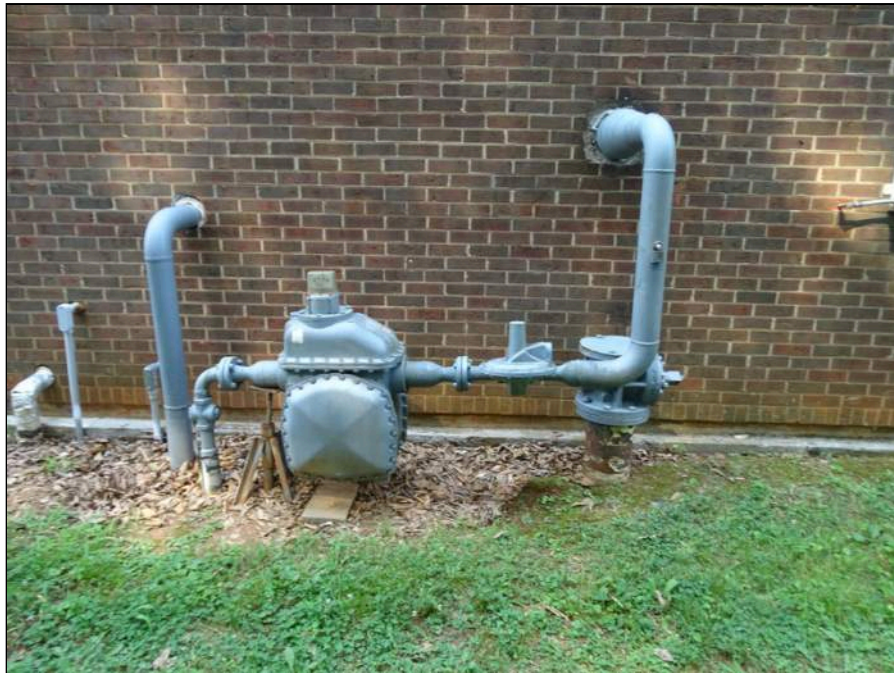
72 - Typical gas meter

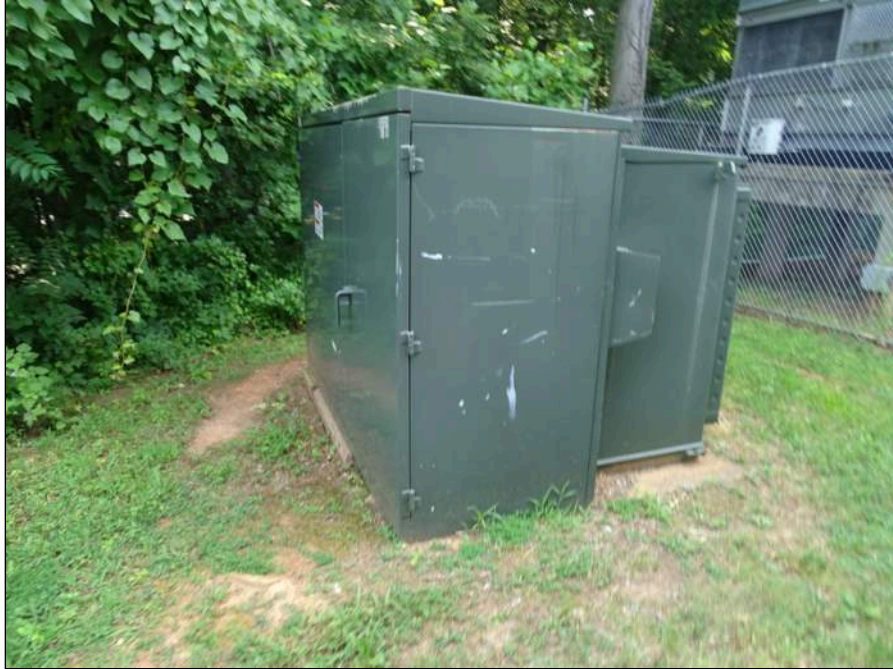
73 - Utility transformer at east side of the site

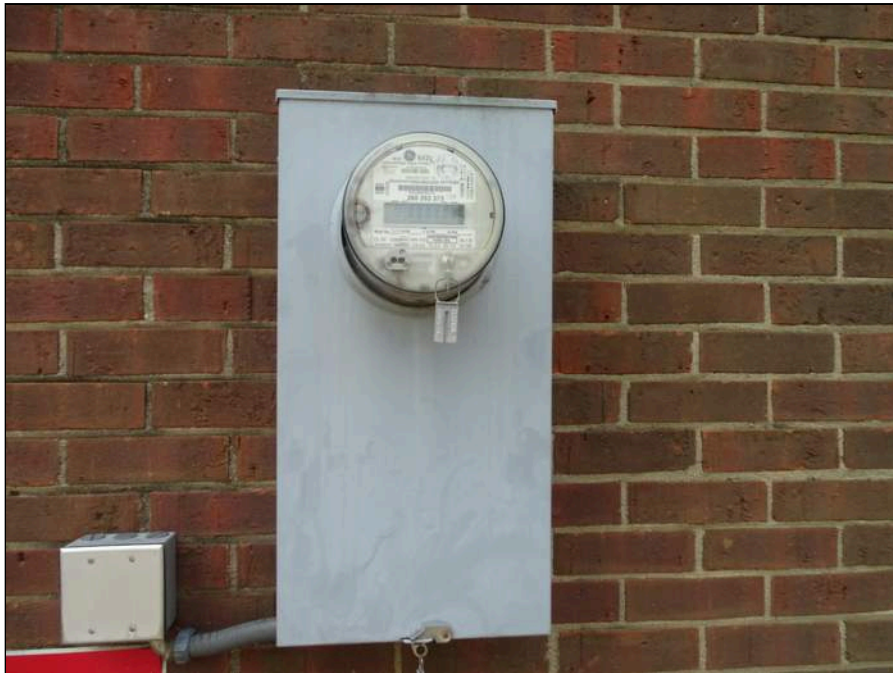
74 - Electrical meter at exterior wall of main utility room

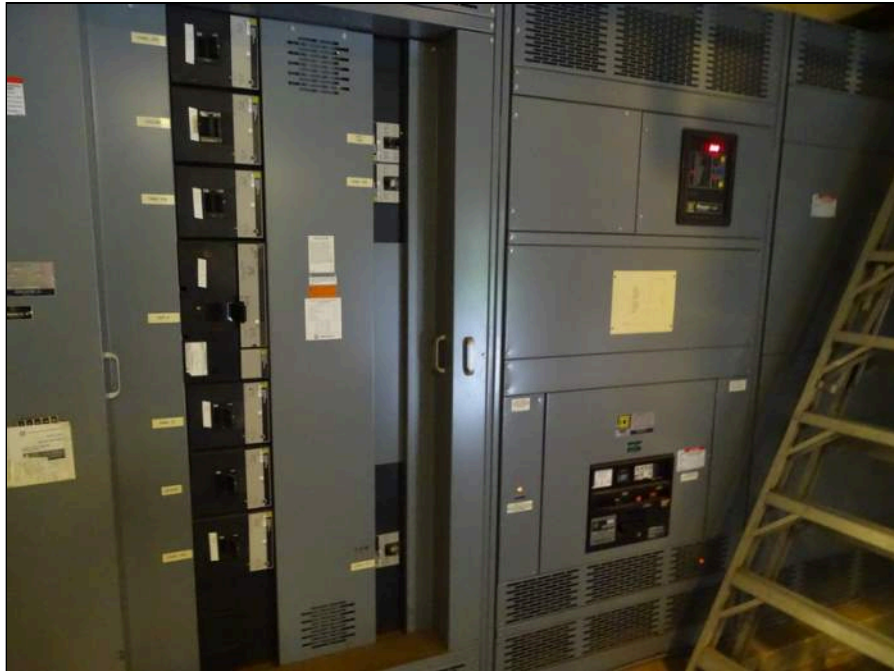
75 - Main electrical switchgear

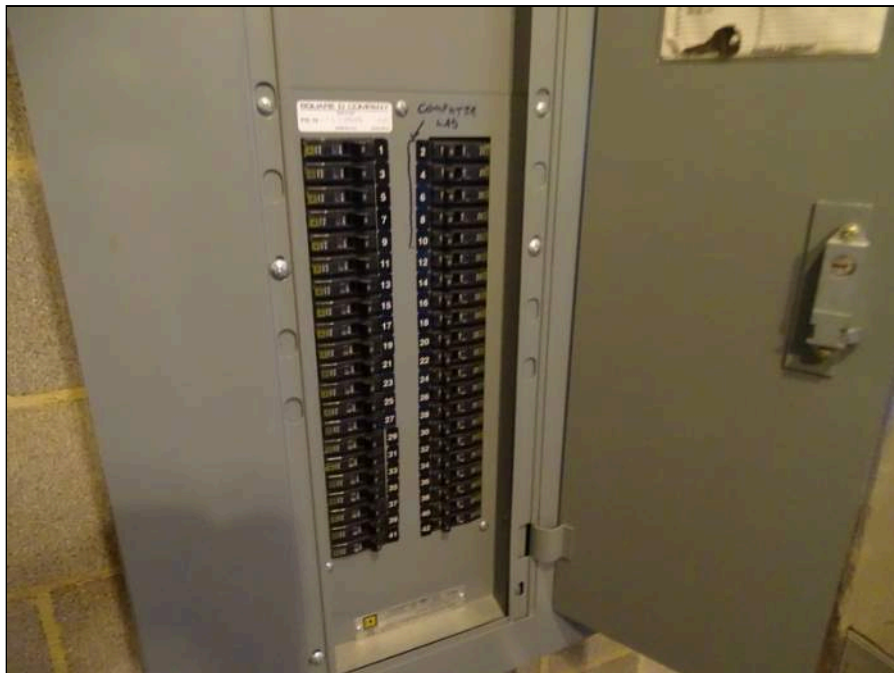
76 - Typical newer electrical circuit breaker panel

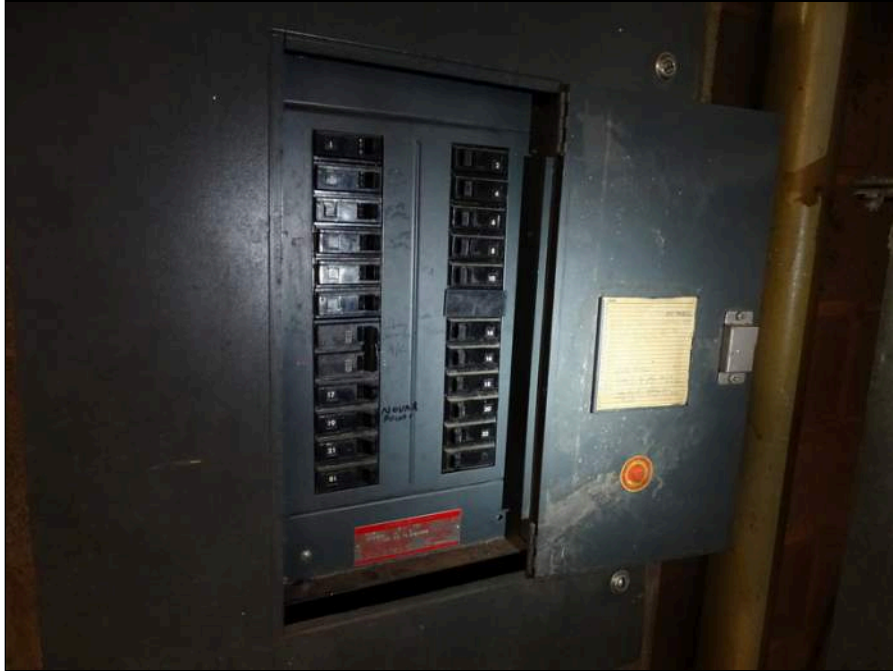
77 - Typical older circuit breaker panel

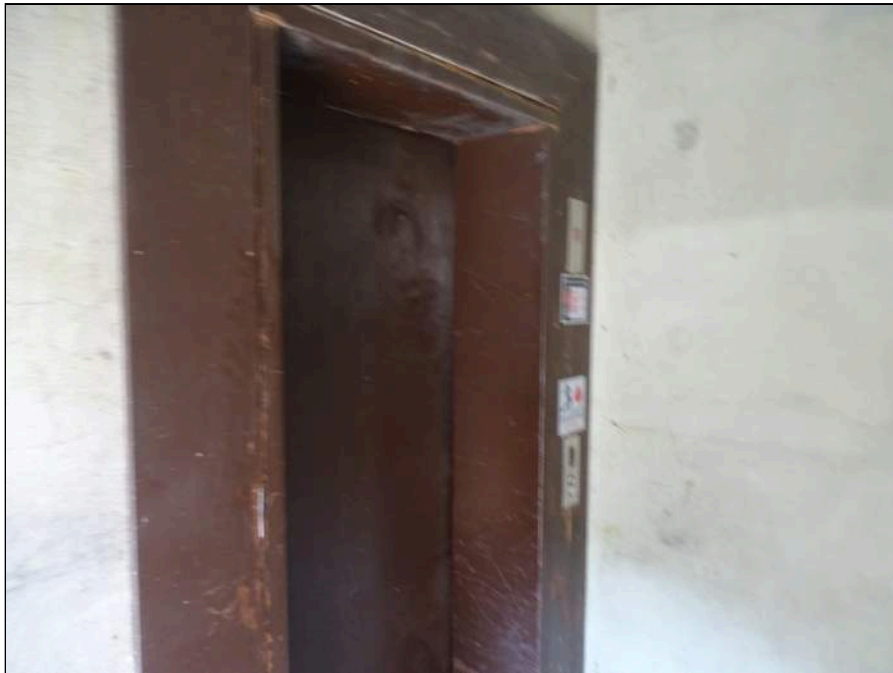
78 - Elevator cab

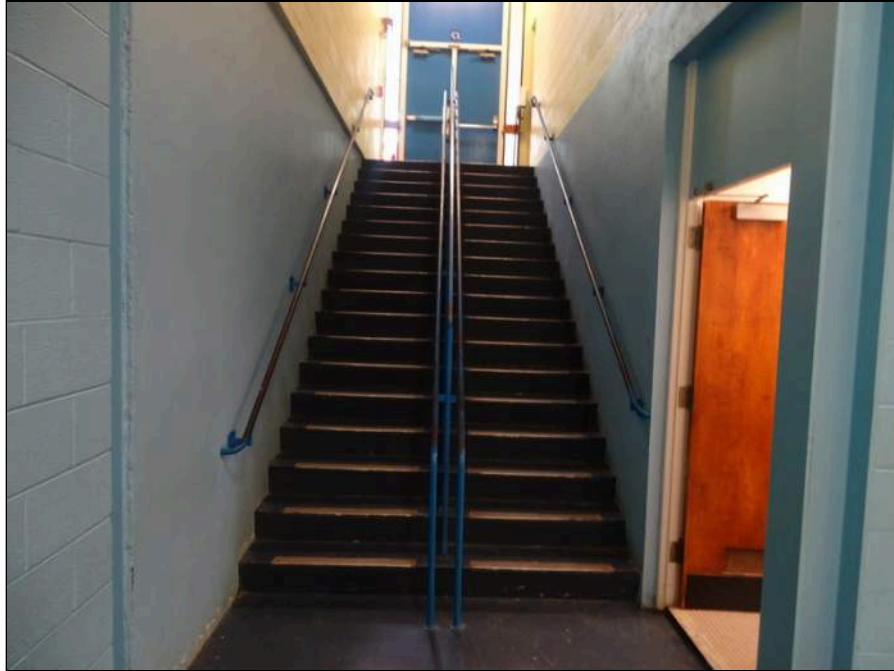
92 - Interior finishes of stair area

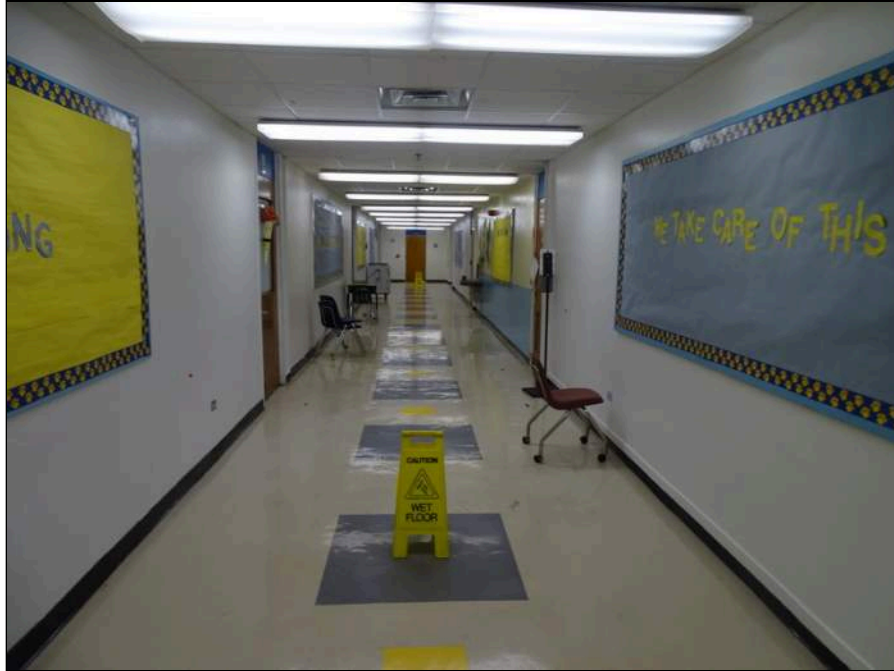
96 - Interior finishes of corridor area
