WASHINGTON PARK BATH HOUSE AND SHELTER
1001 PRESTON AVENUE
CHARLOTTESVILLE, VIRGINIA

ECS PROJECT NO. 46:6713

CITY OF CHARLOTTESVILLE - FACILITIES DEVELOPMENT

Reference: Facility Condition Assessment Report for Washington Park Bath House and Shelter, 1001 Preston Avenue, Charlottesville, Virginia

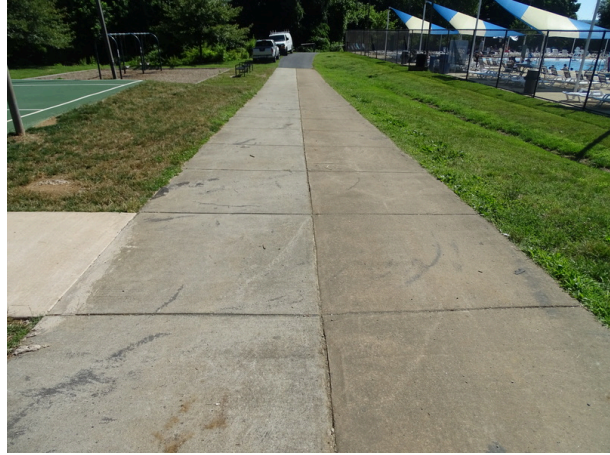
Concrete sidewalk

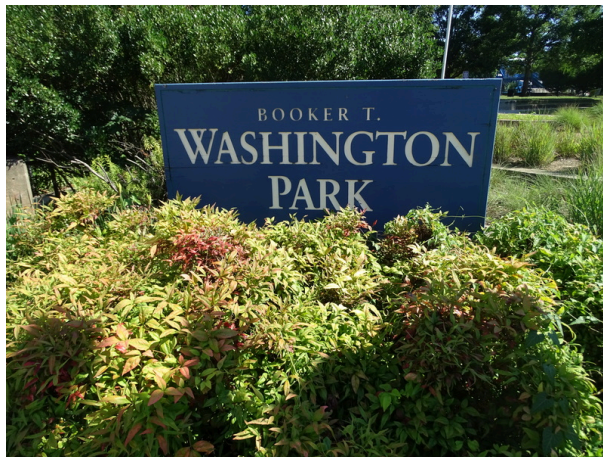
A wood sign was located at the road. The sign was in fair condition. We recommend repainting the sign as a maintenance item.

Monument sign

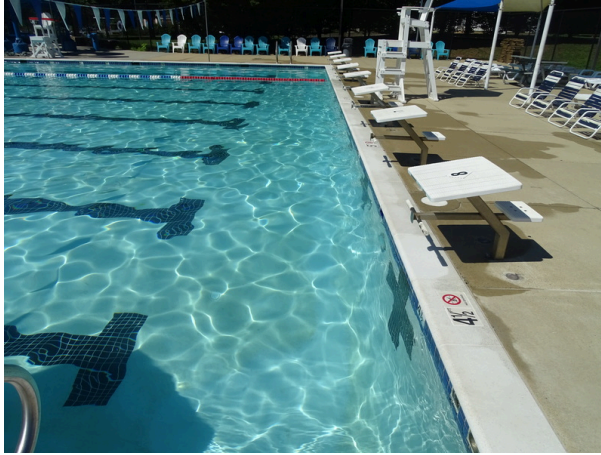
Pool overview

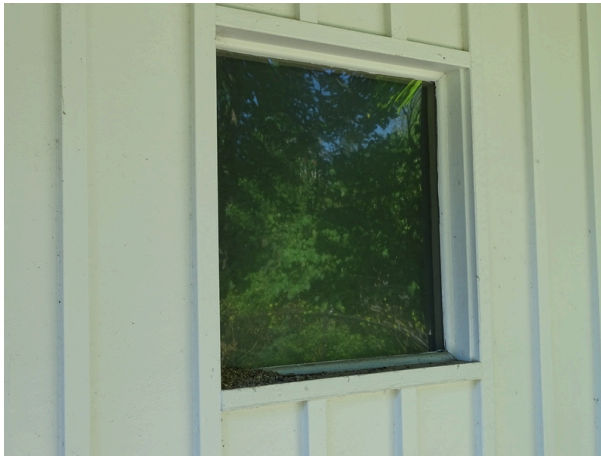
The window system in the Shelter primarily consists of wood framed double pane window units that are original to the property. The gaskets in the windows were generally in good condition. The expected useful life of gaskets is typically 20 years. An allowance has been included for replacement of the gaskets.

Typical shelter windows

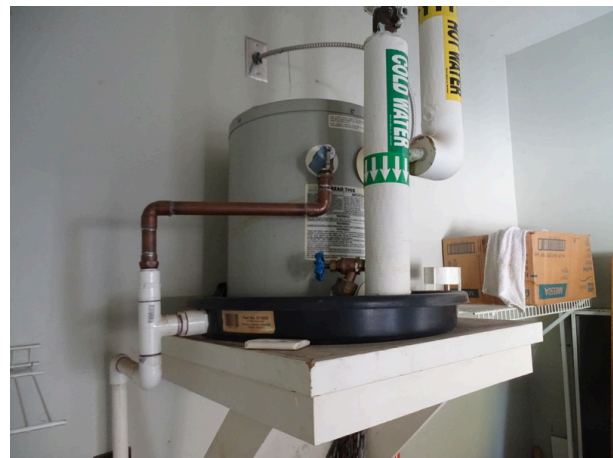
Shelter water heater

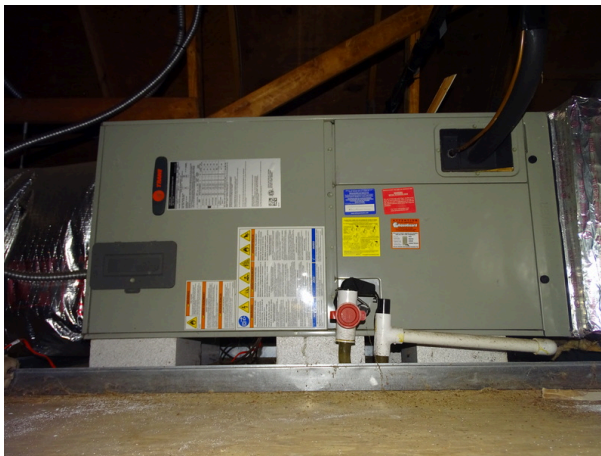
The Shelter building contained an air handler and a condenser that were manufactured by Trane in 2010. Exhaust fans were located in each of the restrooms. The exhaust fans were reportedly in good condition and should be replaced on an as-needed basis as a maintenance item. The expected useful life of air handlers and condensers is 15 years with proper maintenance. Allowances have been included for replacement during the study period.

Typical air handler

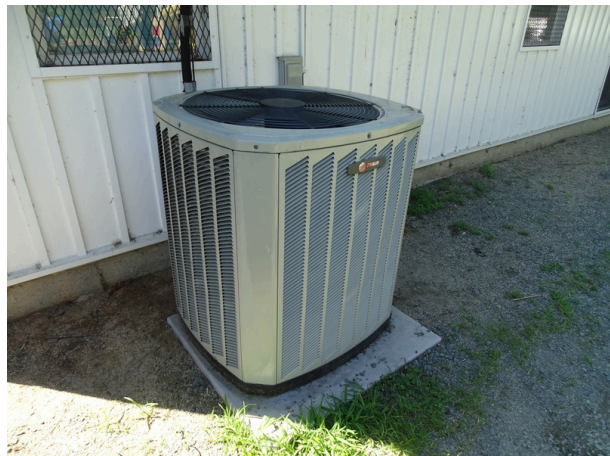
Typical condenser

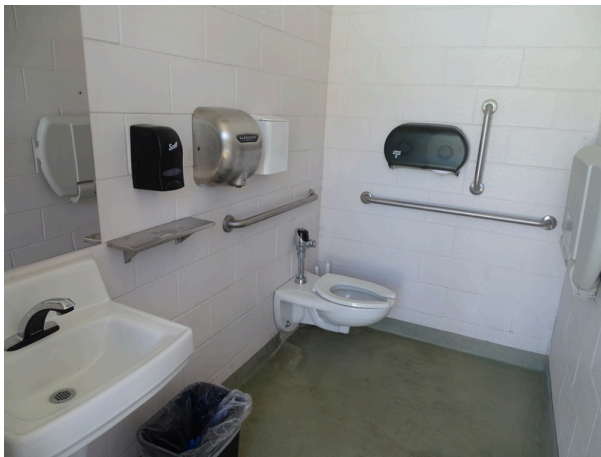
An allowance has been included to replace the epoxy flooring throughout the building. Concrete coatings typically have an expected useful life of 10 years, though the current concrete coating is showing premature deterioration.

Bath house family restroom

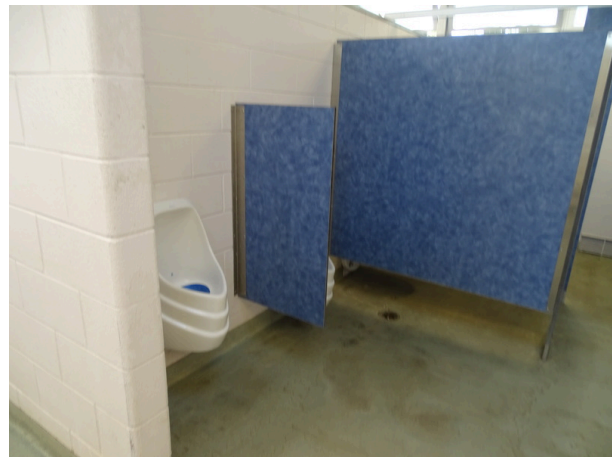
Bath house men's bathroom

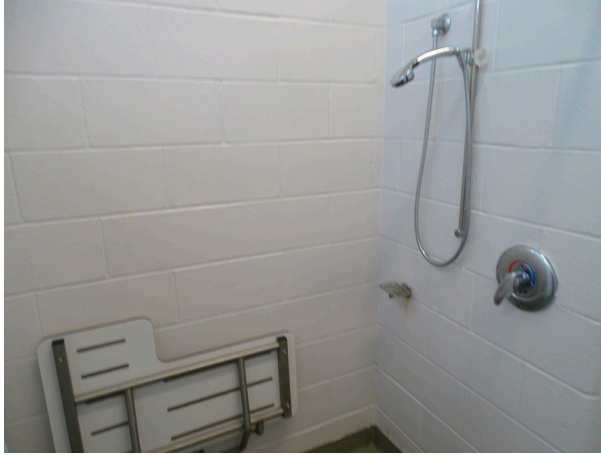
Typical Bath house bathroom

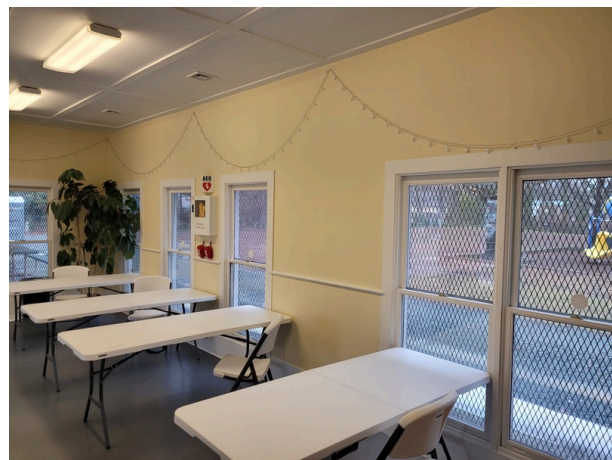
The finishes throughout the building, including in the kitchenette, corridor, and utility room, include vinyl floors, painted gypsum board walls, and painted gypsum board ceilings. The finishes were in generally good condition. It was noted that motion sensing light switches were installed, but none of the sensors appeared to work. To operate the lights, you must press the button.

Shelter interior finishes

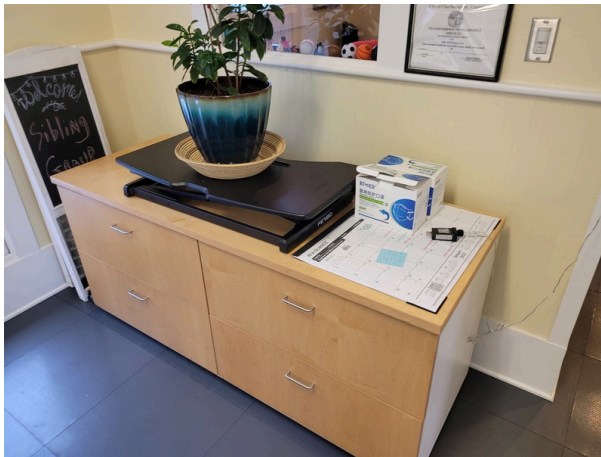
Shelter interior finishes

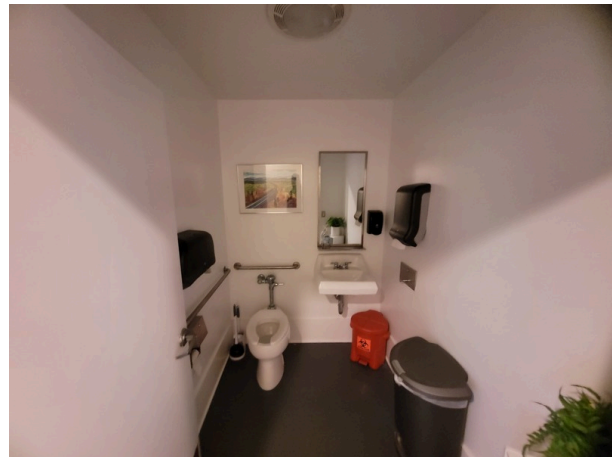
Shelter interior finishes

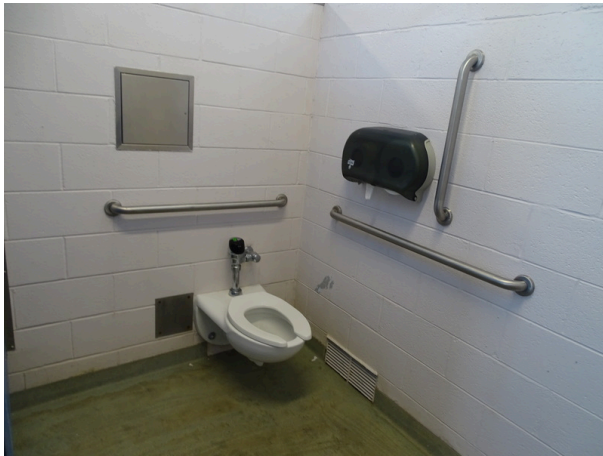
Accessible bath house bathroom

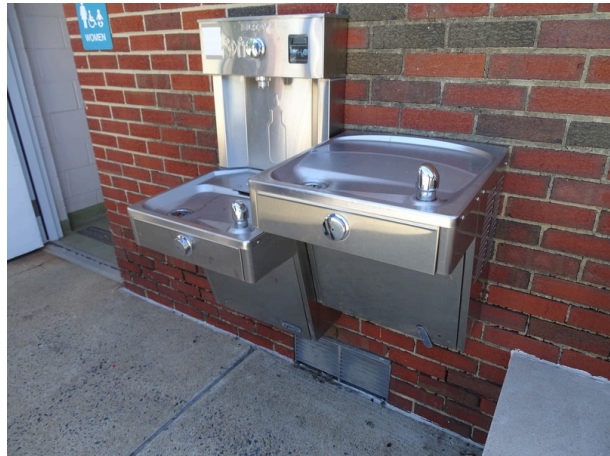
Bath house accessible drinking fountain

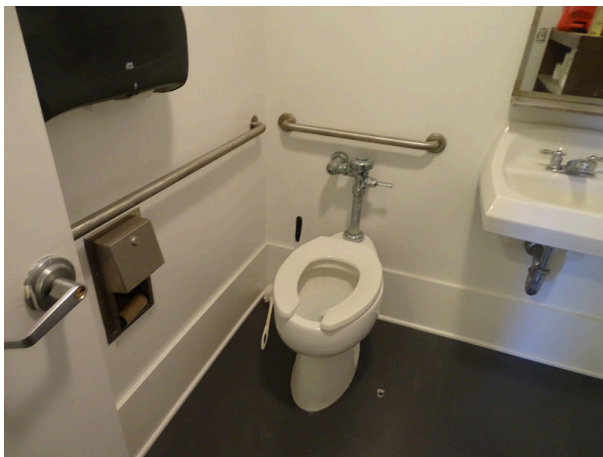
Accessible shelter restroom

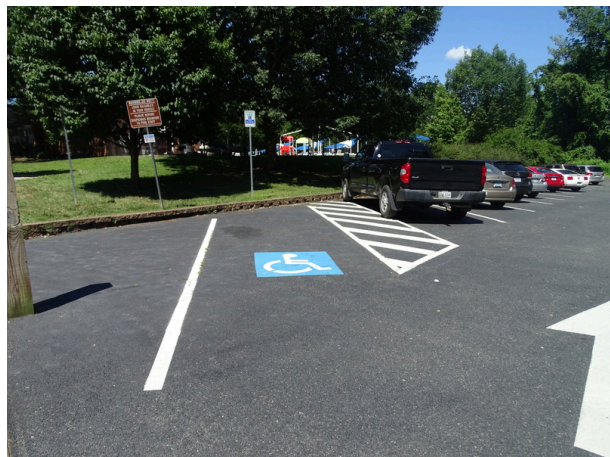
Accessible parking overview

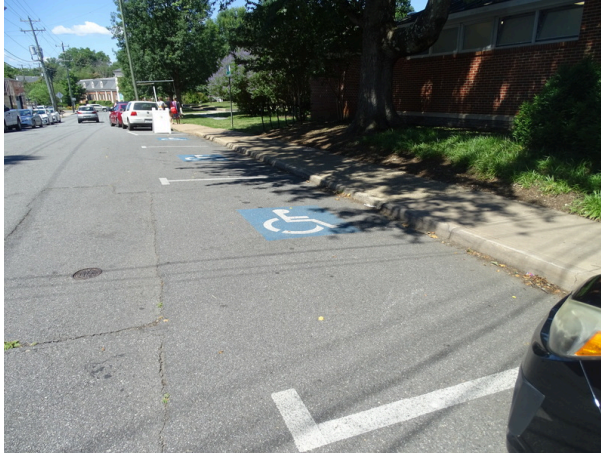
For a space to be considered van accessible, it must be 132" wide with a 60" aisle OR 96" wide with a 96" wide aisle. No space currently meets this specification. Signage indicating the space as van accessible must also be provided. We recommend providing a van accessible space, aisle, and signage.

Three of the marked accessible parking spaces are located on the street as parallel parking spaces. The curb adjacent to these spaces is not at the same level as the parking spaces, therefore these spaces are not provided with a compliant access aisle. We recommend that no less than the minimum number of accessible spaces required are located in the parking lot, to include at least 1 van space and required access aisles.

Non-compliant accessible parking

Cost Recommendation	EUL	EFF AGE	RUL	Year	Cost
REPLACE OR RELOCATE DRINKING FOUNTAIN AT SHELTER	15	15	0	Immediate	\$5,000
PROVIDE VAN ACCESSIBLE PARKING SPACE AND ACCESS AISLE	15	15	0	Immediate	\$500
Total					\$5,500

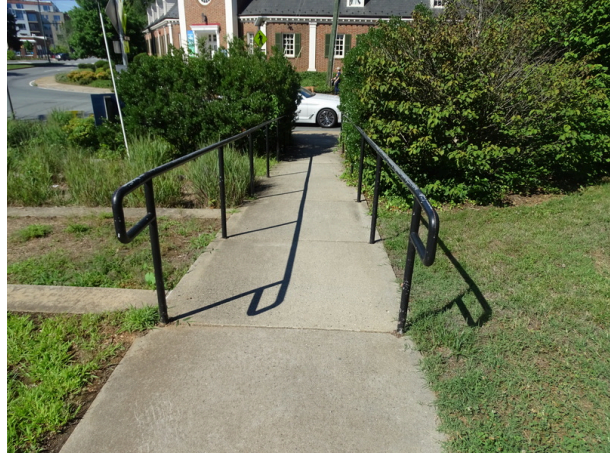
Accessible ramp

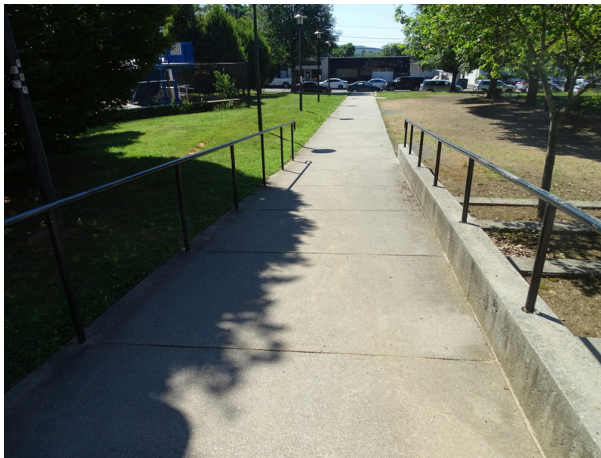
Accessible ramp

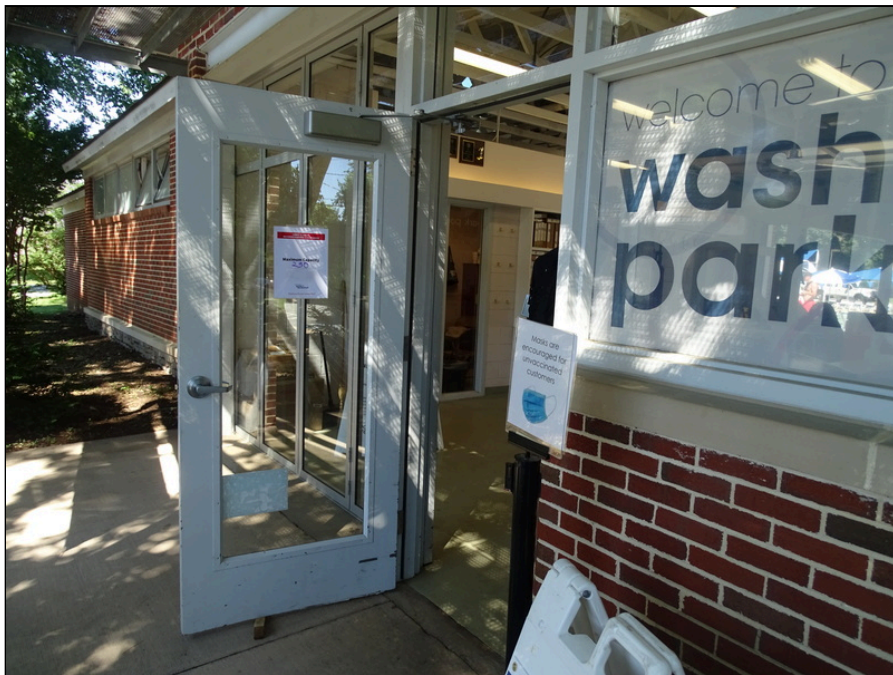
2 - Bath house overview

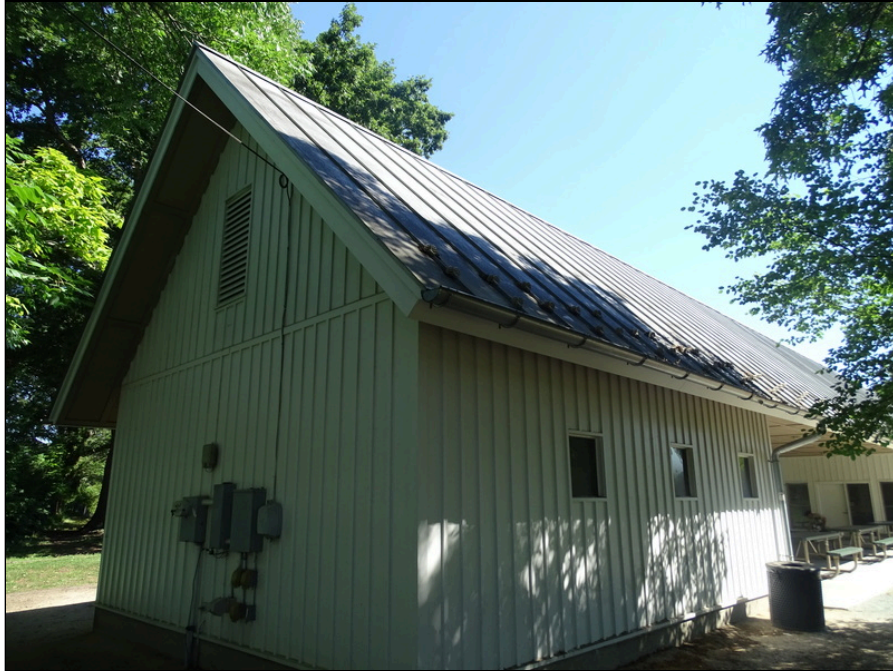
3 - Shelter overview

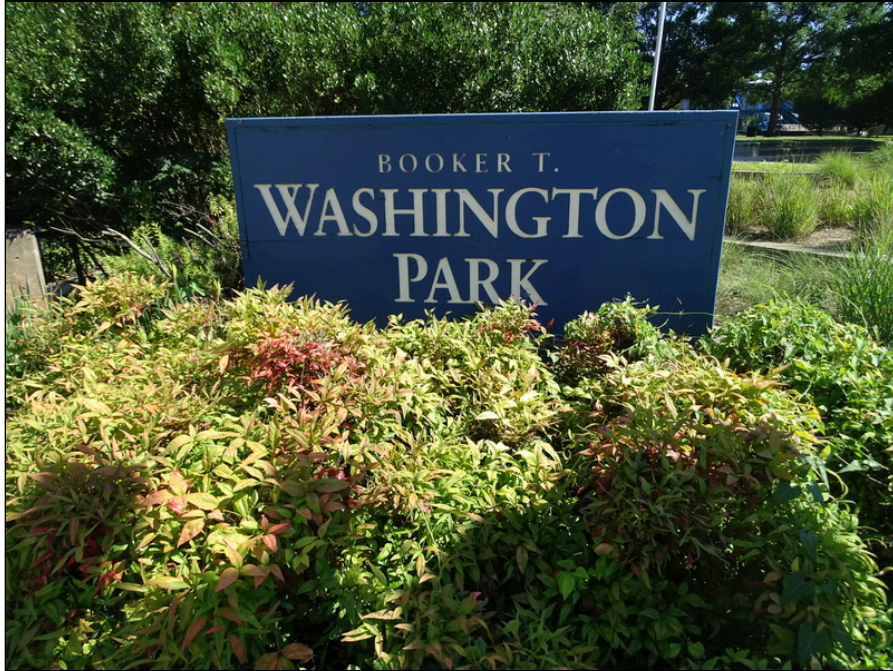
7 - Monument sign

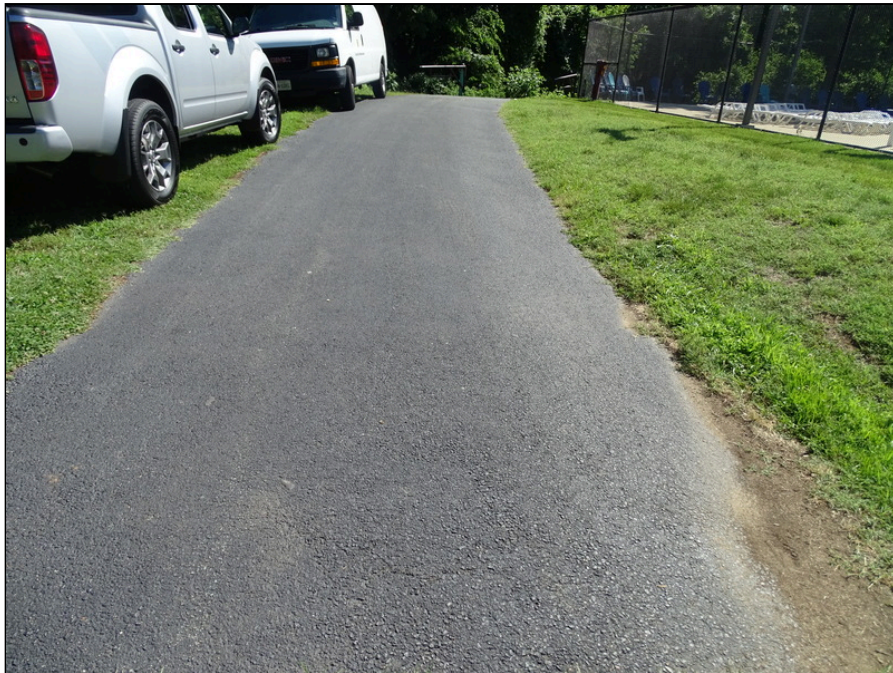
8 - Asphalt pavement overview

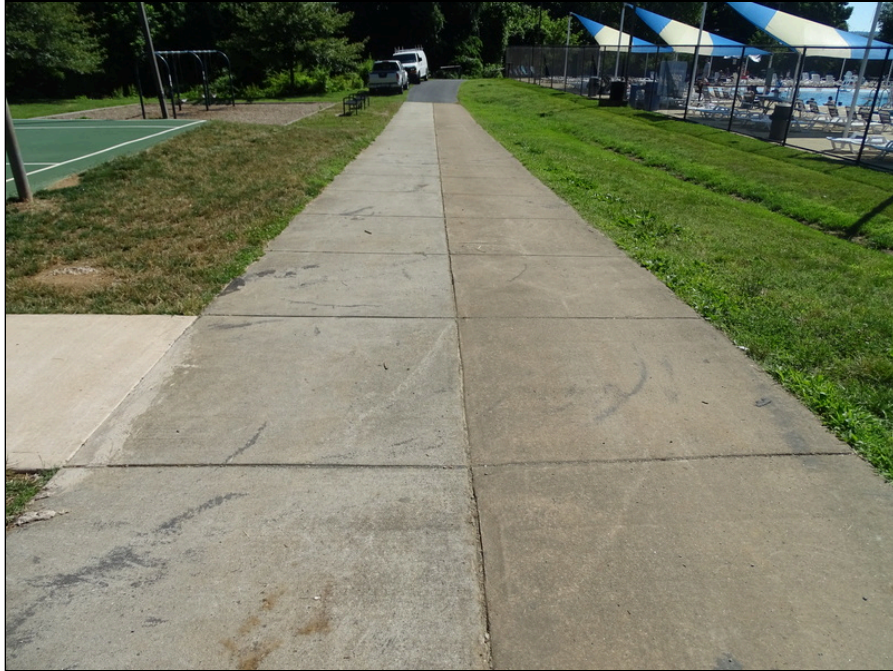
11 - Concrete sidewalk

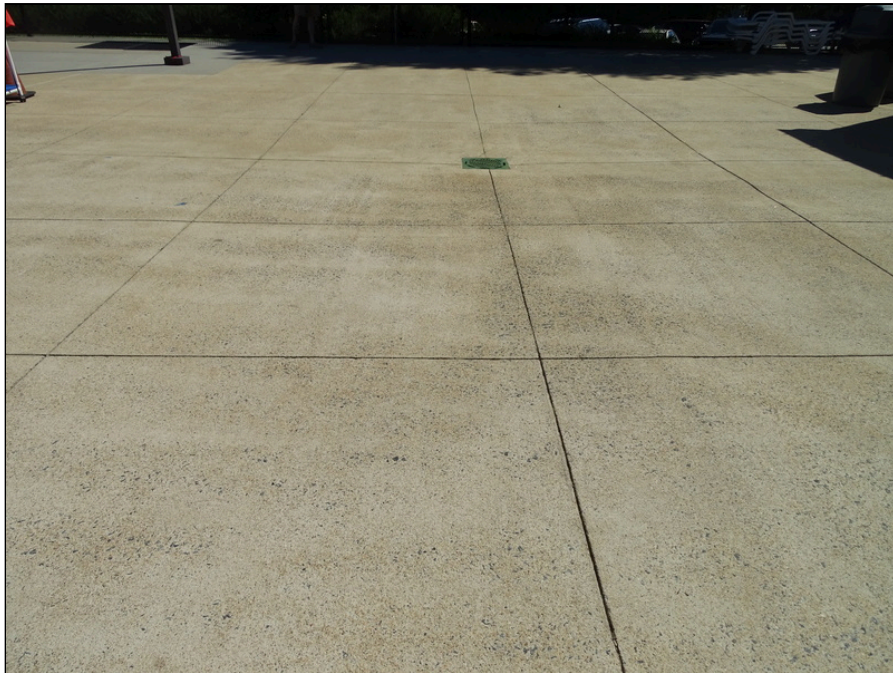
12 - Concrete pavement

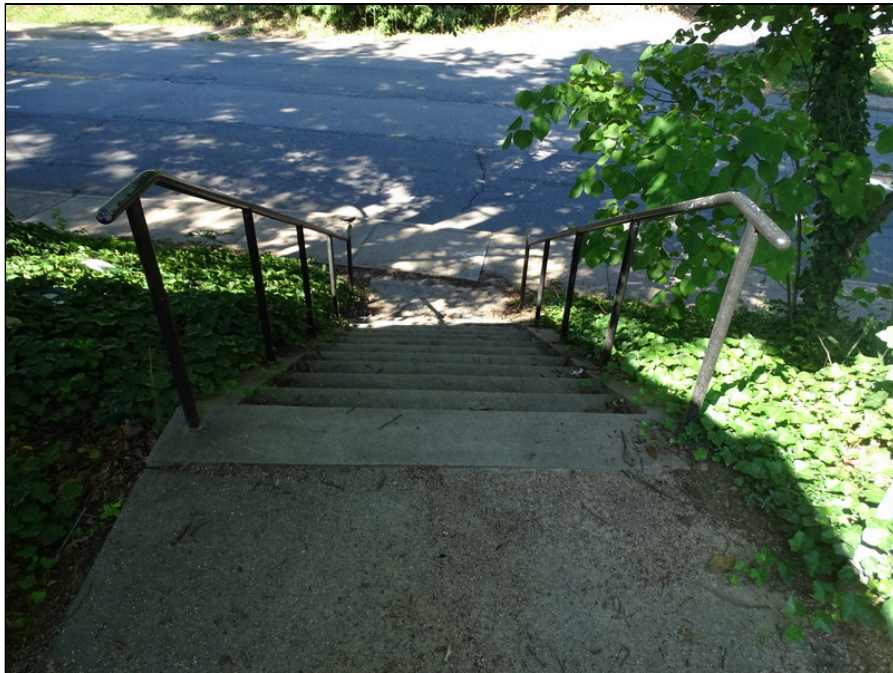
14 - Typical concrete steps

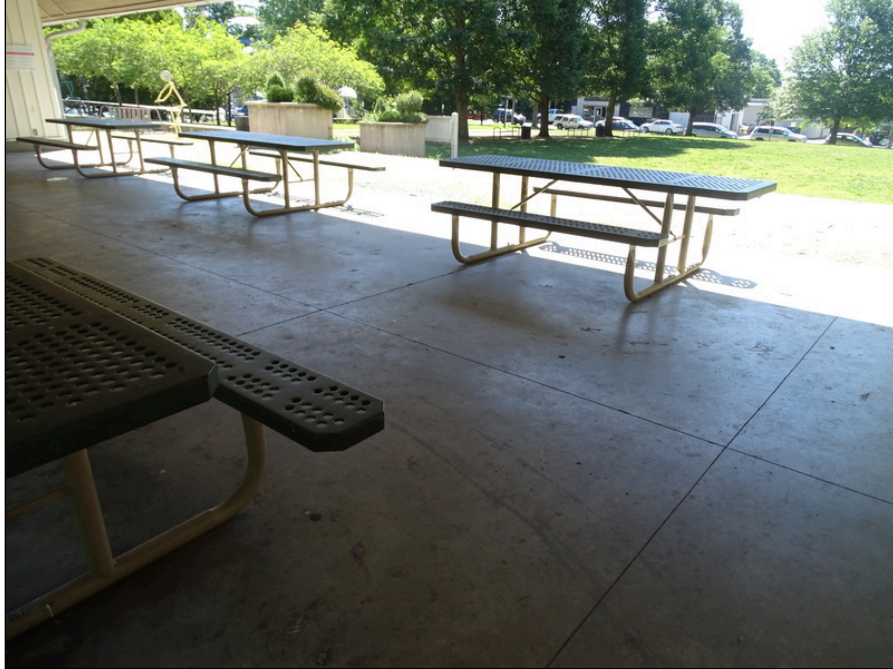
15 - Concrete patio at shelter

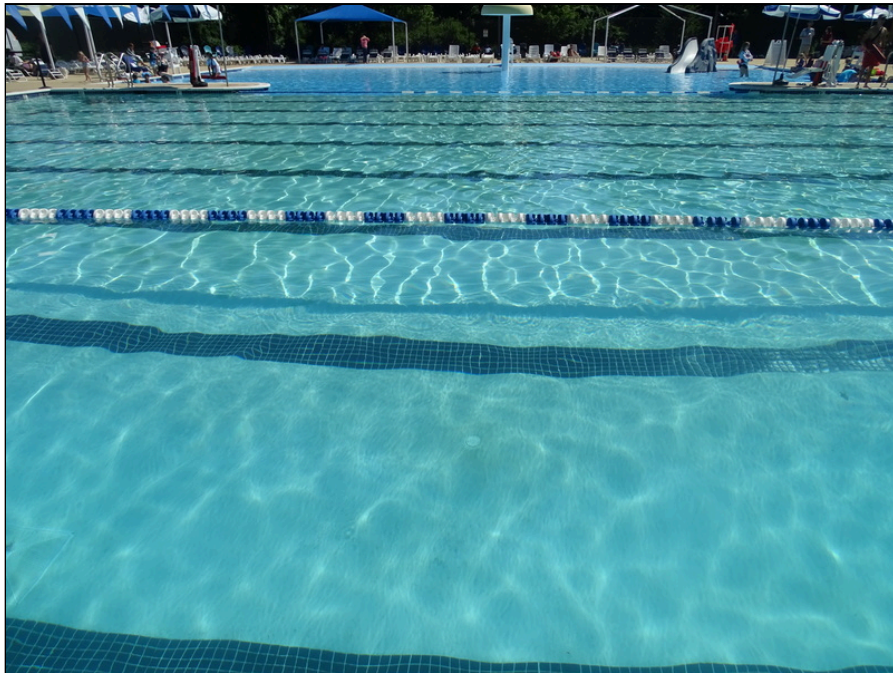
20 - Pool overview

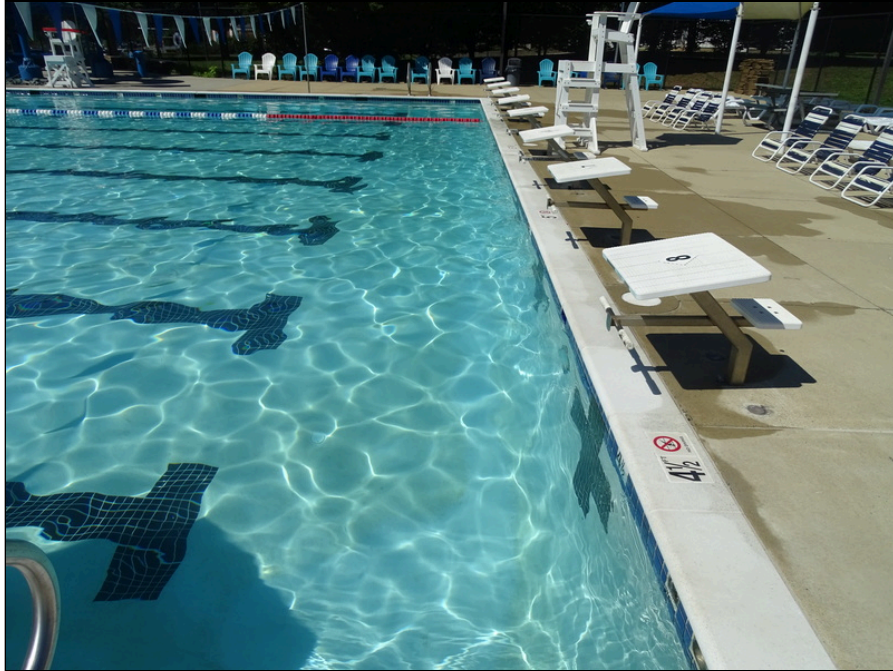
21 - Pool overview

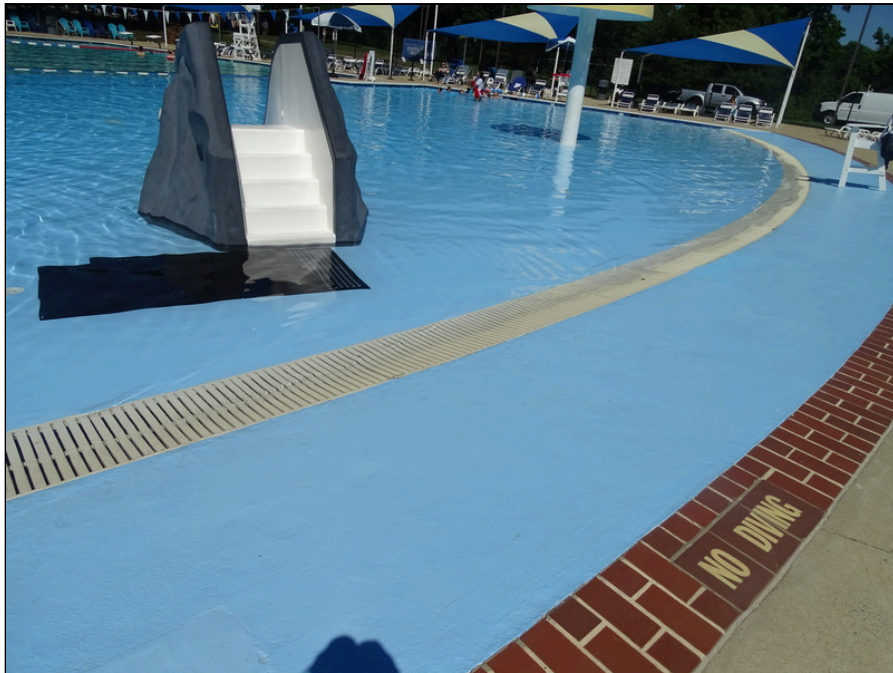
22 - Pool overview

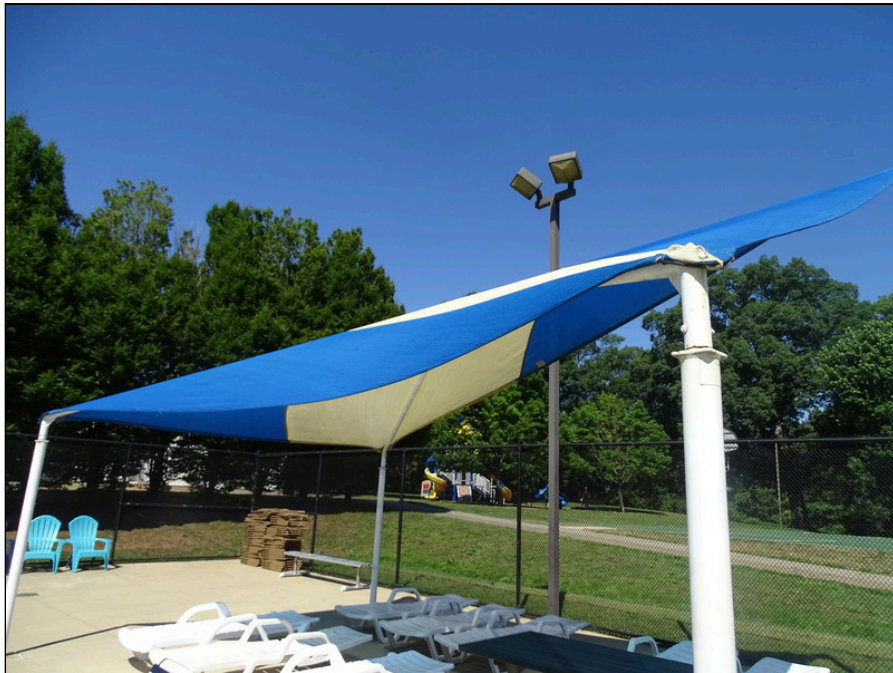
24 - Pole mounted lighting overview

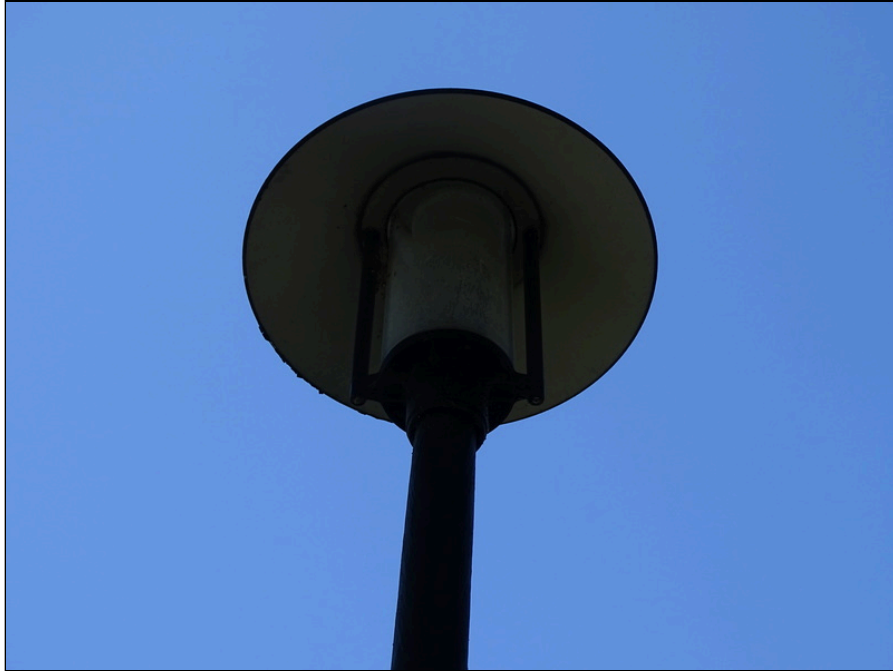
27 - Pole mounted lighting

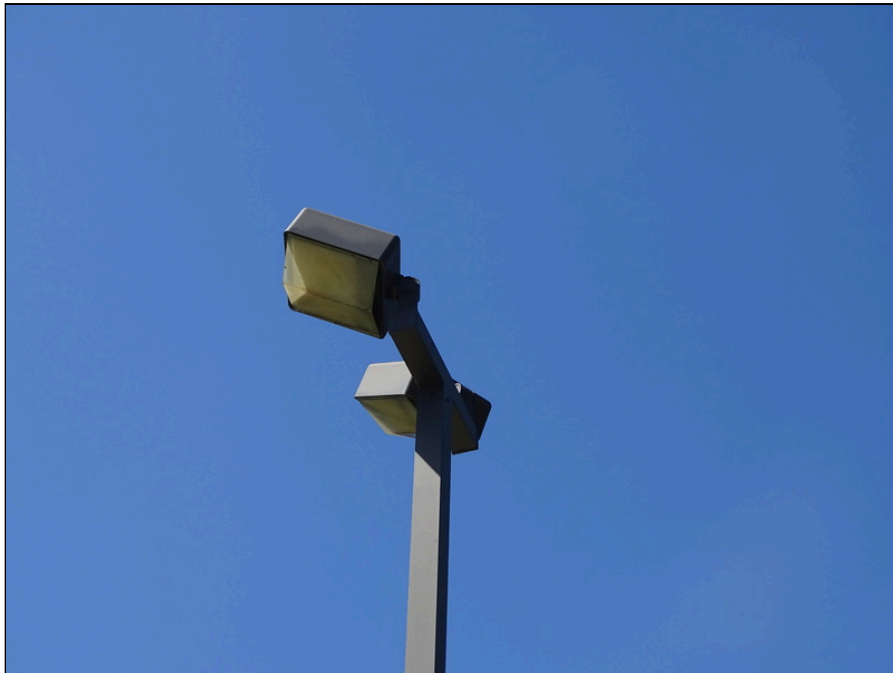
28 - Pole mounted lighting

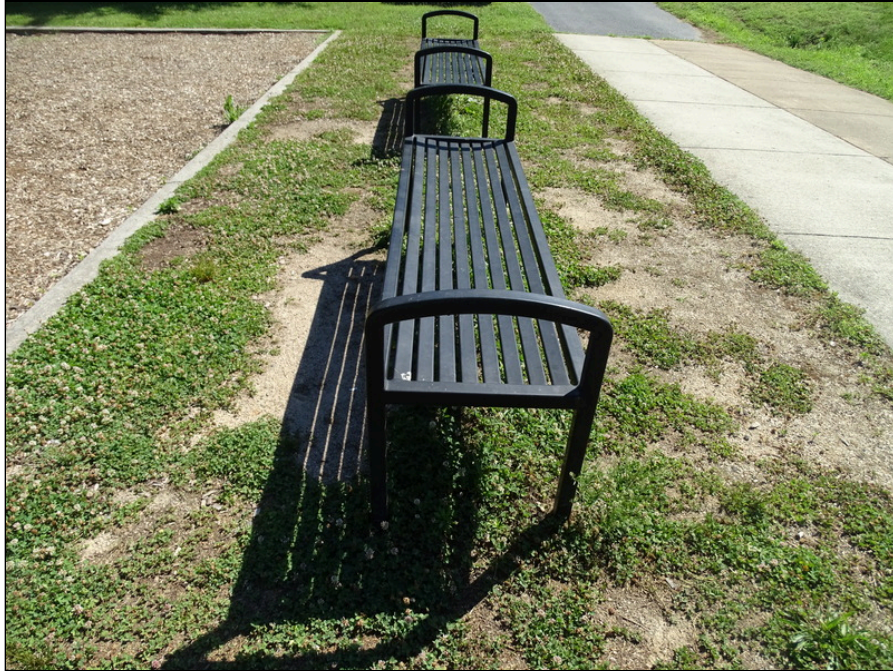
29 - Typical landscaping

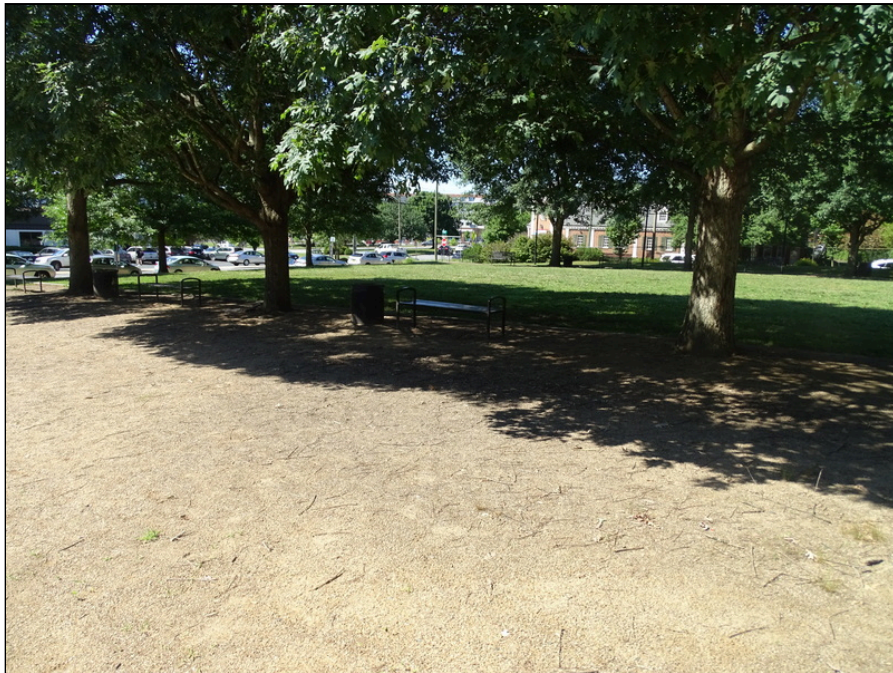
30 - Typical landscaping

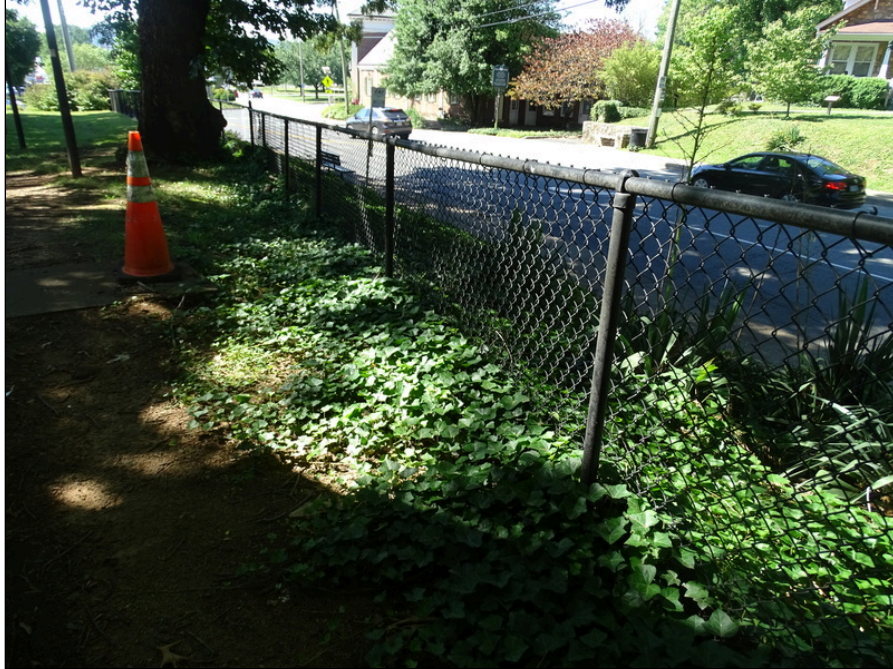
31 - Typical landscaping and fencing

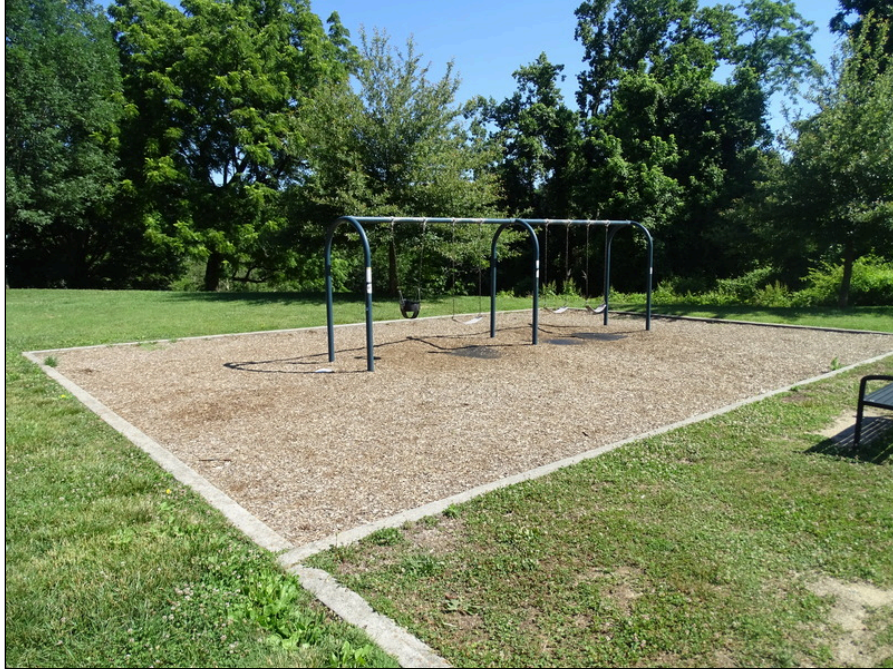
33 - Typical playground

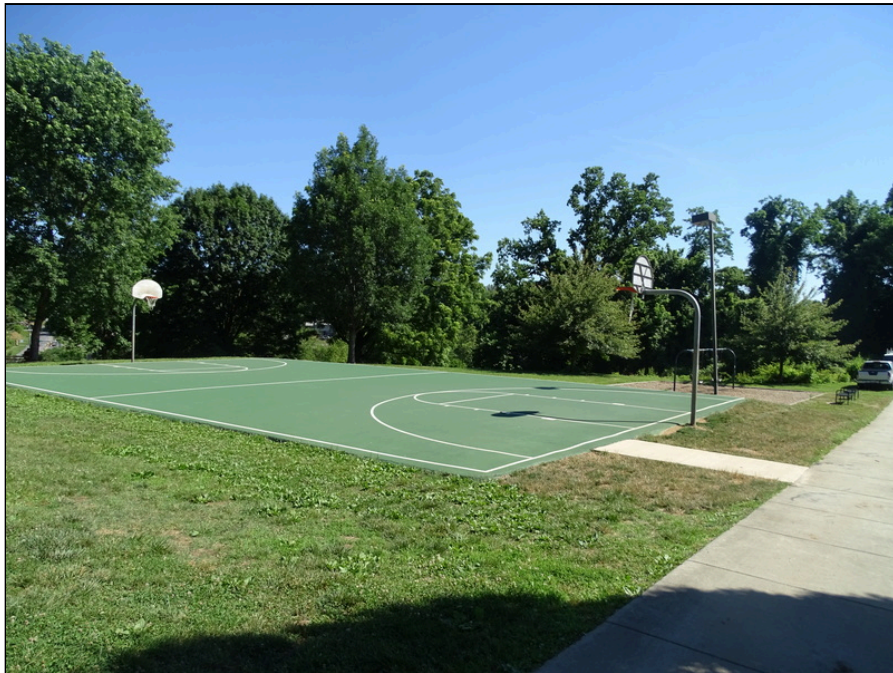
34 - Typical playground

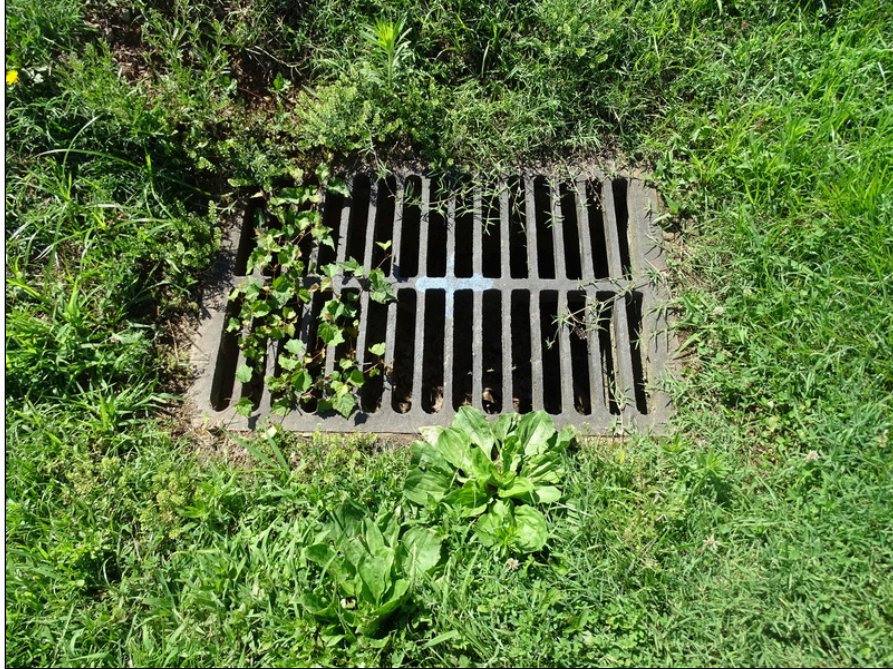
35 - Typical drainage

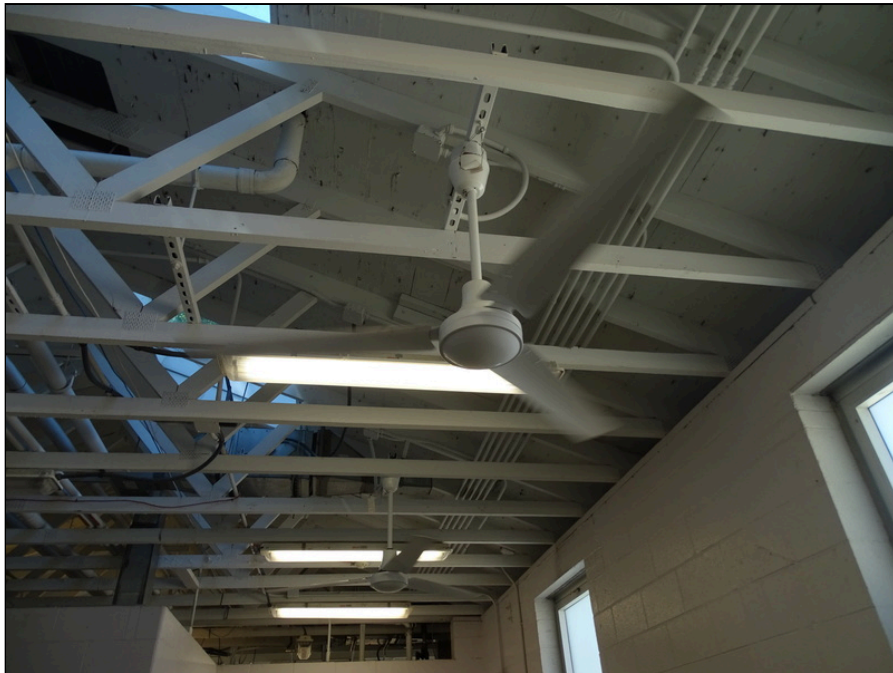
36 - Bath house framing

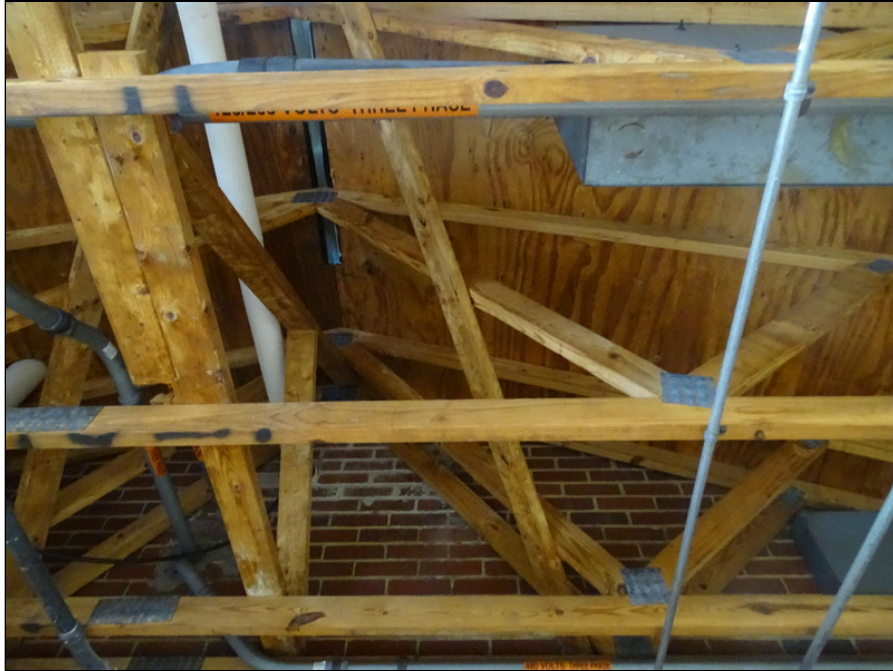
37 - Bath house framing

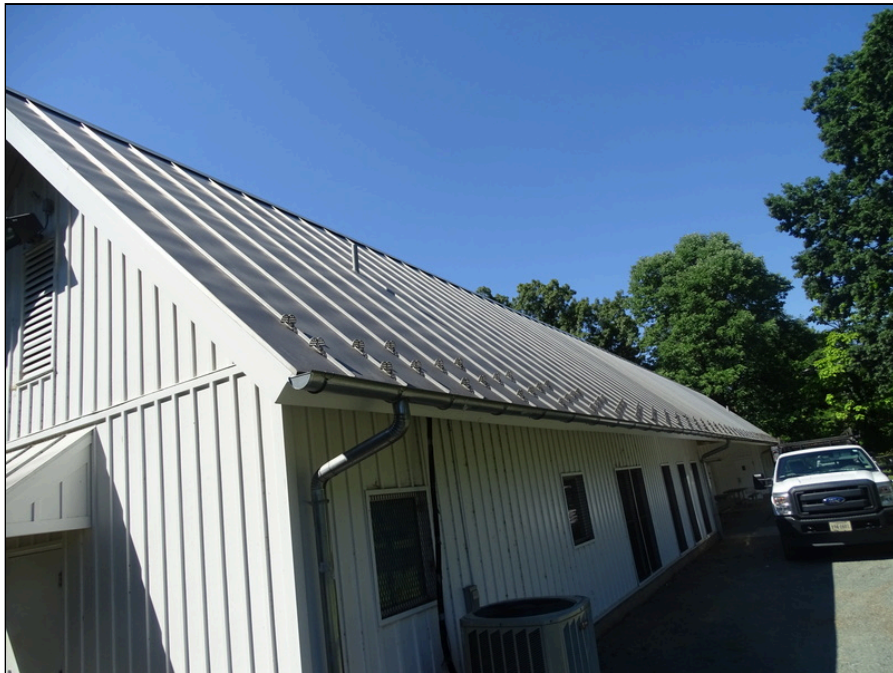
38 - Shelter exterior

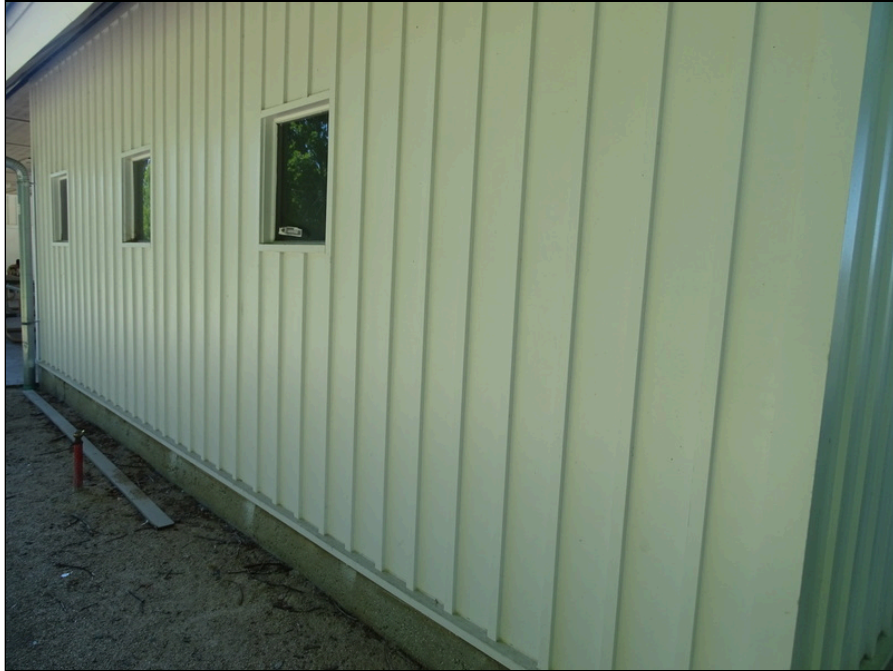
39 - Shelter exterior

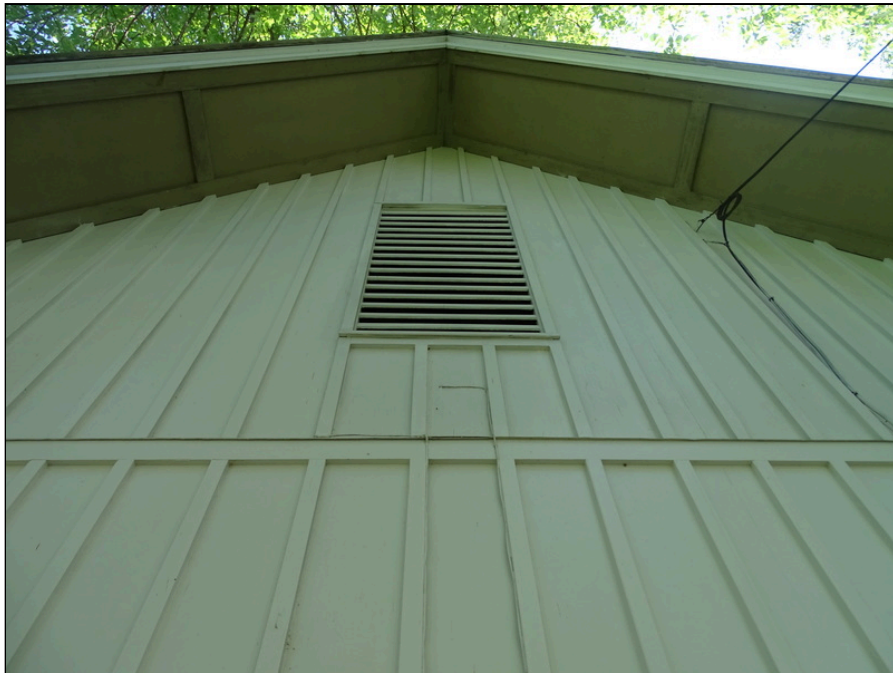
40 - Shelter exterior

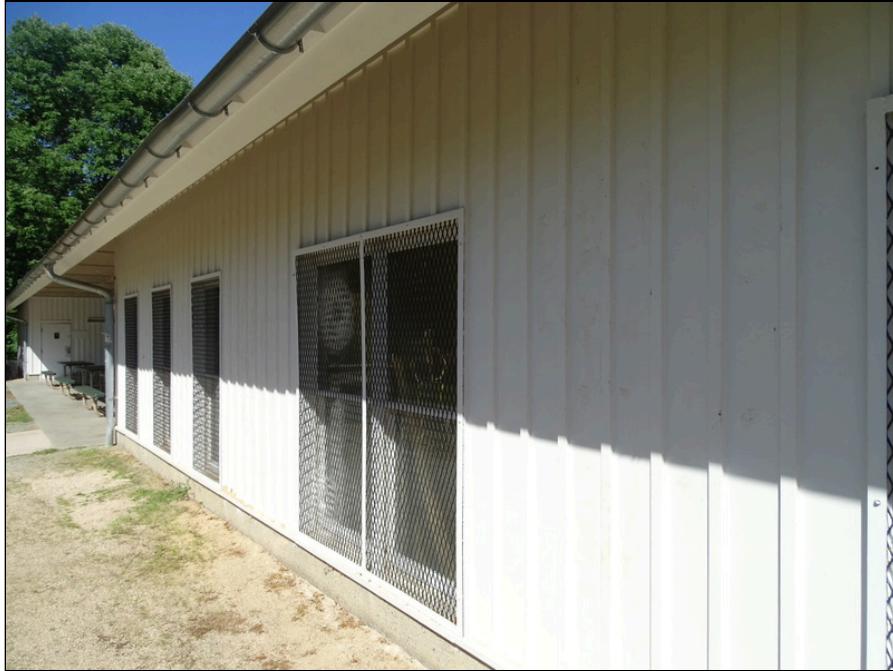
41 - Shelter exterior

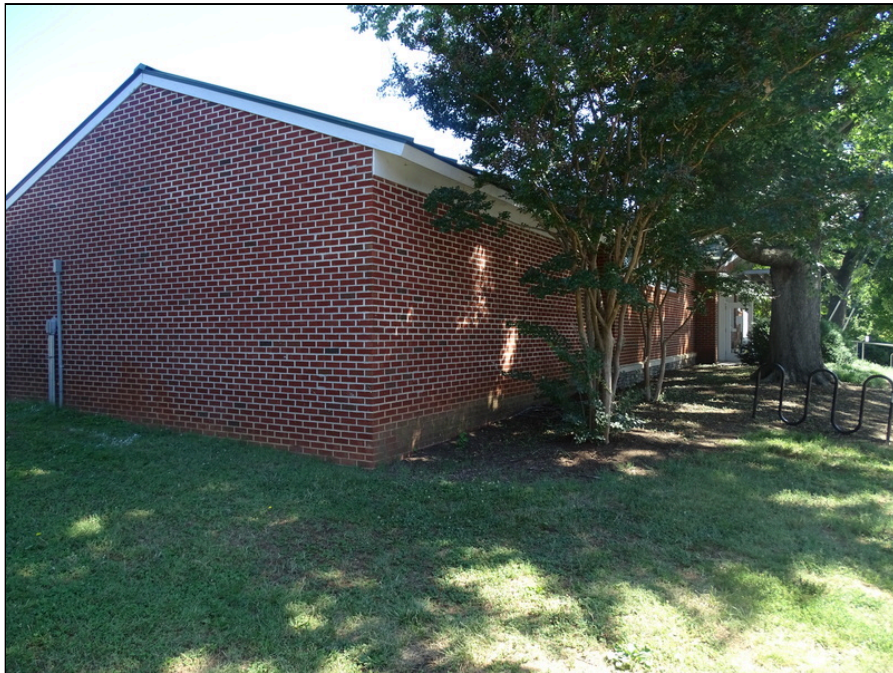
42 - Bath house exterior
