WASHINGTON PARK BATH HOUSE AND SHELTER
1001 PRESTON AVENUE
CHARLOTTESVILLE, VIRGINIA

ECS PROJECT NO. 46:6713

CITY OF CHARLOTTESVILLE - FACILITIES DEVELOPMENT

Reference: Facility Condition Assessment Report for Washington Park Bath House and Shelter, 1001 Preston Avenue, Charlottesville, Virginia

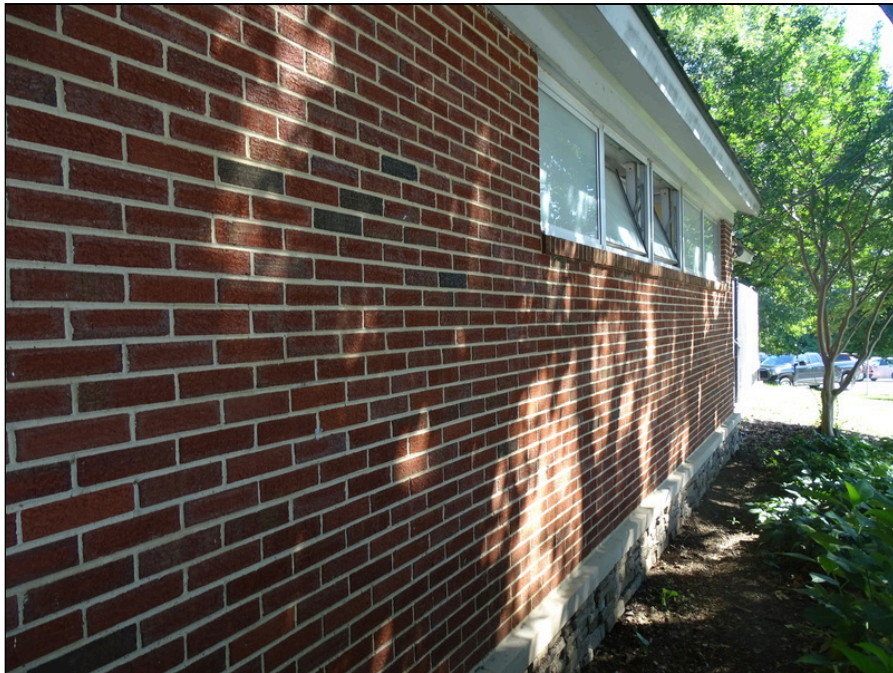
44 - Bath house exterior

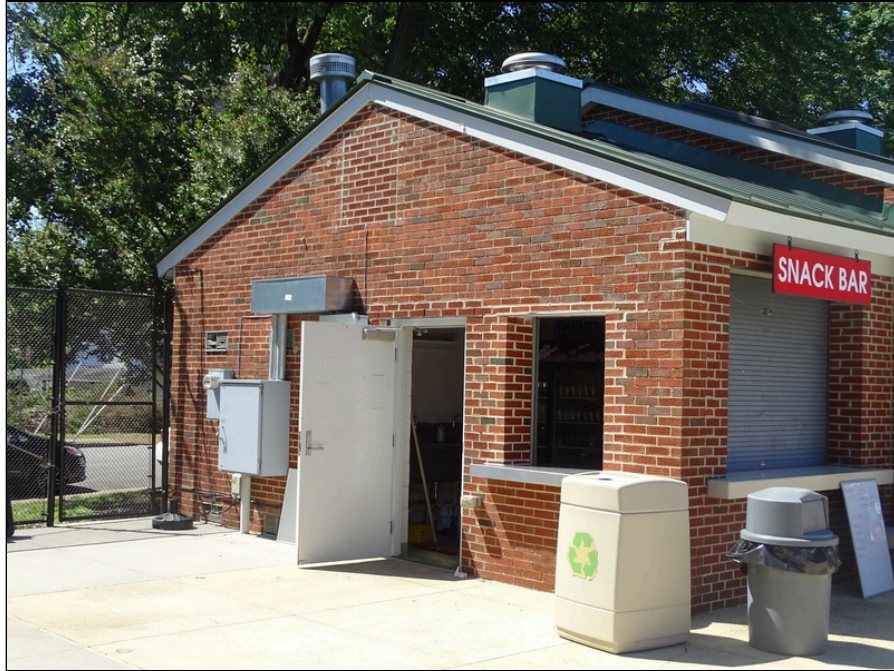
47 - Bath house exterior

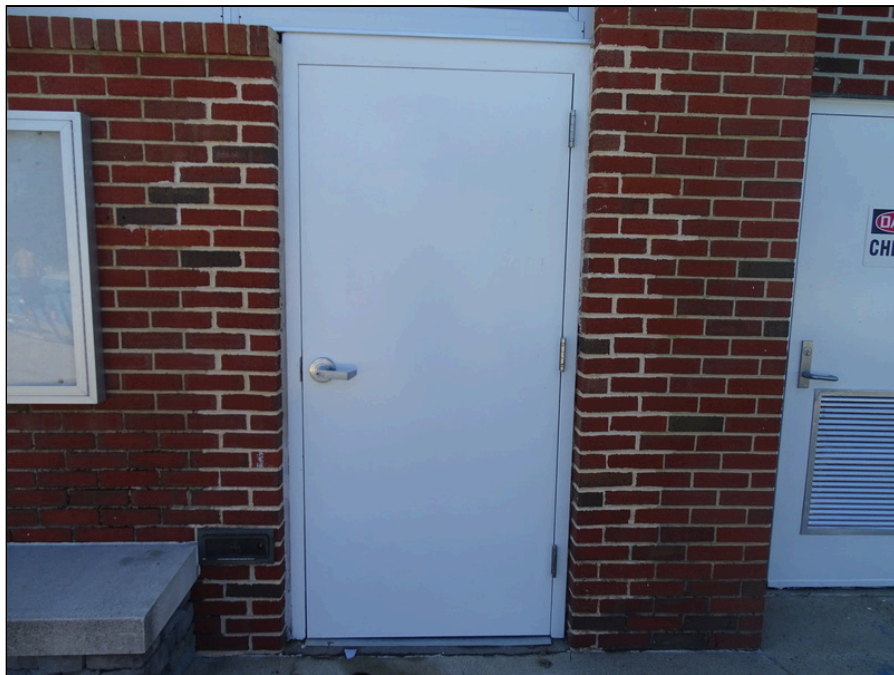
48 - Bath house typical exterior door

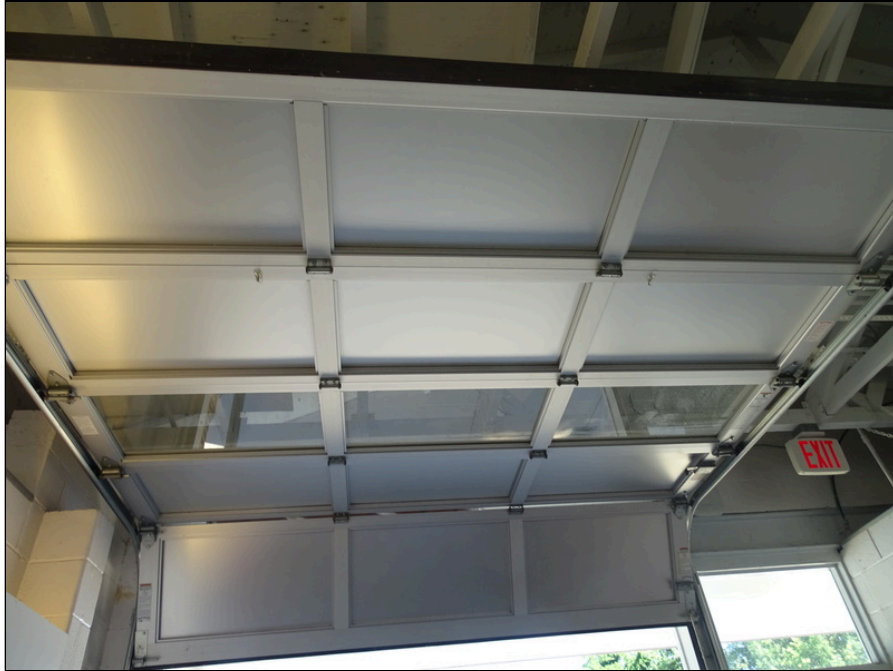
49 - Bath house roll-up door

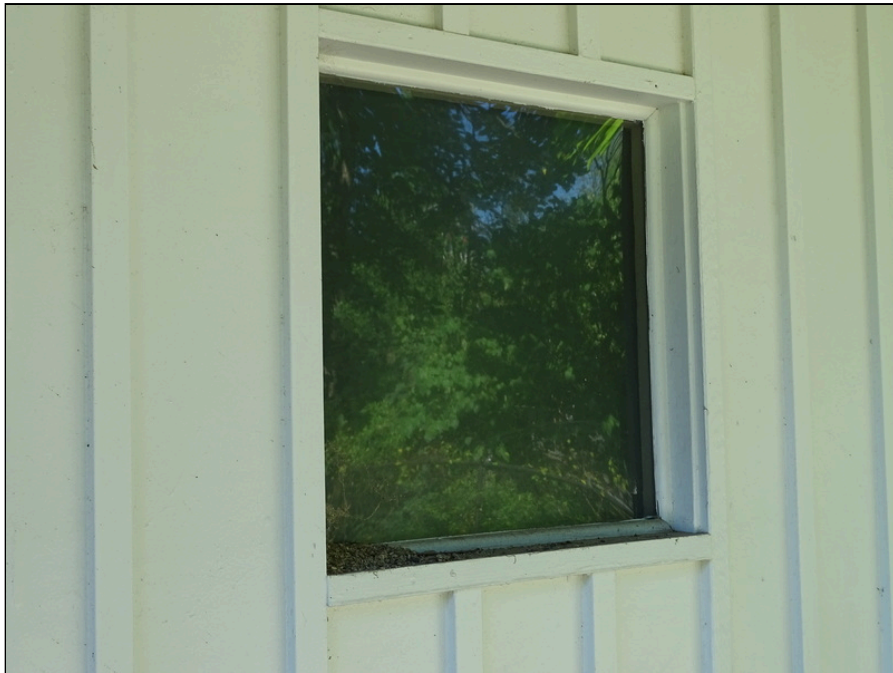
50 - Typical shelter windows

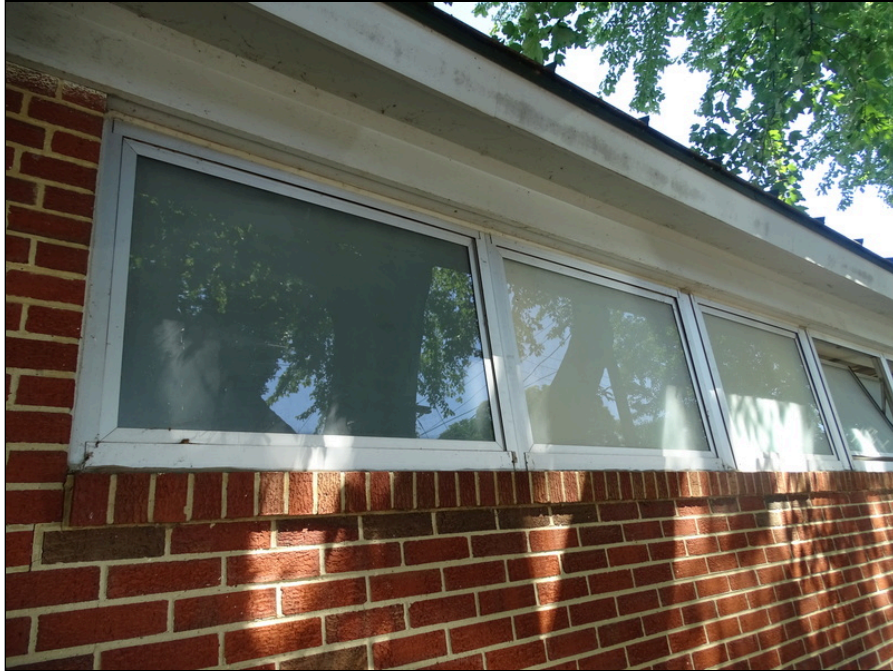
51 - Typical bath house windows

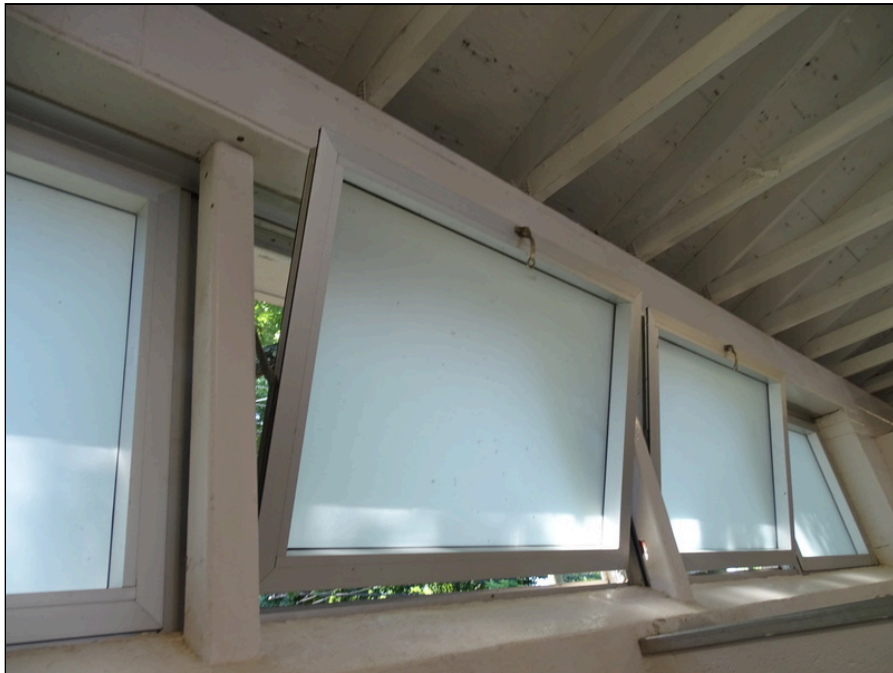
52 - Typical bath house windows

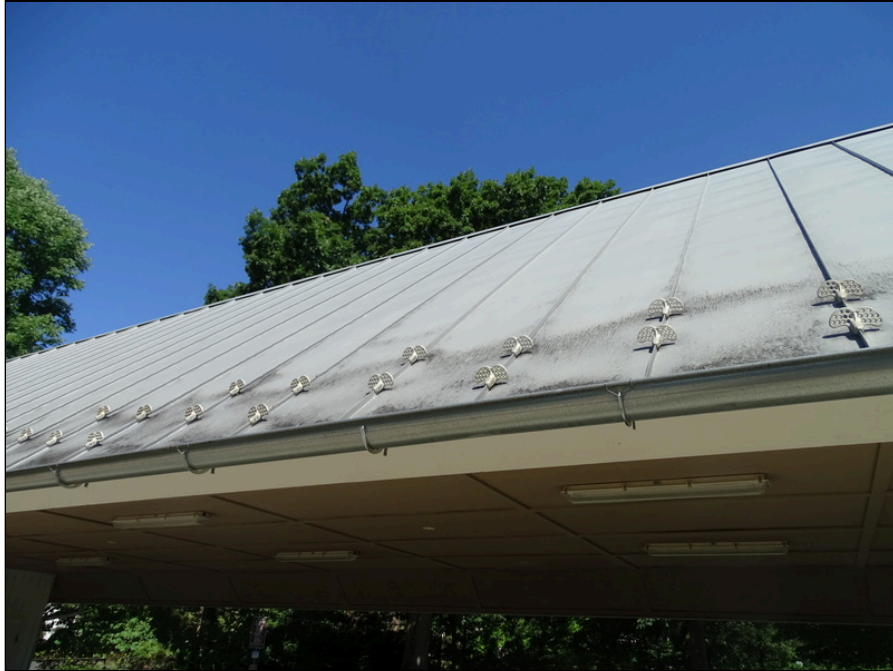
53 - Shelter roofing system

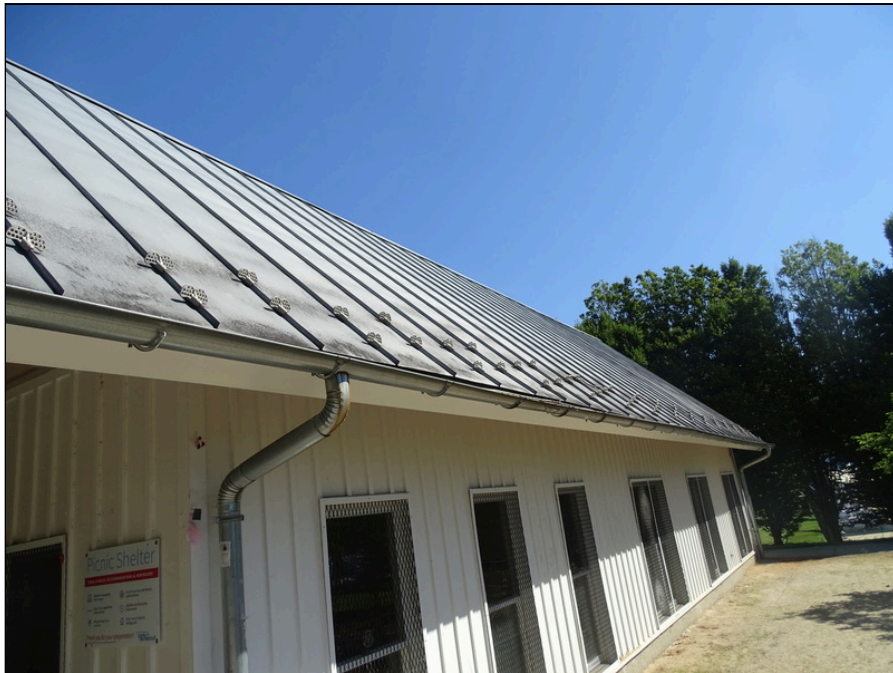
54 - Shelter roofing system

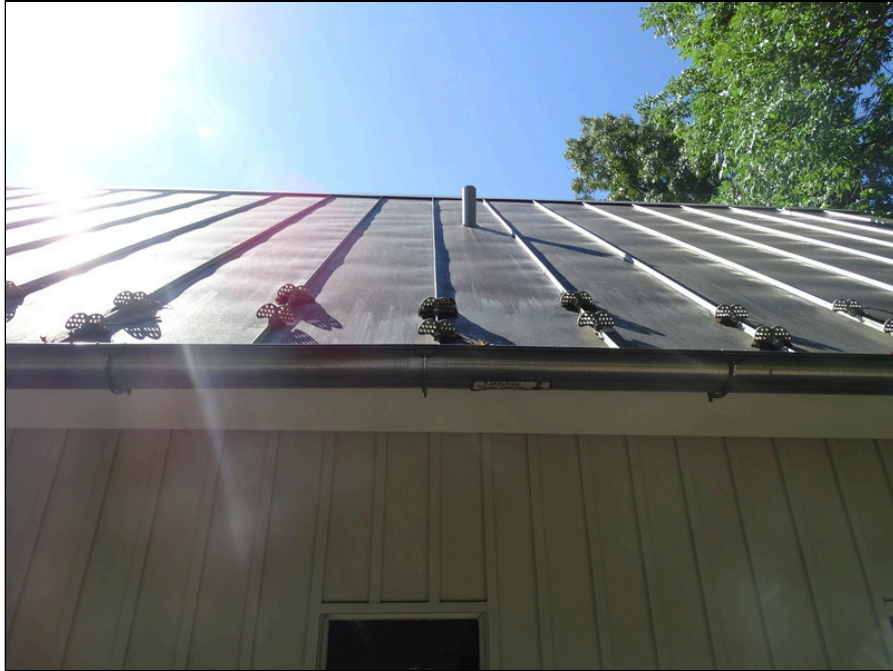
55 - Shelter roofing system

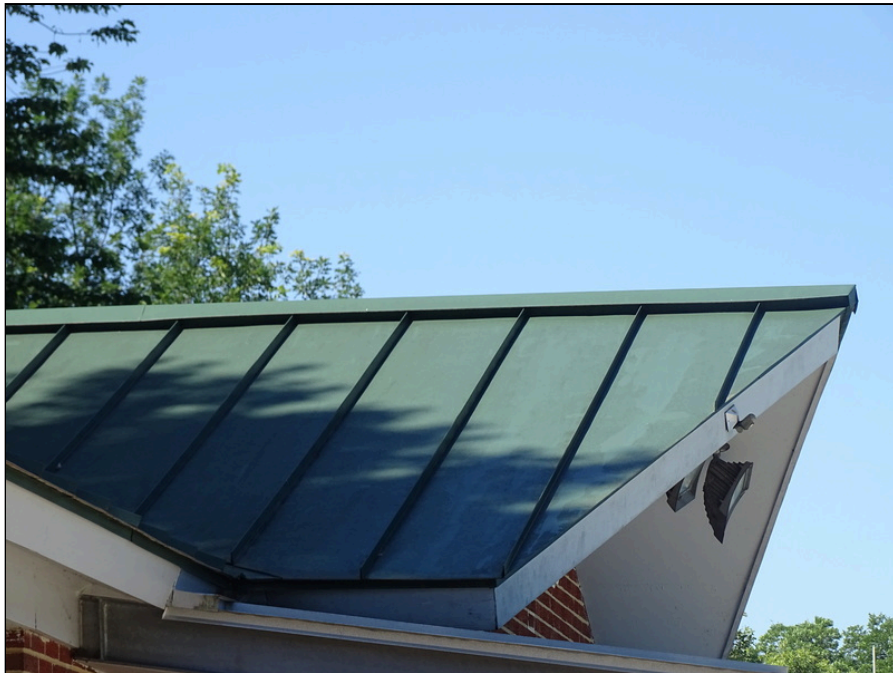
56 - Bath house roof

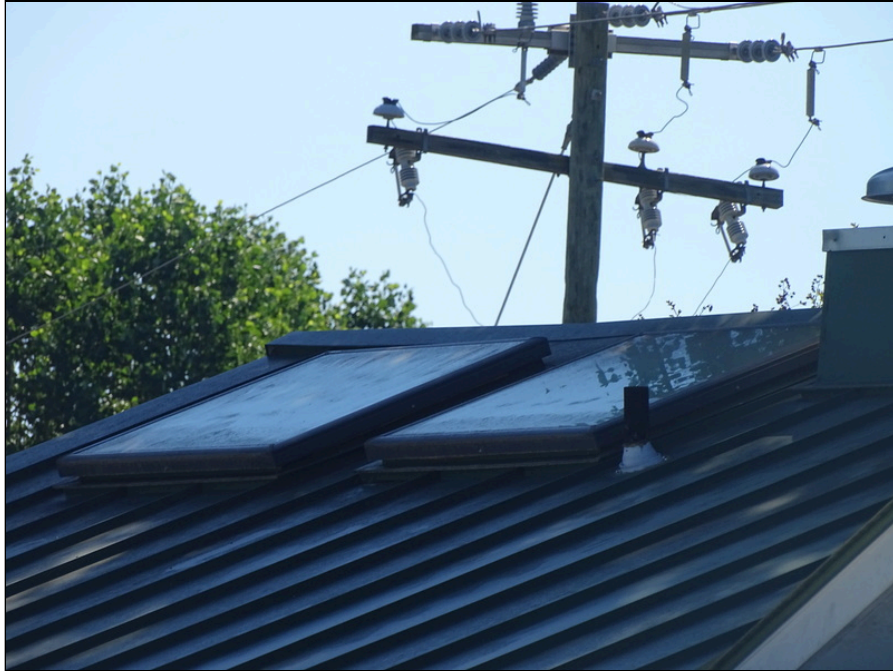
57 - Bath house roof

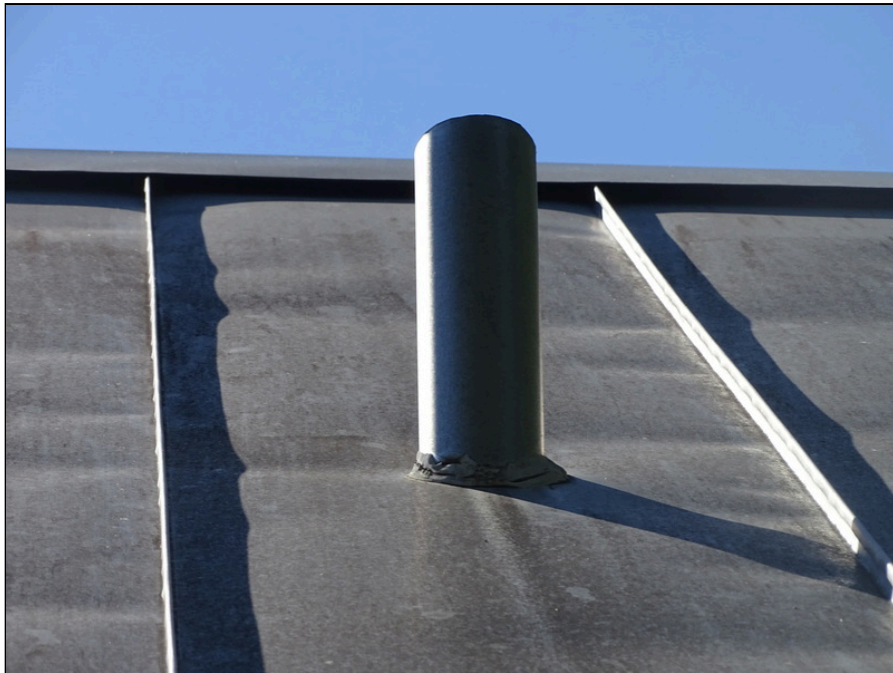
58 - Plumbing Penetration at Bath house roof

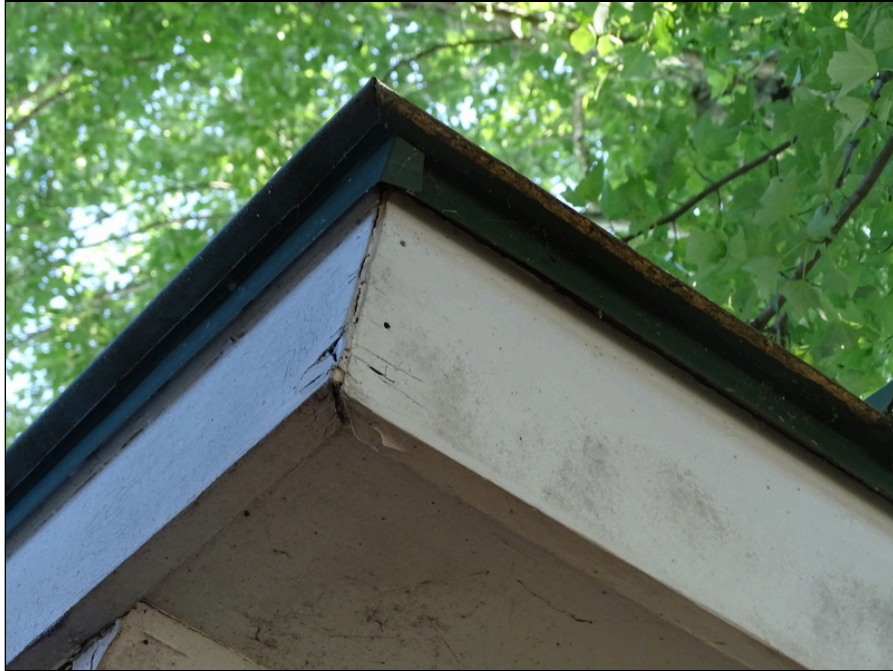
59 - Bath house roof soffit

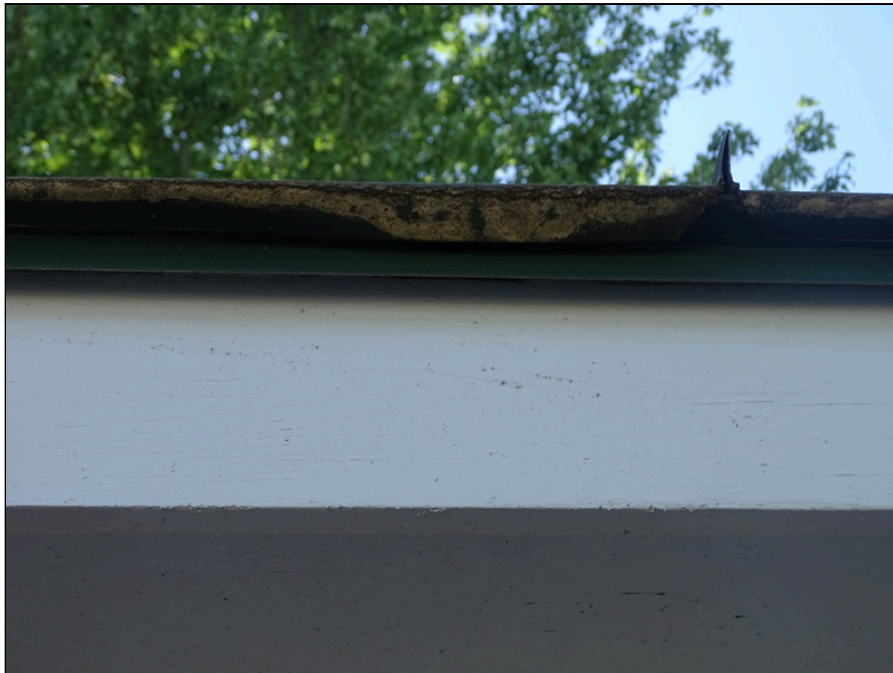
60 - Bath house roof soffit

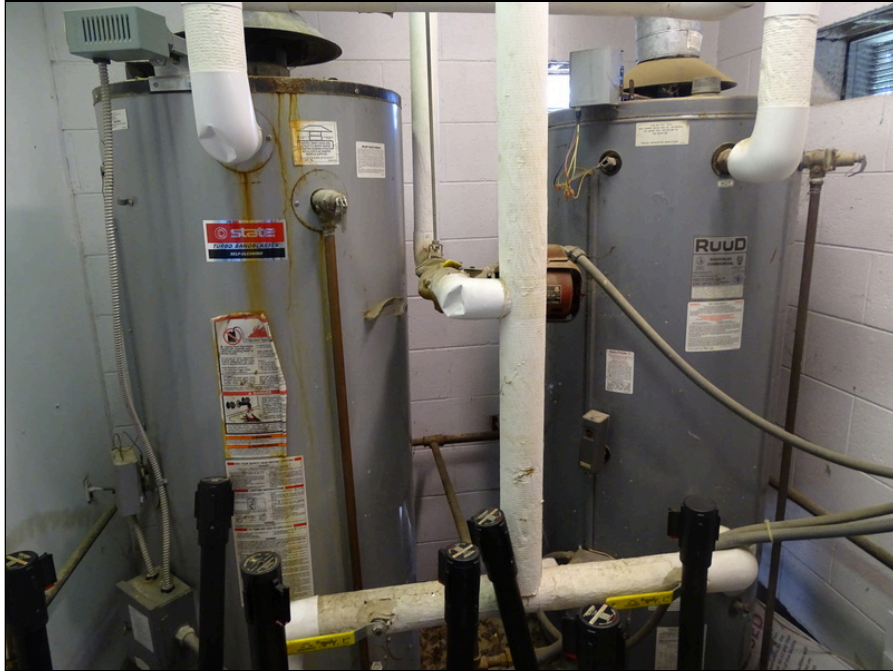
61 - Bath house water heaters

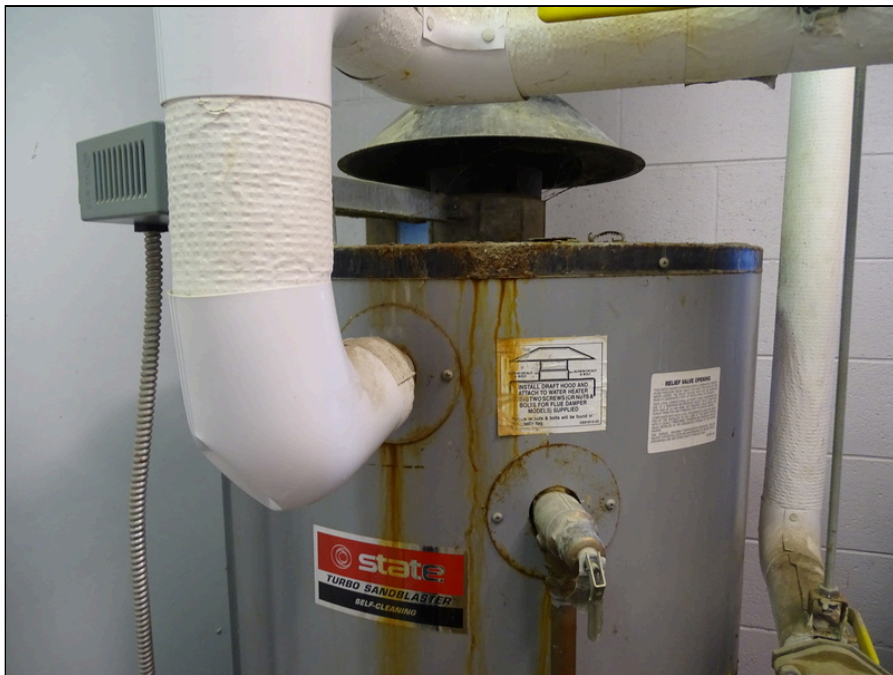
62 - Shelter water heater

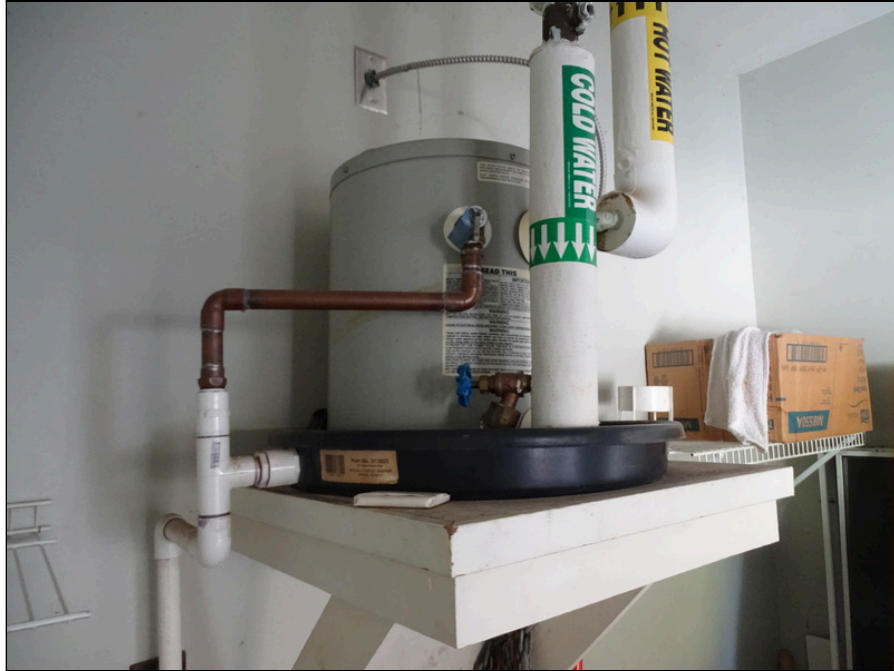
63 - Shelter water heater

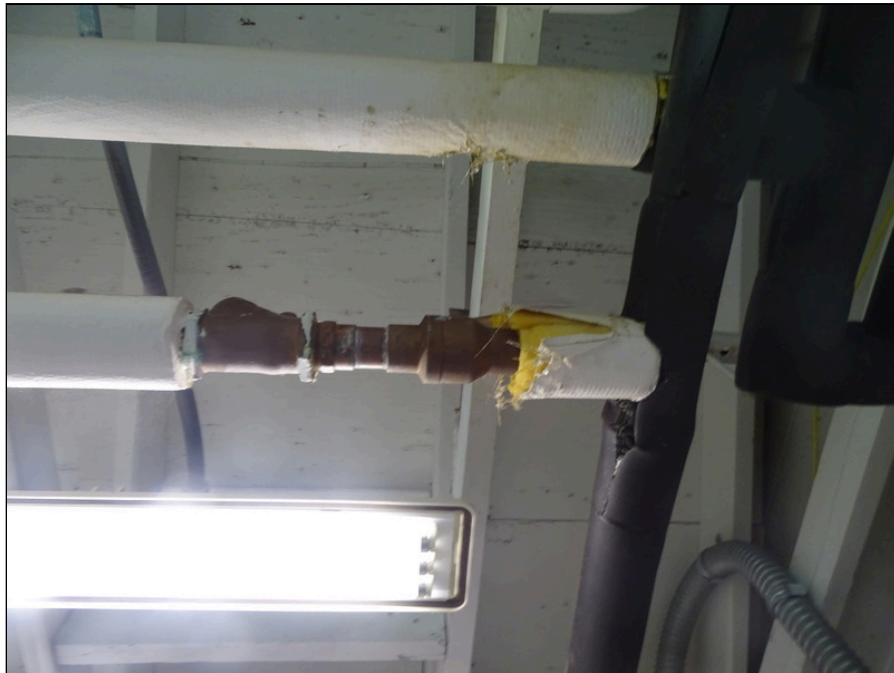
64 - Shelter water piping

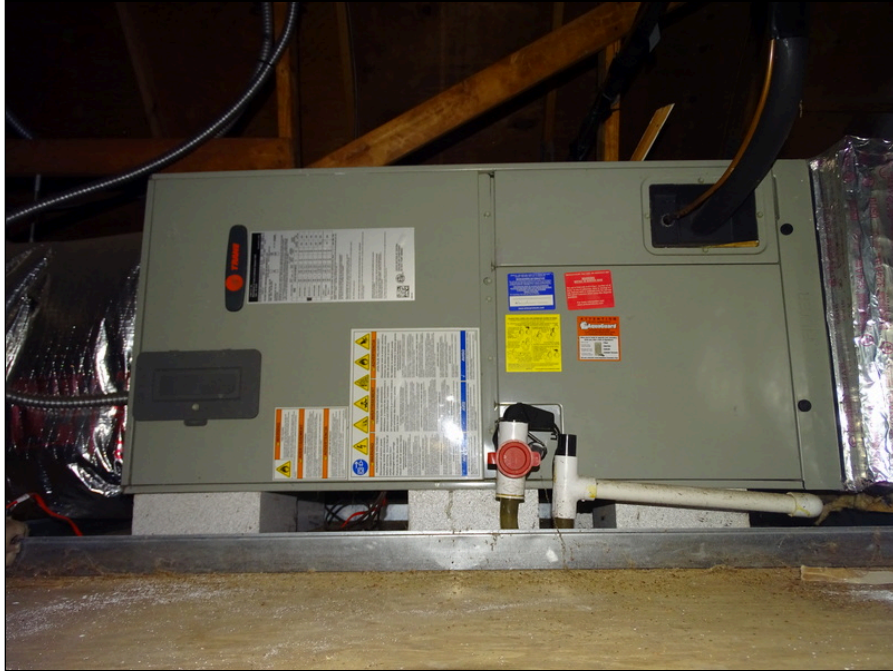
65 - Typical air handler

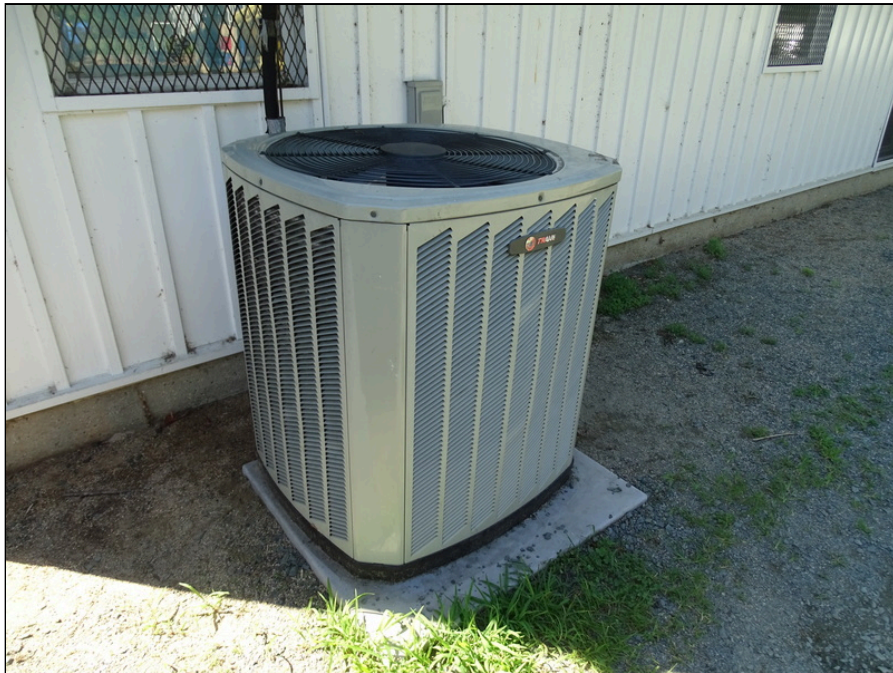
66 - Typical condenser

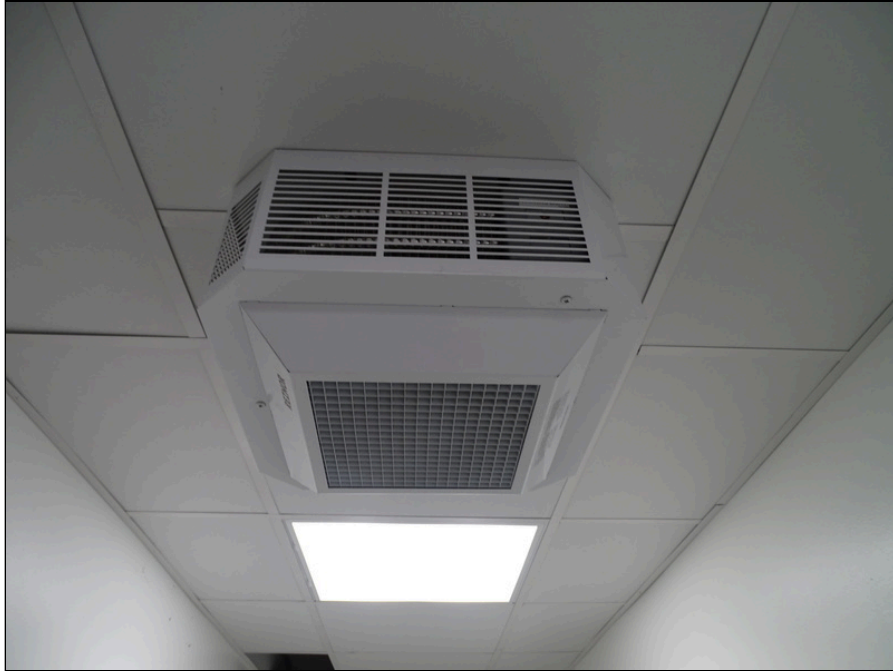
67 - HVAC unit in the Shelter

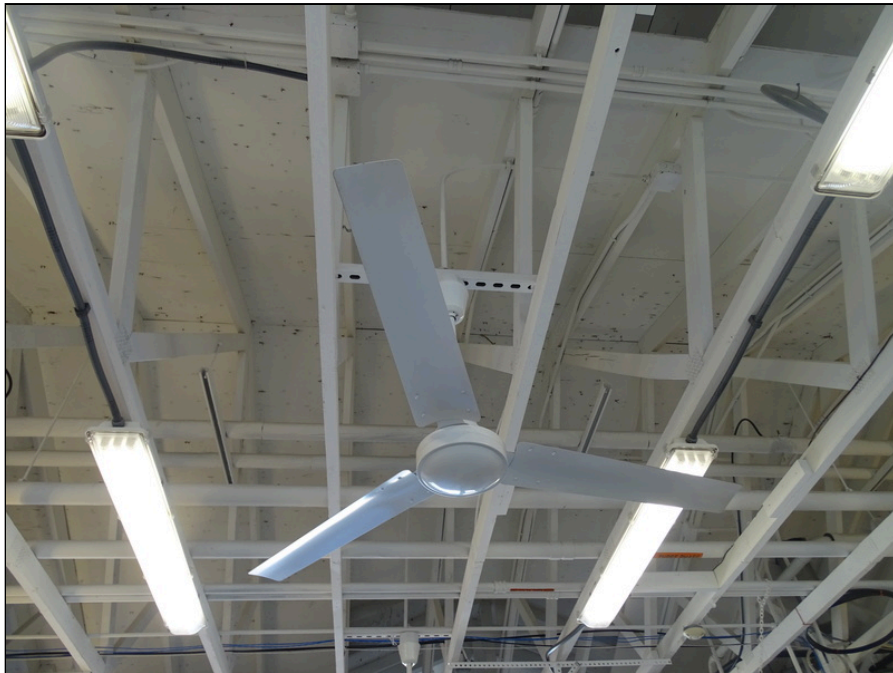
68 - Ceiling fan in Bath house

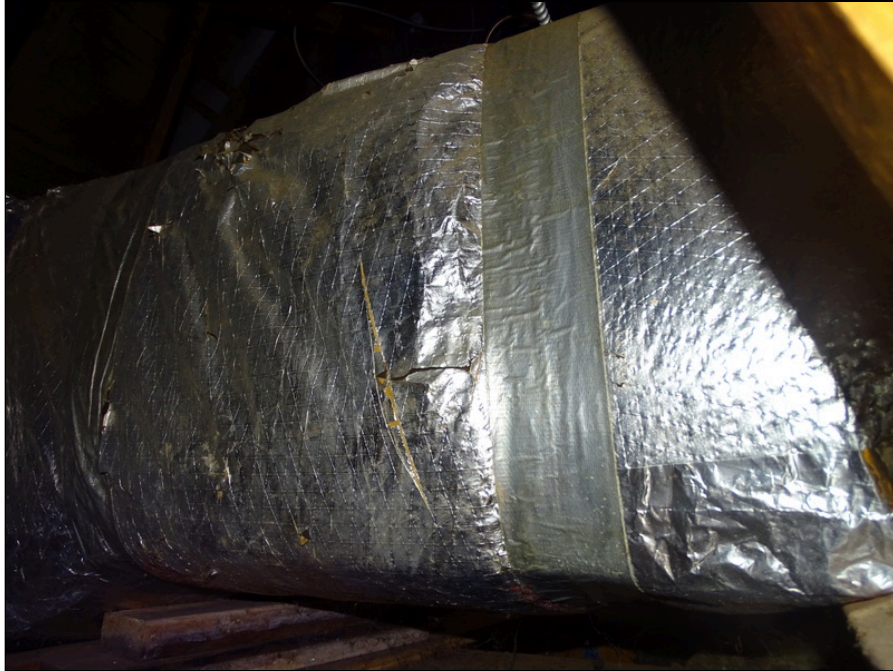
69 - Typical mechanical duct

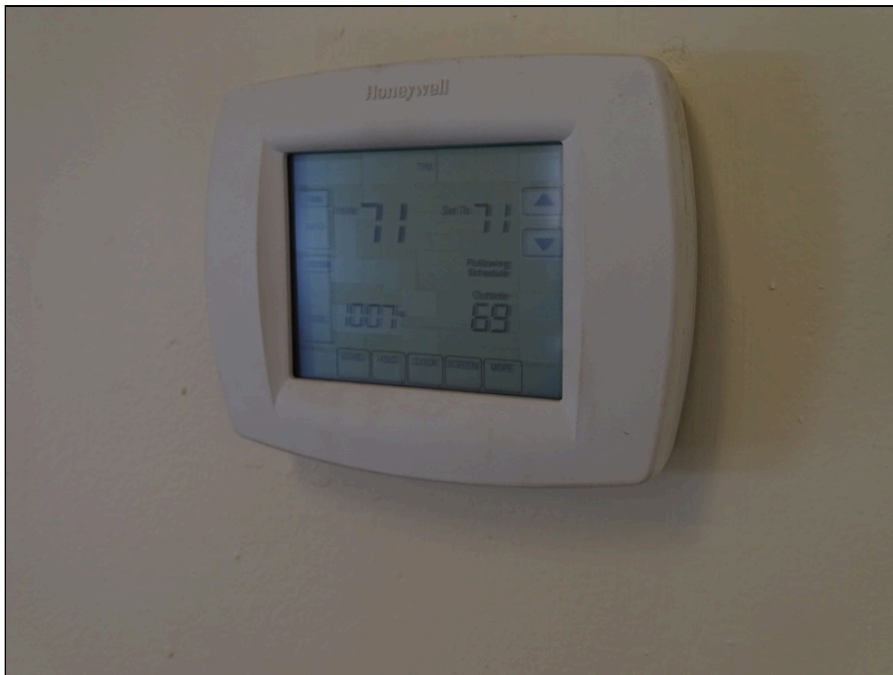
70 - Thermostat in shelter

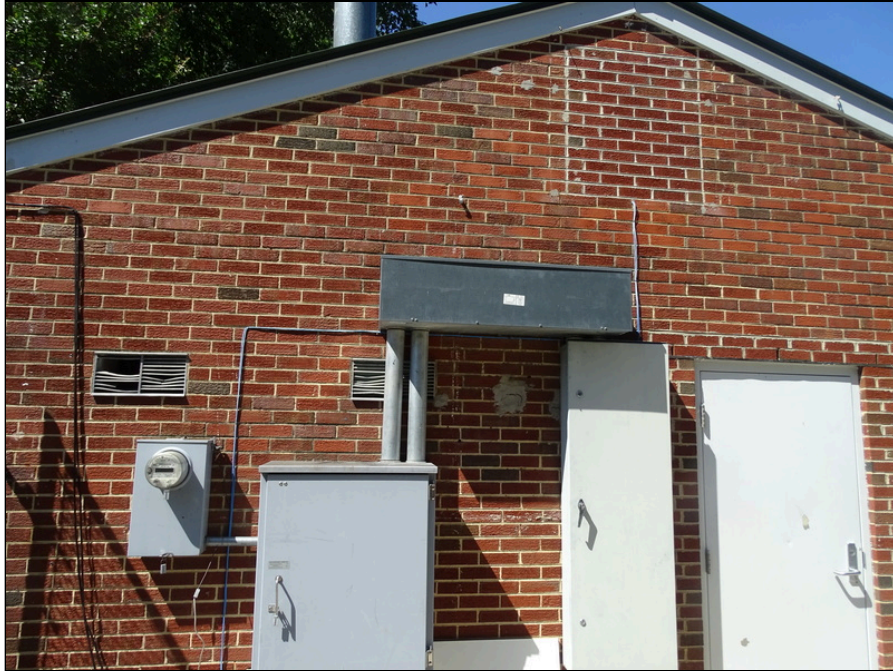
71 - Electrical entrance at the Bath house

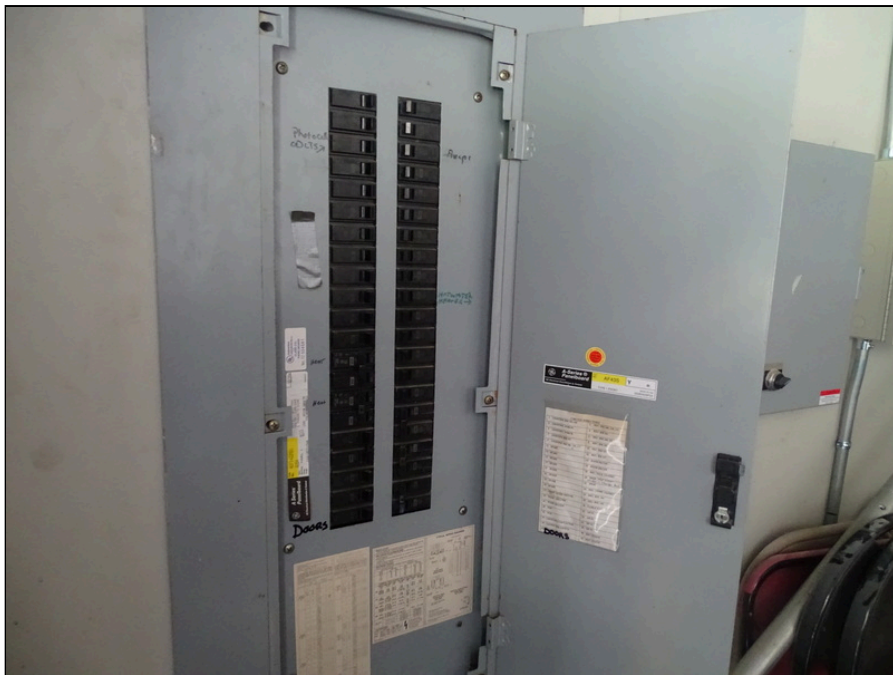
72 - Shelter electrical panel

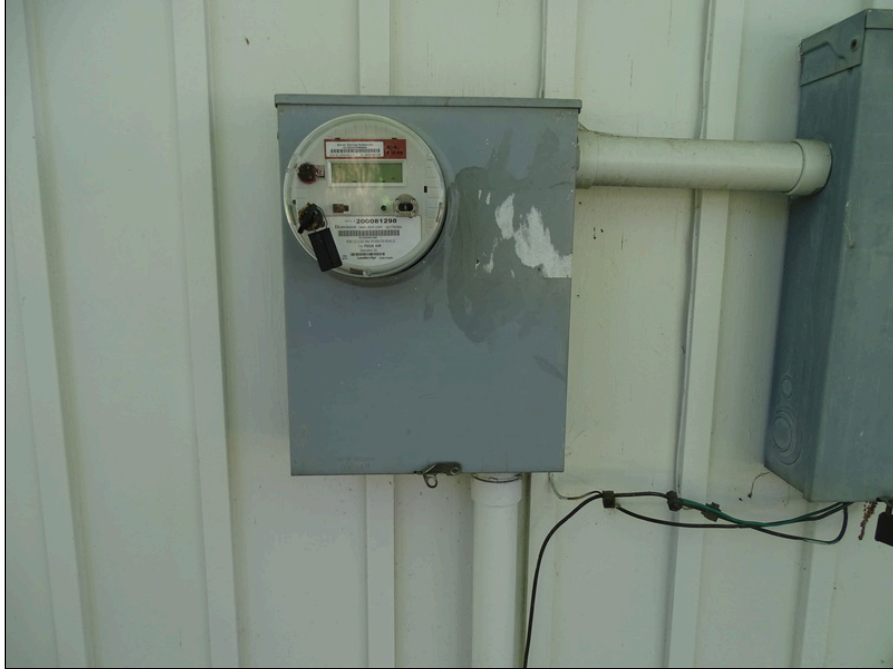
73 - Typical meter at shelter

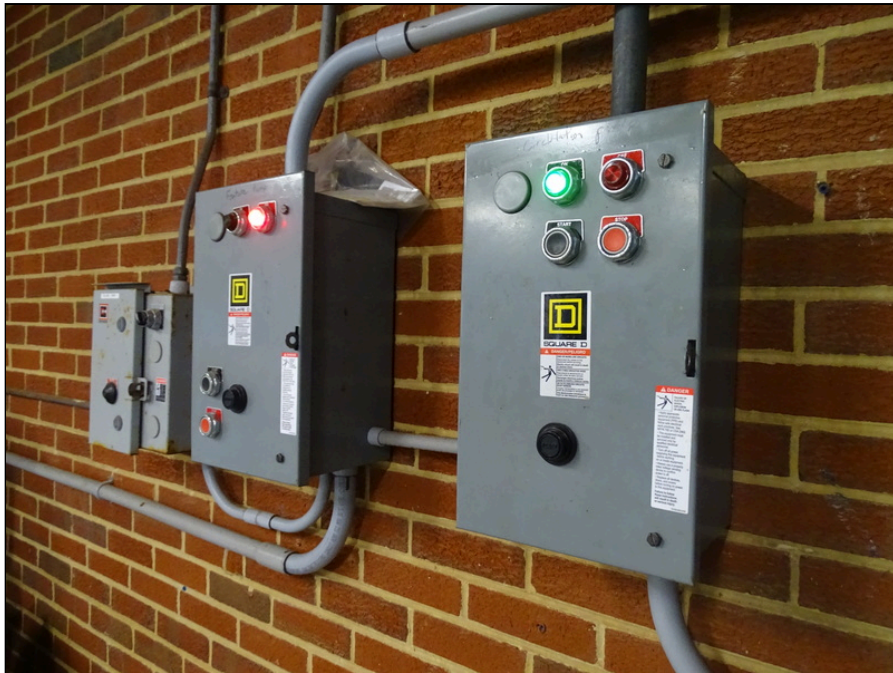
74 - Electrical emergency switch

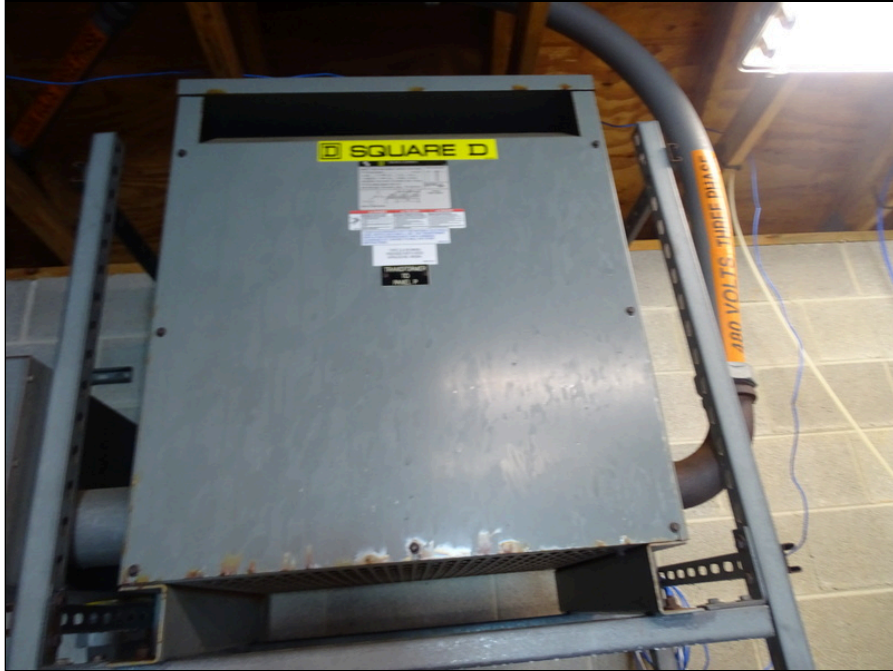
75 - Typical building transformer

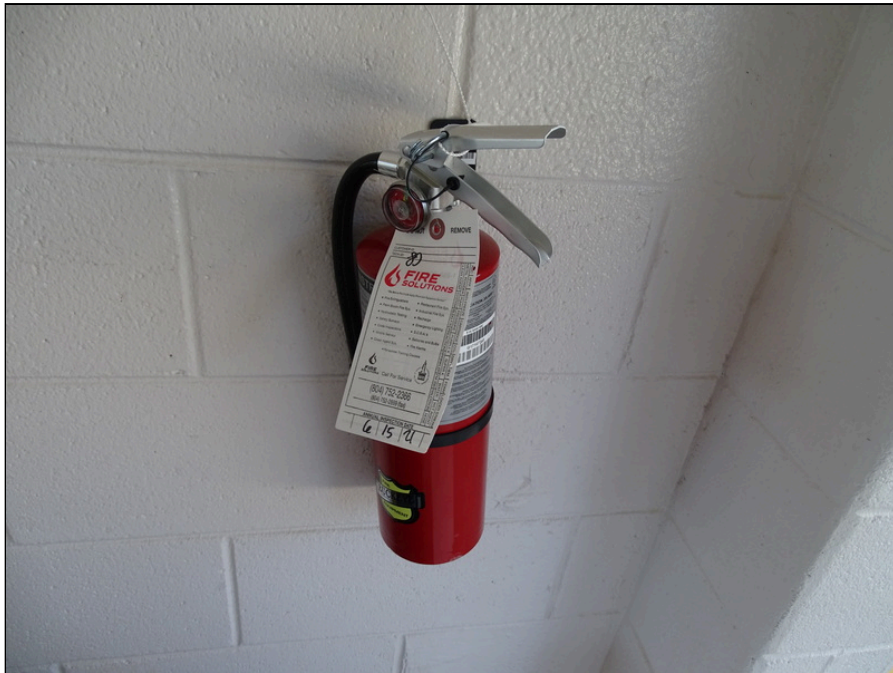
76 - Fire extinguisher in the Shelter

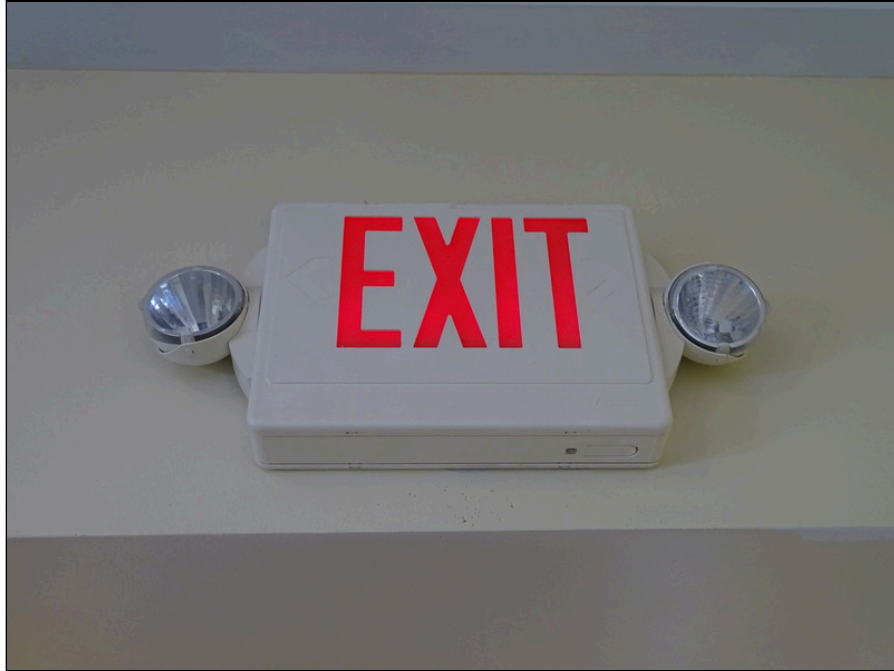
77 - Exit light and security camera in Shelter

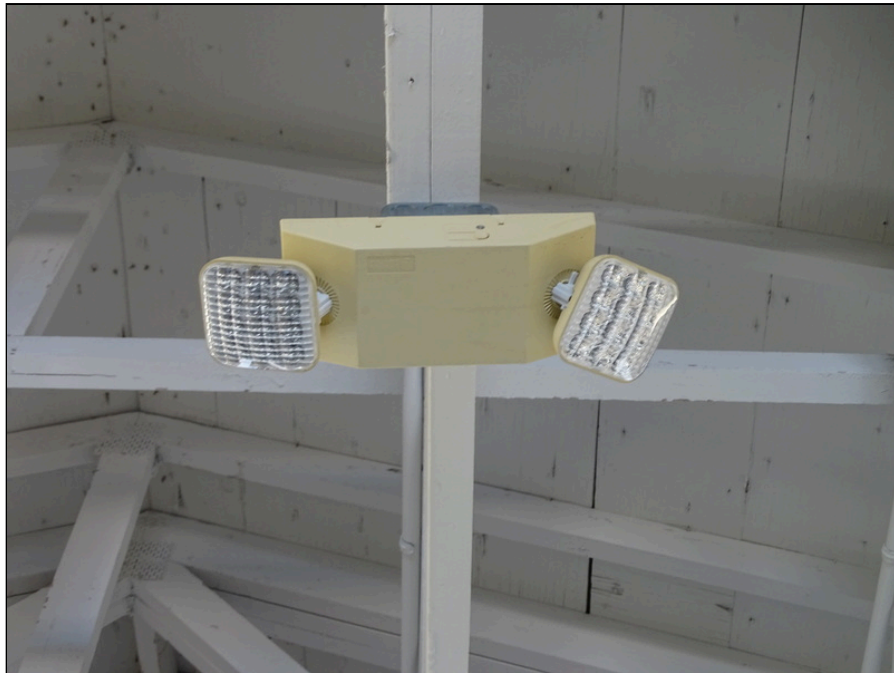
78 - Exit lights in Bath house

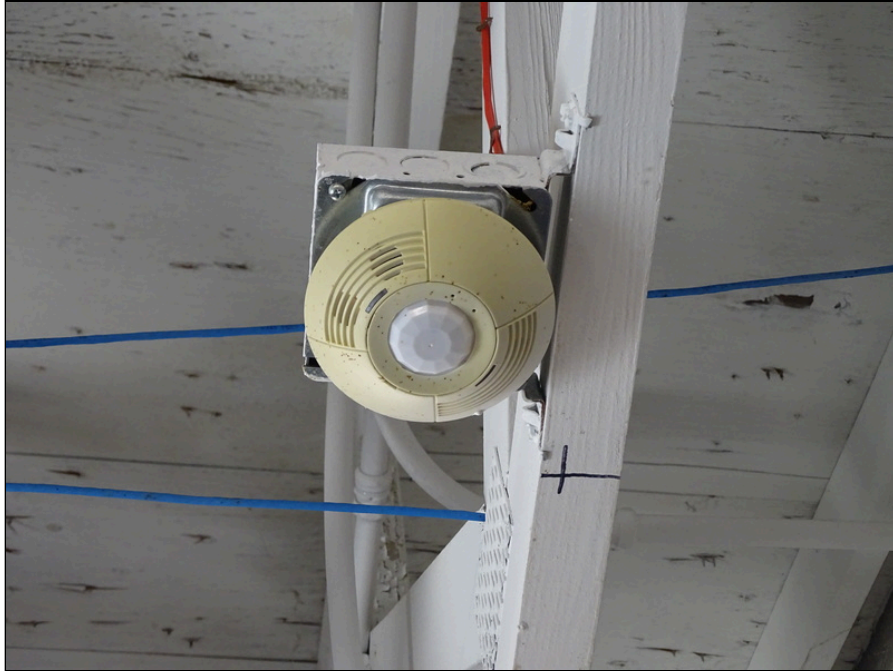
79 - Smoke detector in Bath house

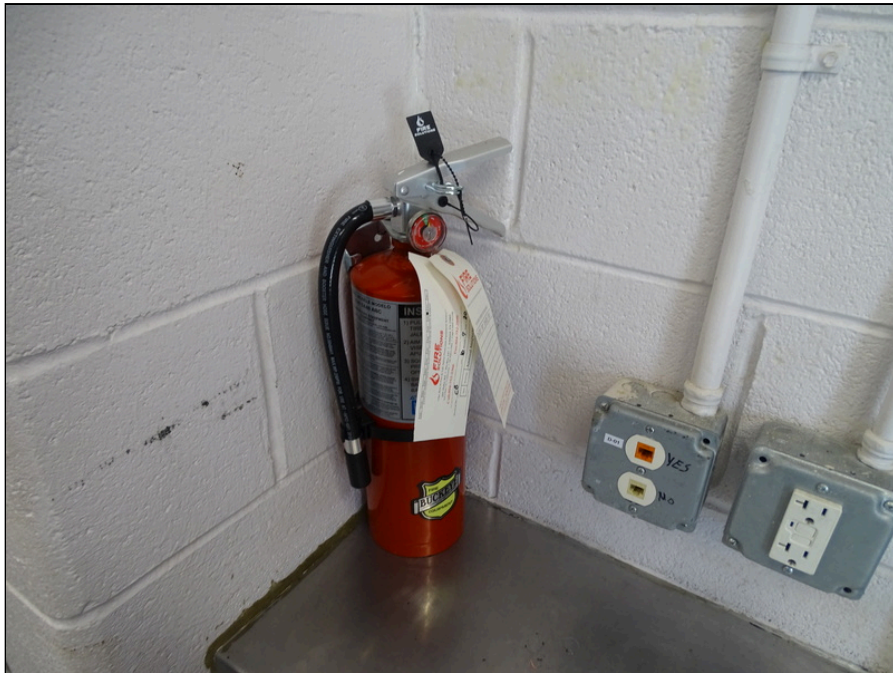
80 - Bath house fire extinguisher

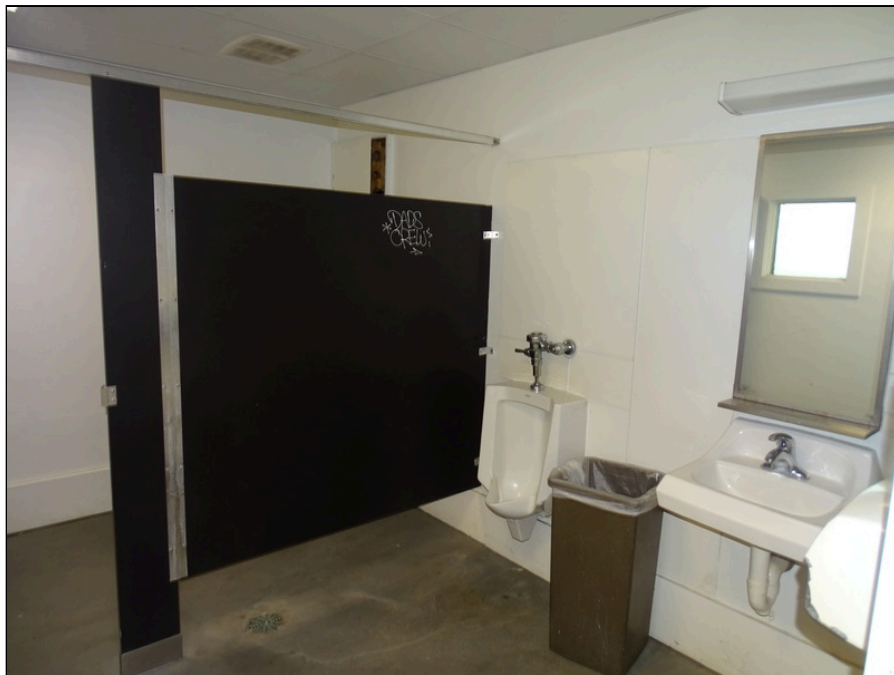
82 - Shelter restroom

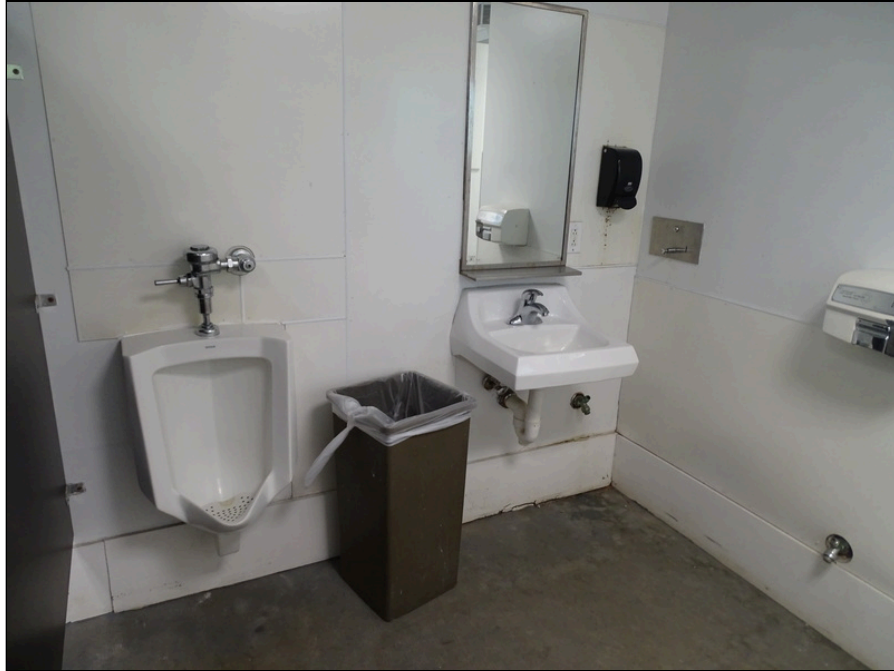
83 - Shelter restroom

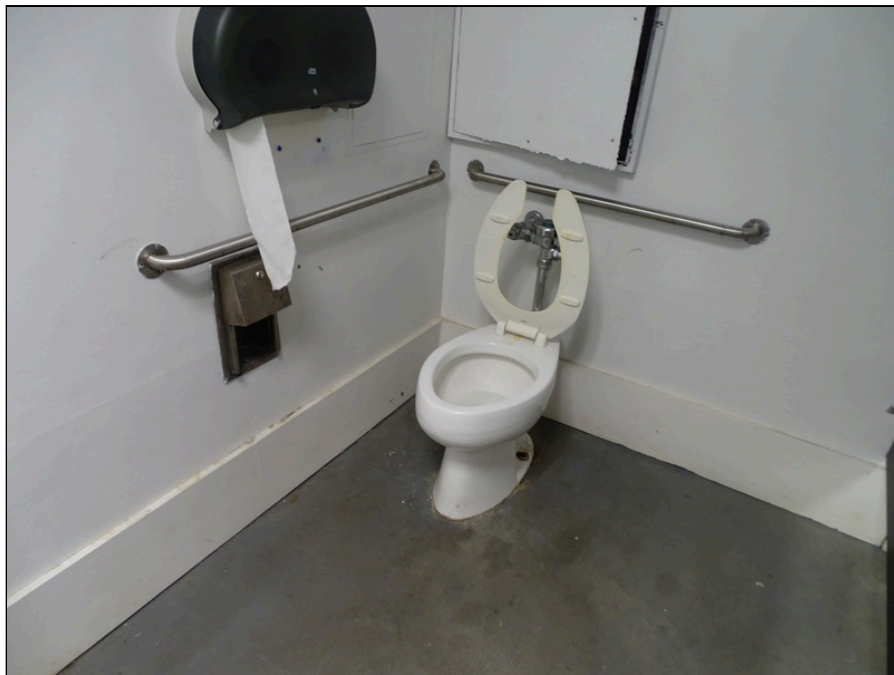
84 - Shelter restroom
