WASHINGTON PARK BATH HOUSE AND SHELTER
1001 PRESTON AVENUE
CHARLOTTESVILLE, VIRGINIA

ECS PROJECT NO. 46:6713

CITY OF CHARLOTTESVILLE - FACILITIES DEVELOPMENT

Reference: Facility Condition Assessment Report for Washington Park Bath House and Shelter, 1001 Preston Avenue, Charlottesville, Virginia

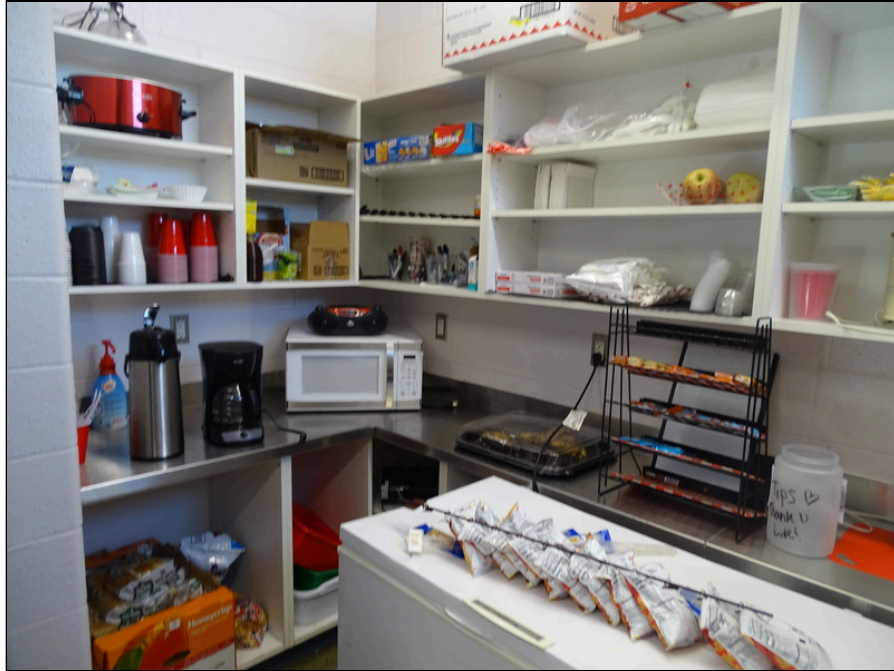
86 - Shelter kitchenette

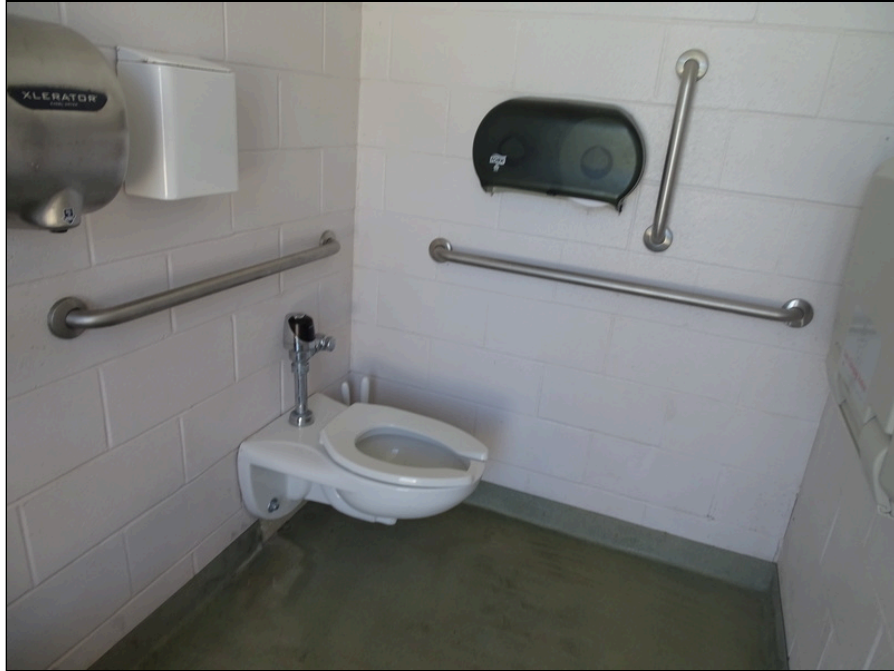
88 - Bath house family restroom

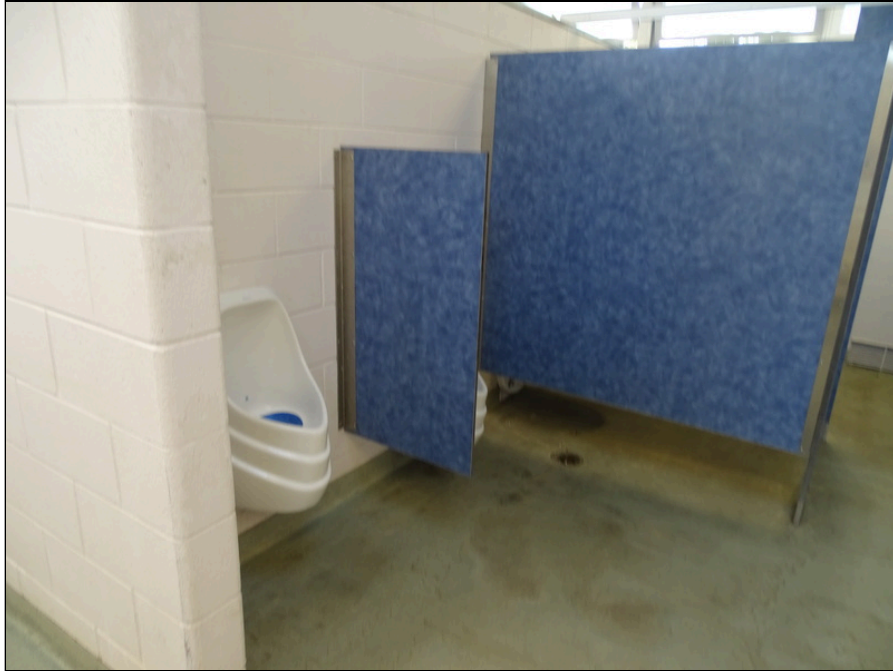
90 - Bath house storage room

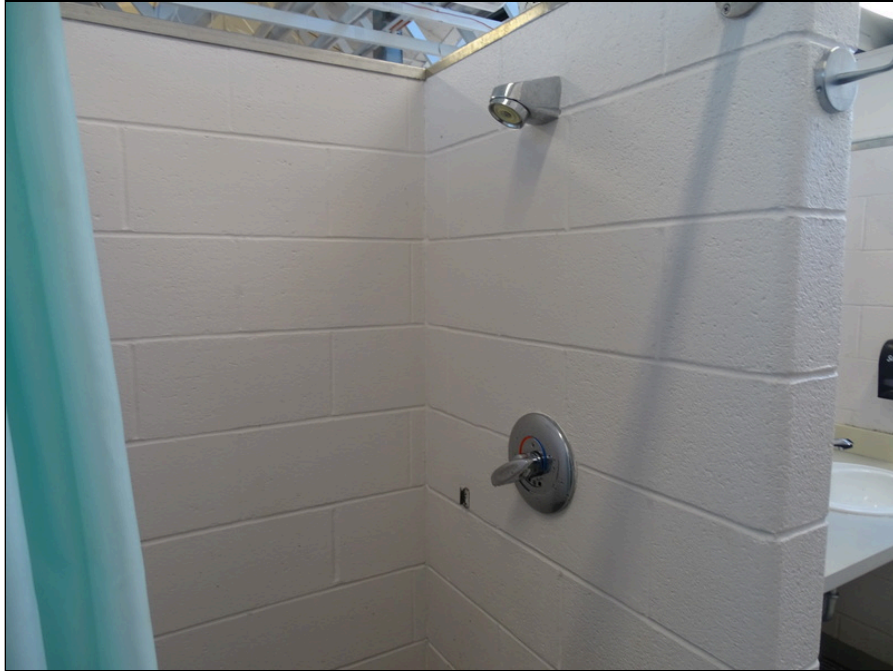
92 - Typical Bath house bathroom

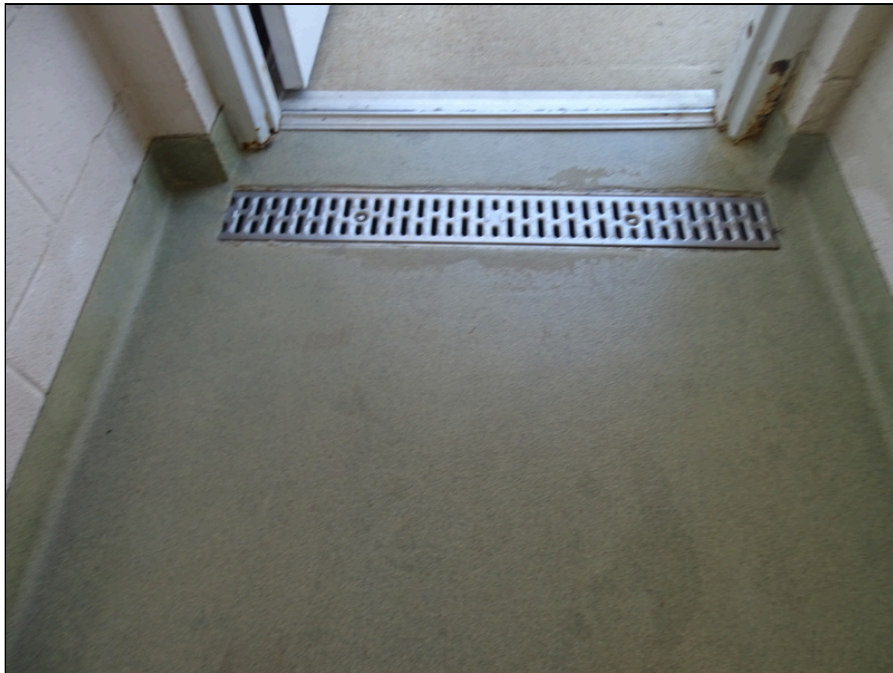
93 - Typical Bath house bathroom

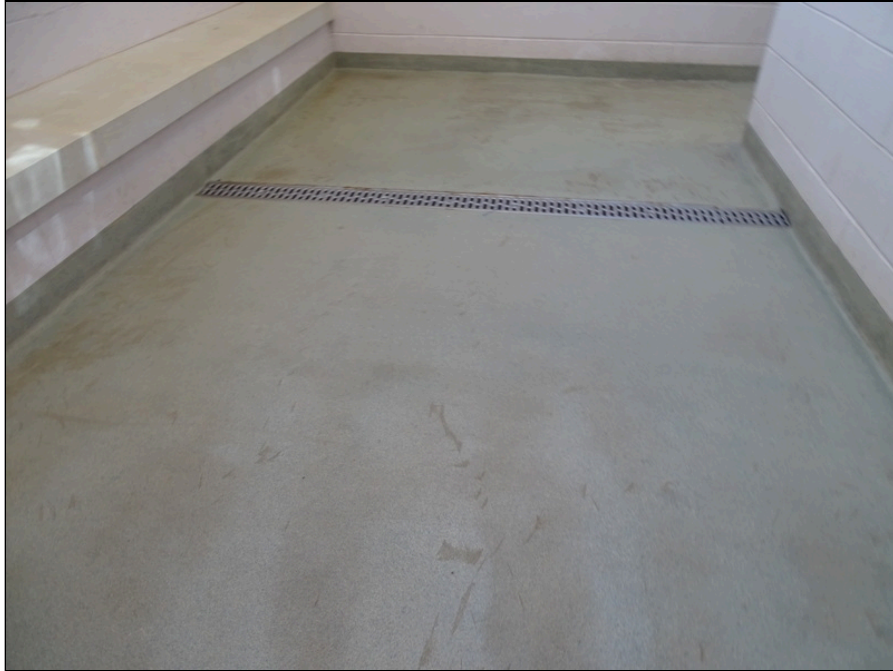
94 - Bath house family restroom drainage

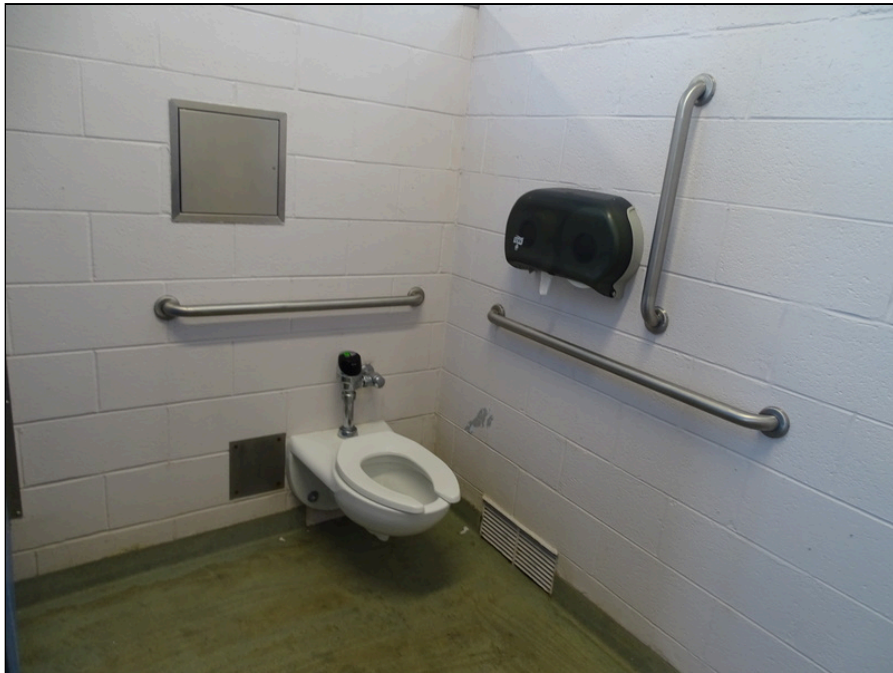
95 - Bath house family restroom floor

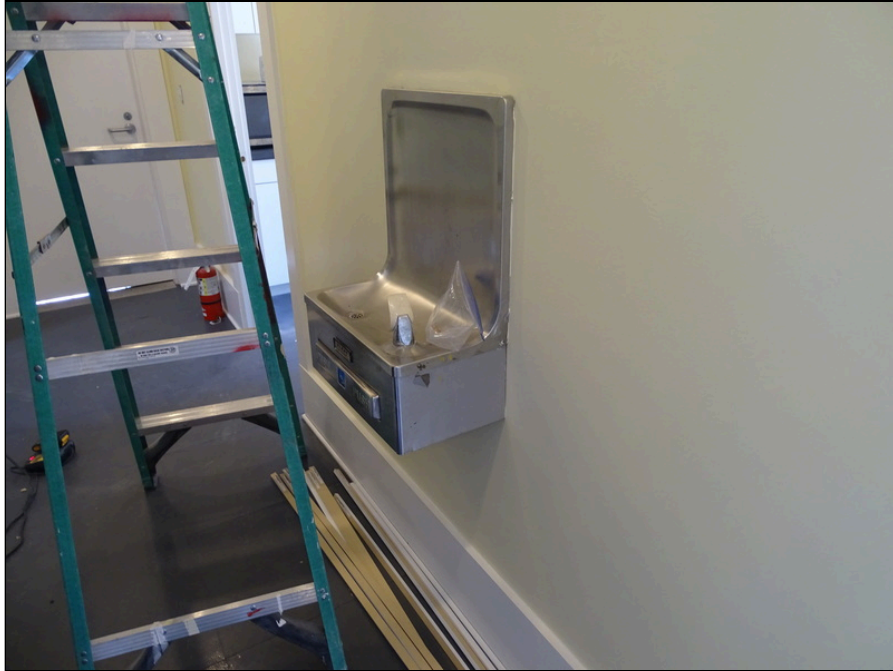
96 - Accessible bath house bathroom

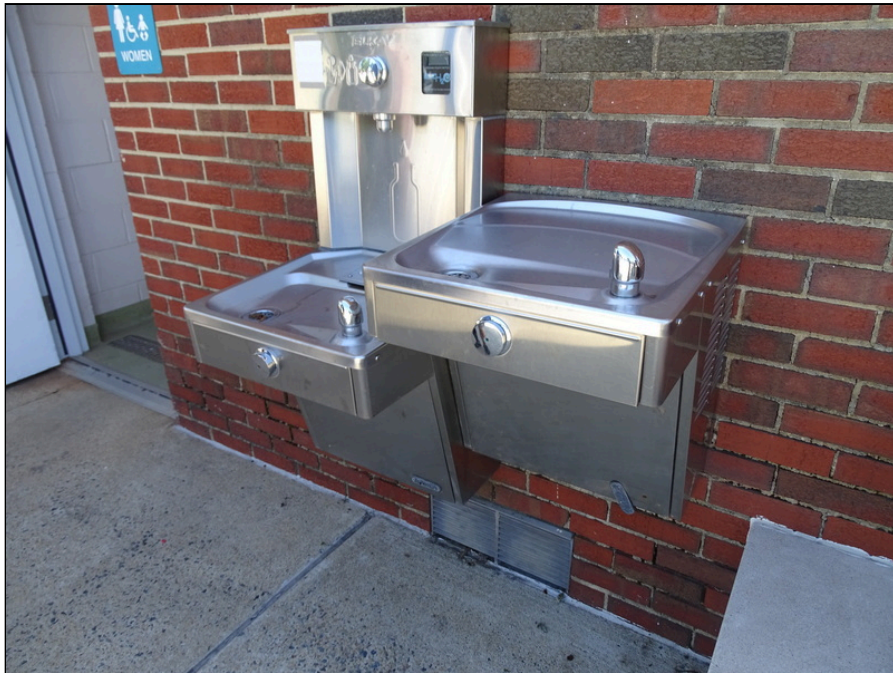
97 - Shelter drinking fountain

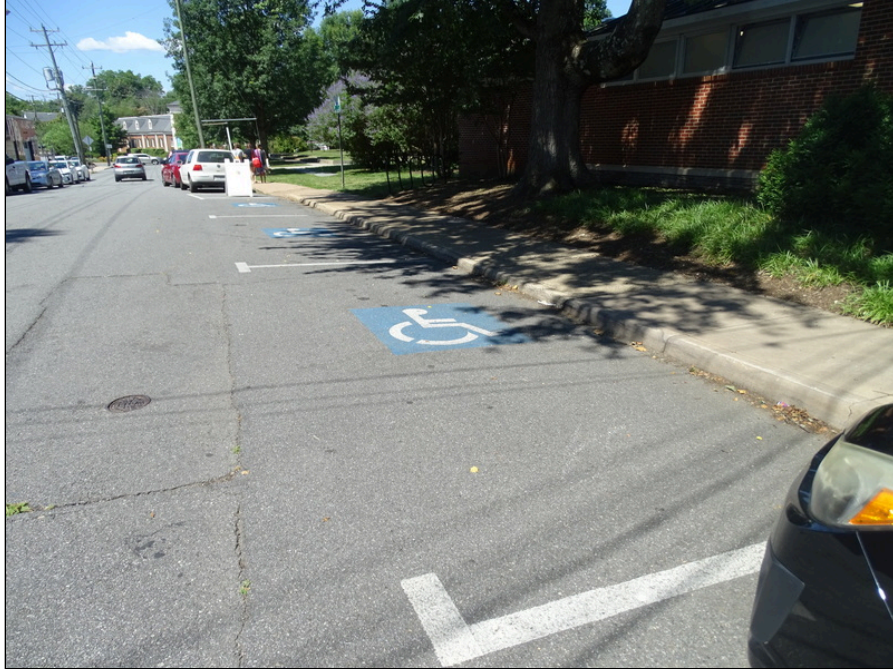
100 - Accessible parking overview

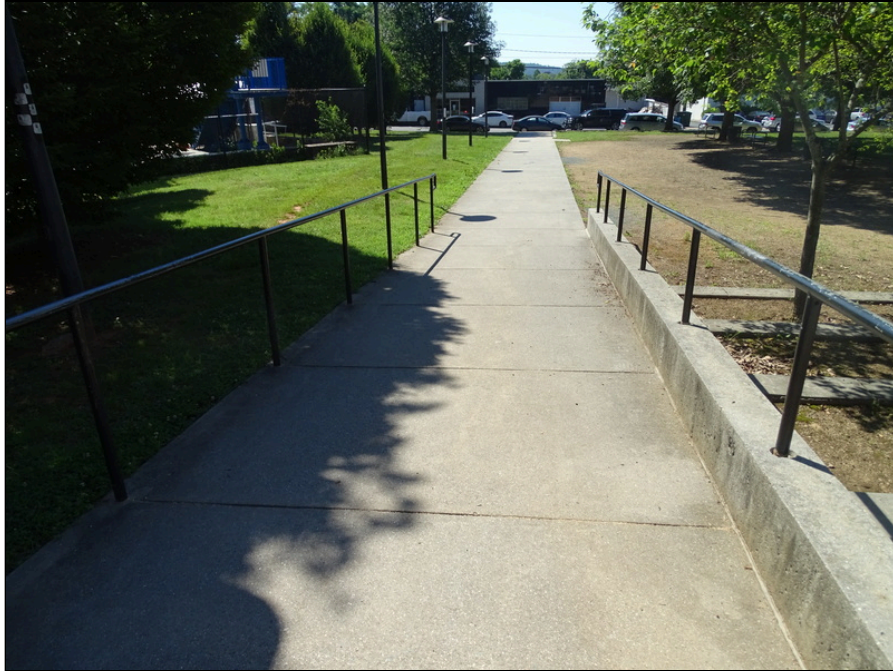
102 - Accessible ramp

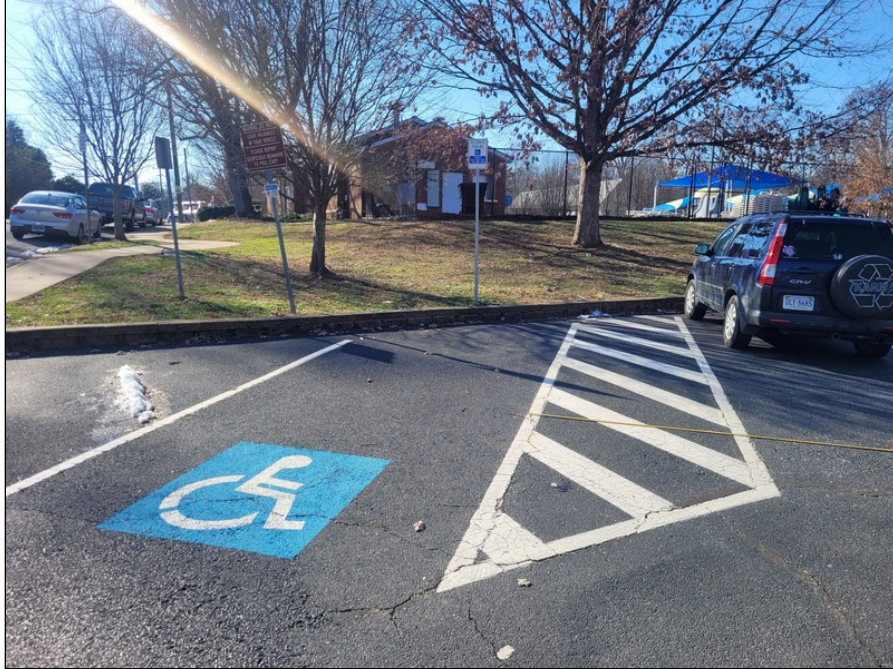
104 - Accessible parking

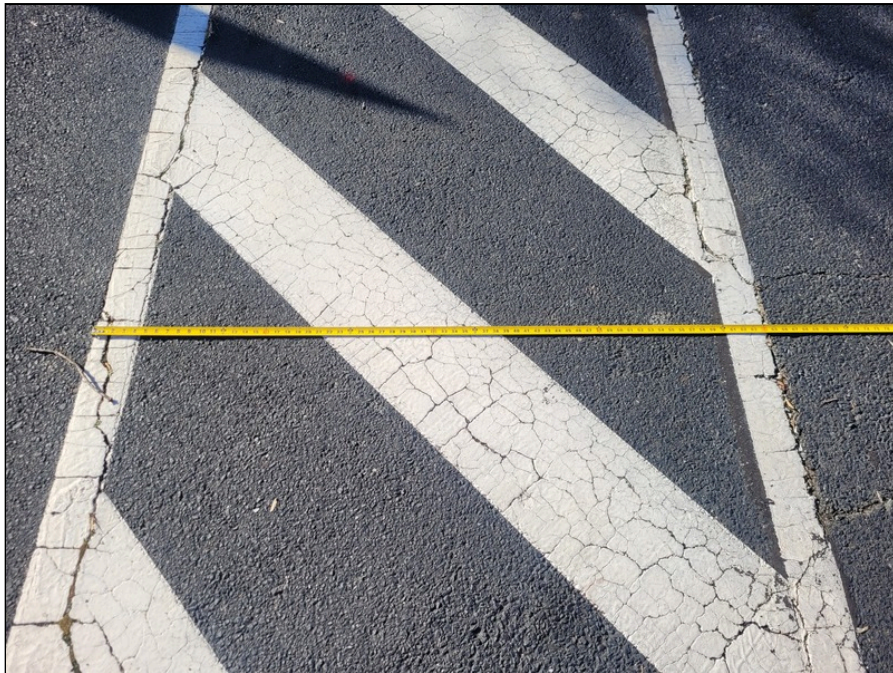
105 - Accessible aisle

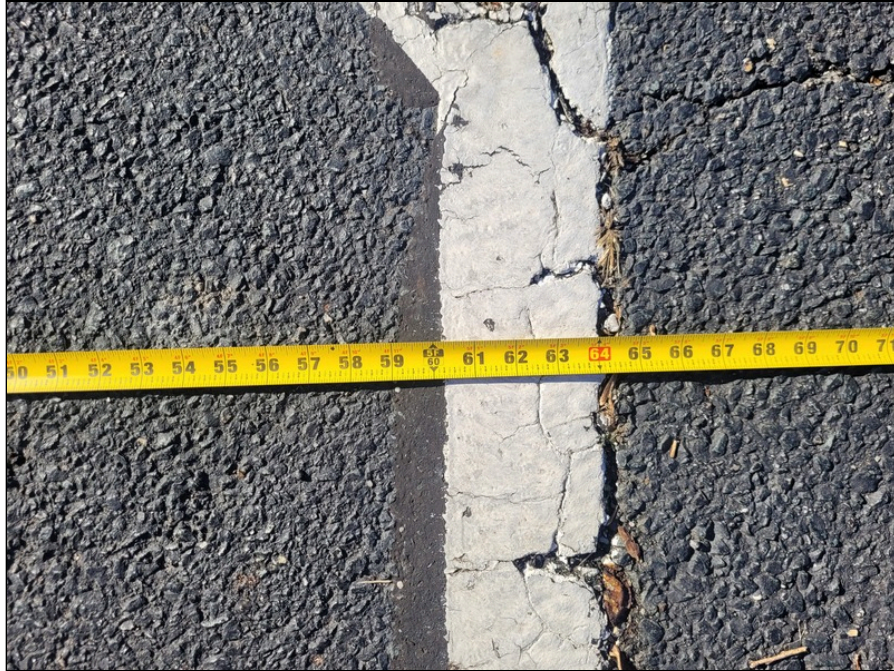
106 - Accessible 64" aisle

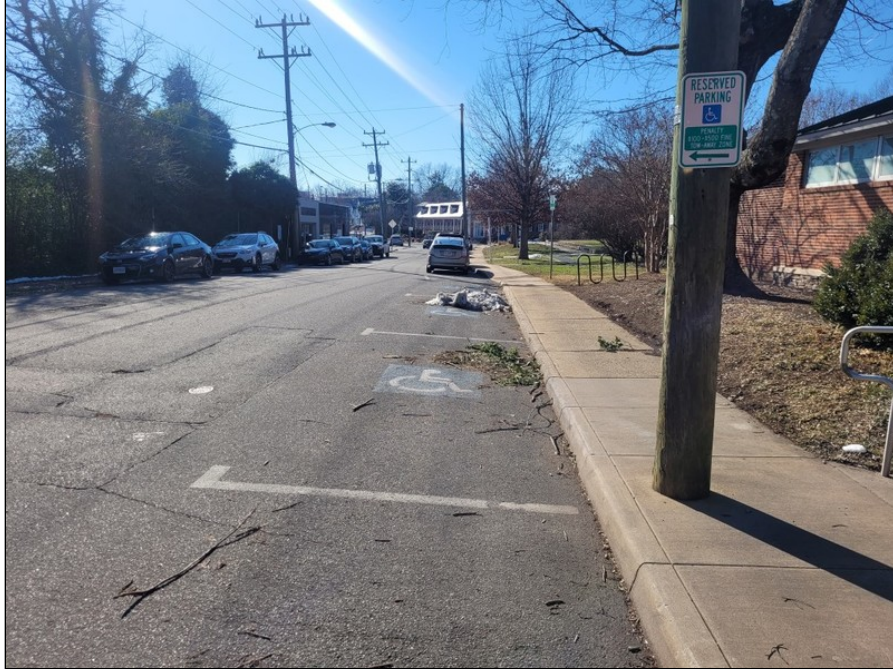
108 - Accessible parking signage

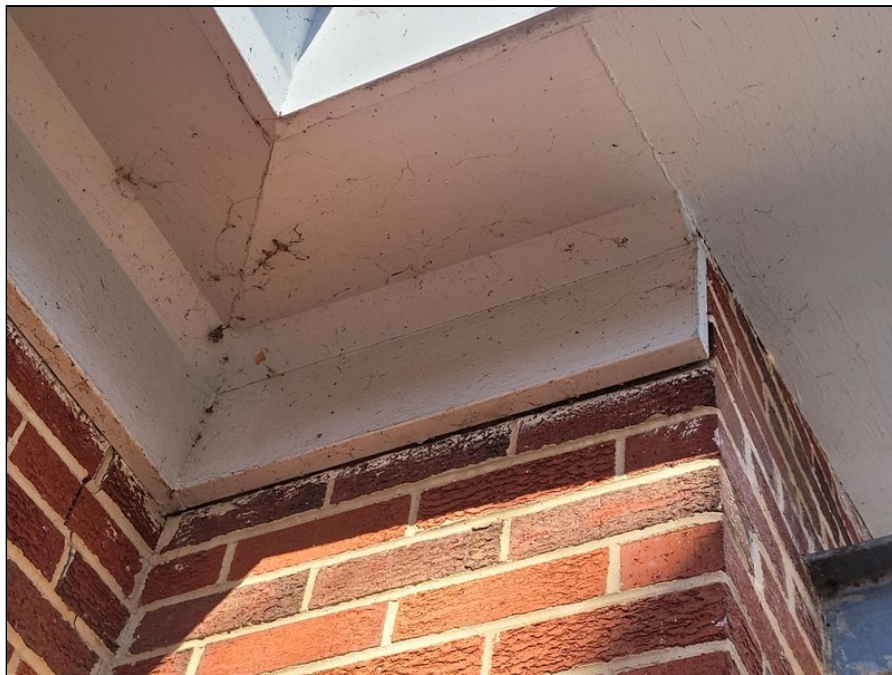
111 - Bath house brick crack

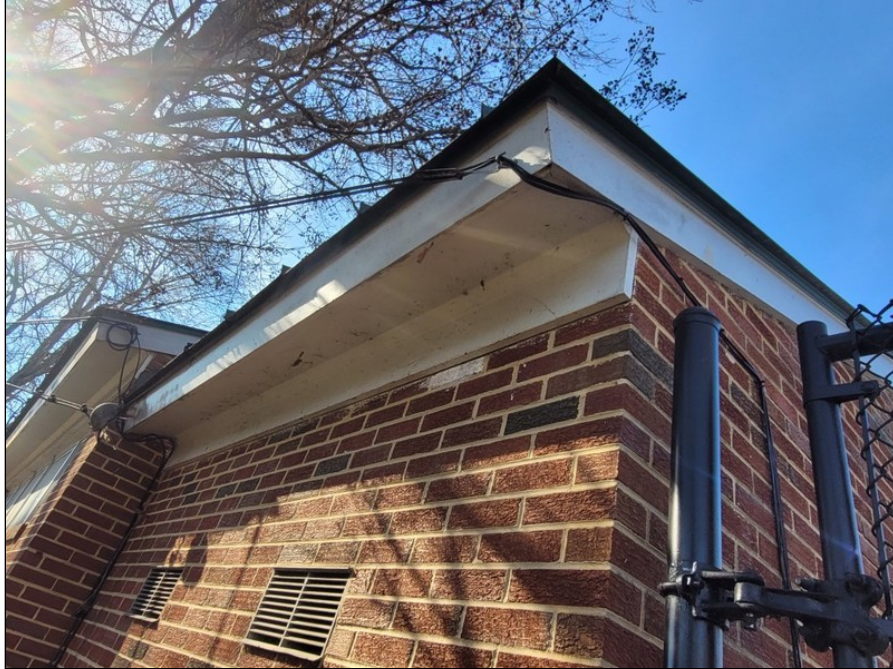
112 - Bath house soffit

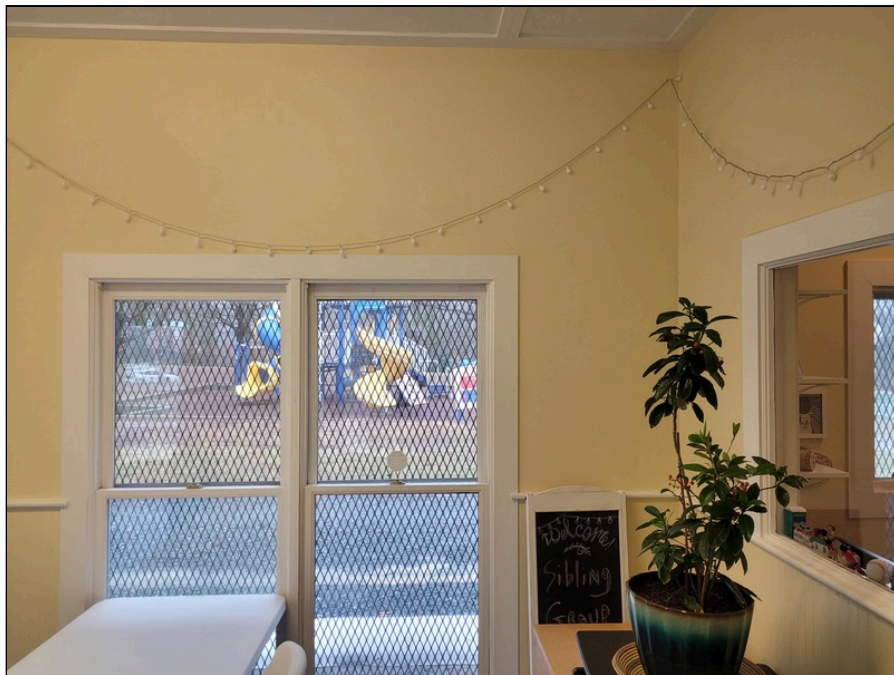
117 - Shelter interior finishes

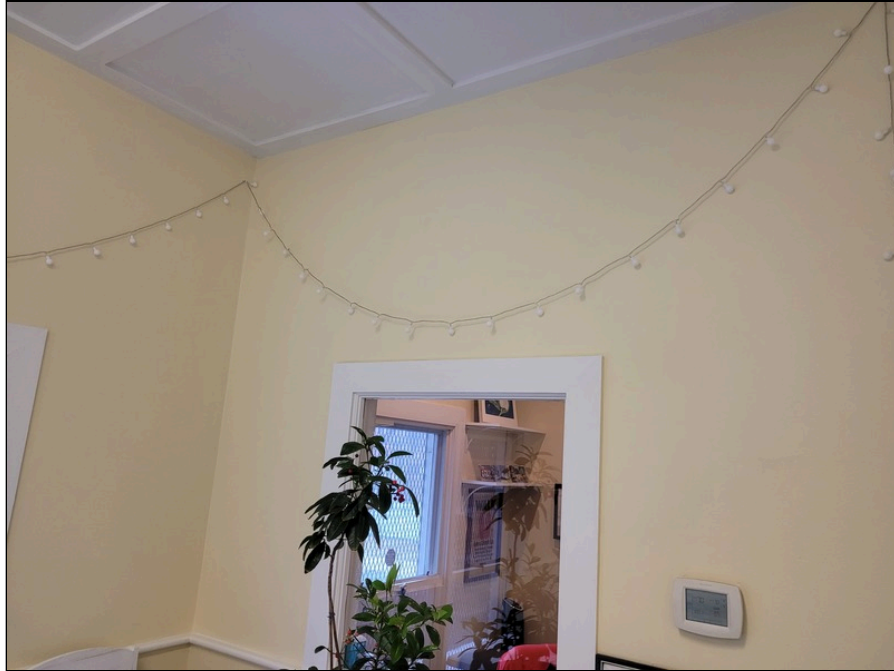
118 - Shelter interior finishes

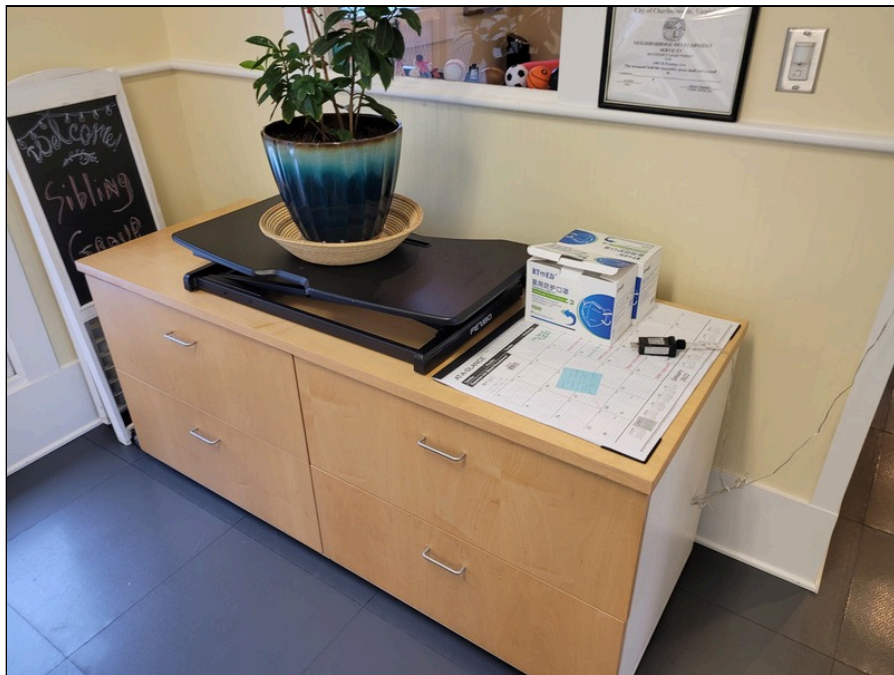
119 - Shelter interior finishes

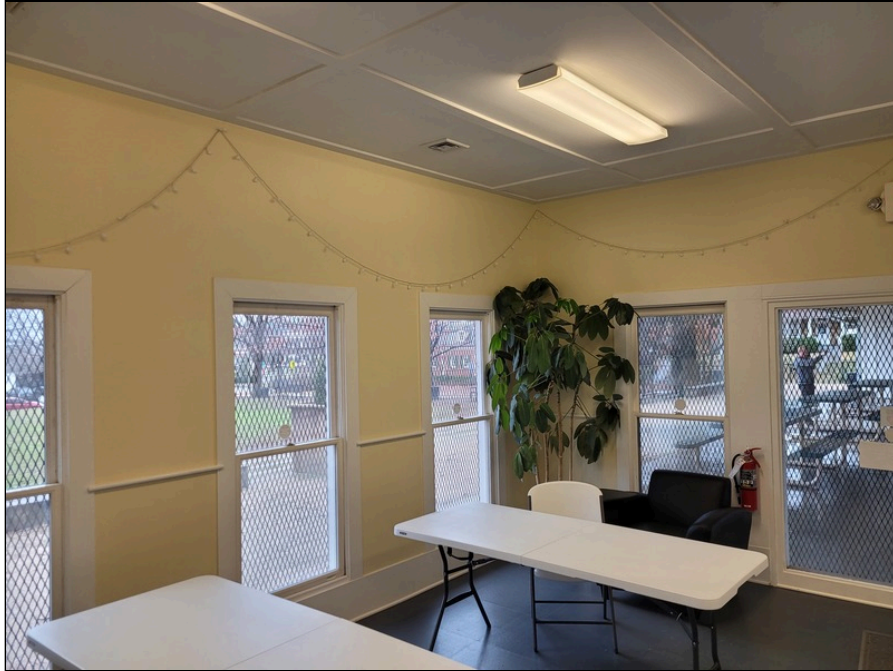
120 - Shelter interior finishes

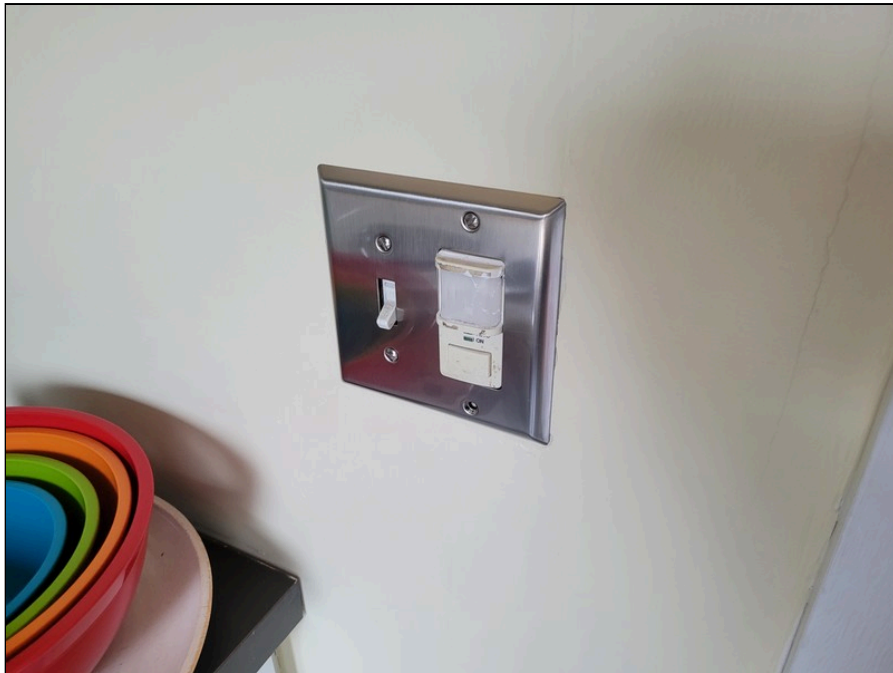
123 - Shelter interior lighting

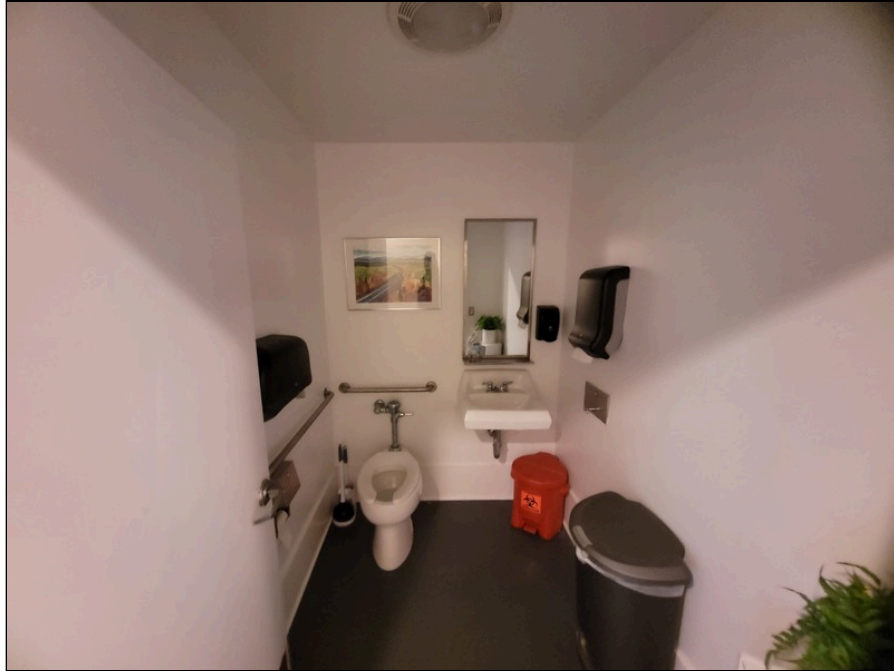
126 - Shelter interior finishes

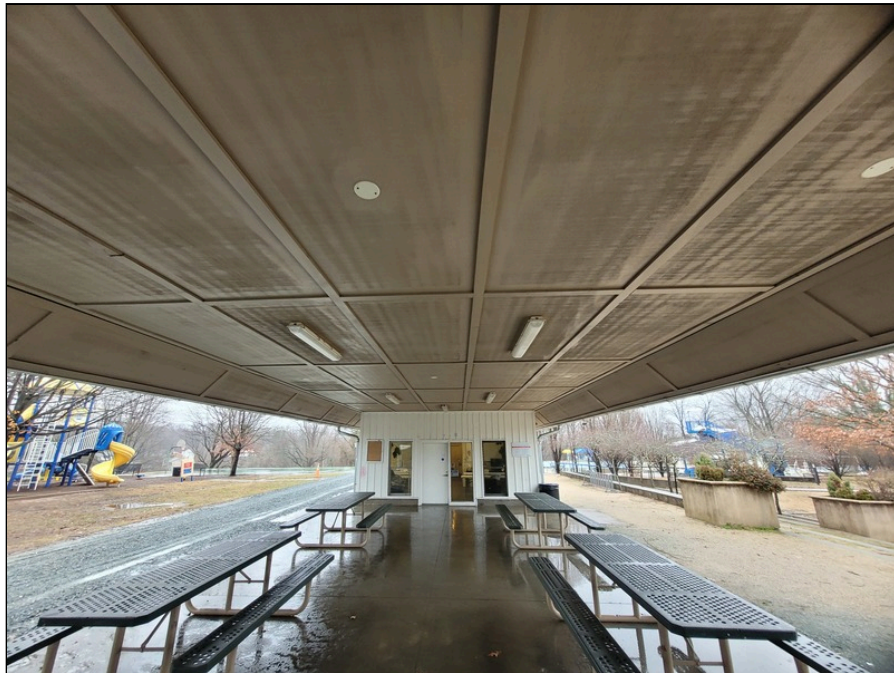
128 - Shelter ceiling

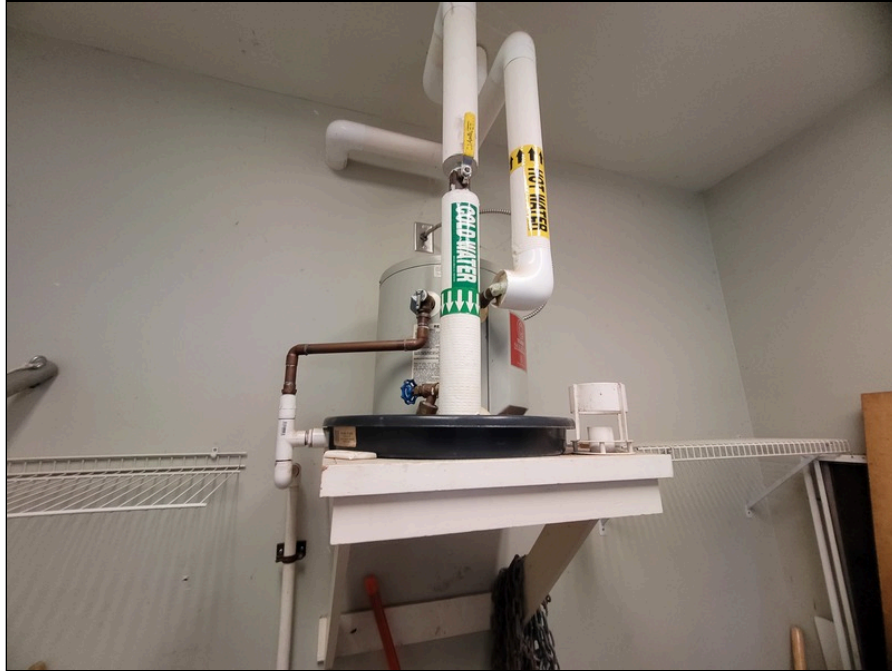
129 - Shelter water heater

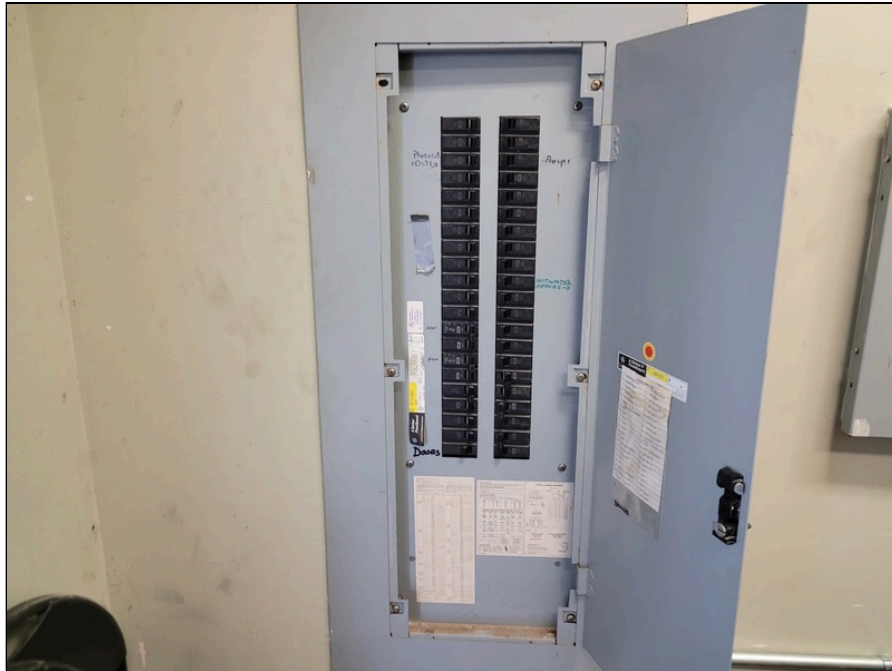
131 - Typical electric panel

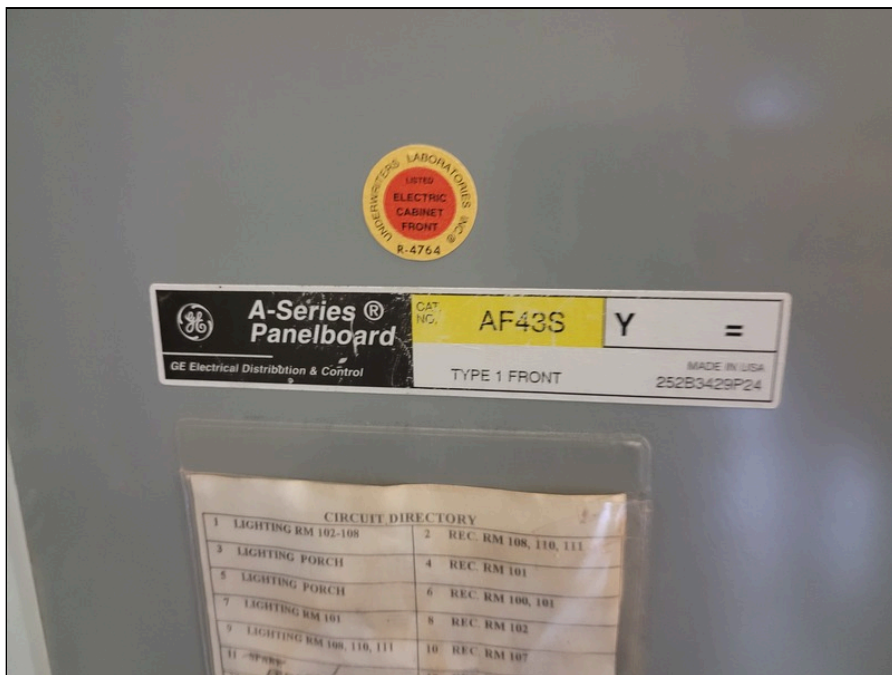
132 - Typical electric panel

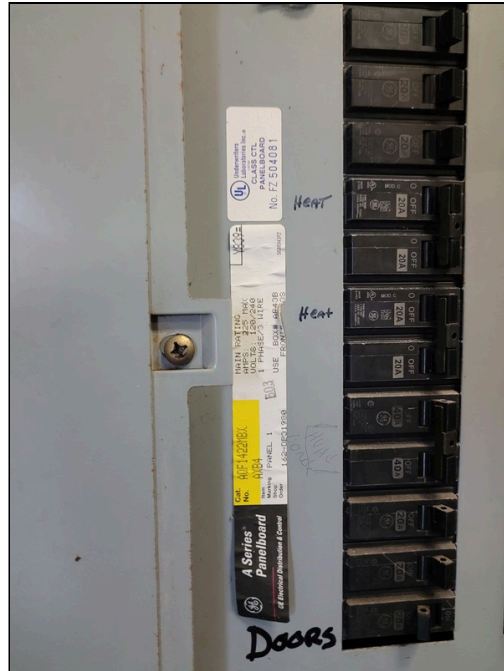
133 - Typical electric panel

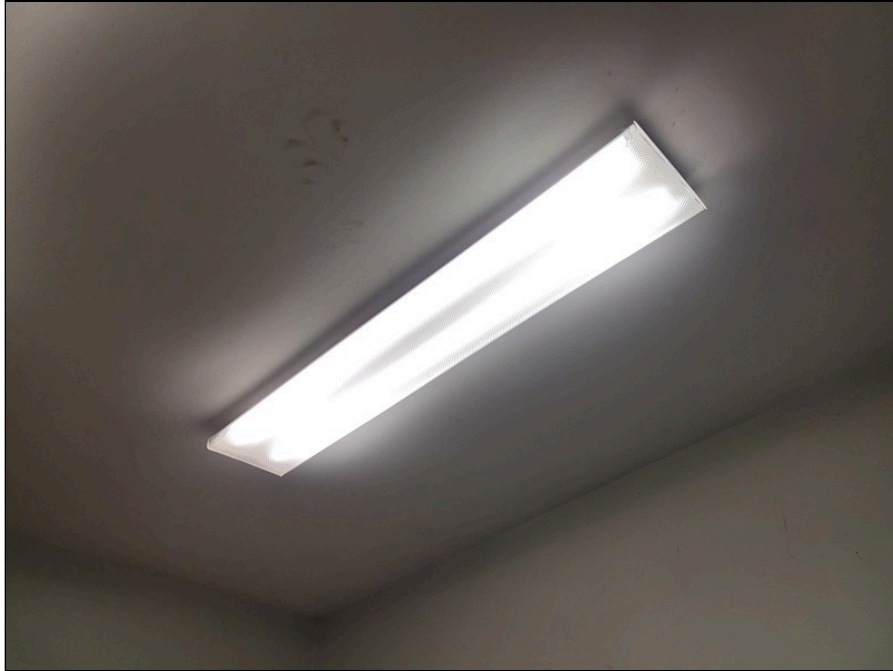
135 - Shelter lighting

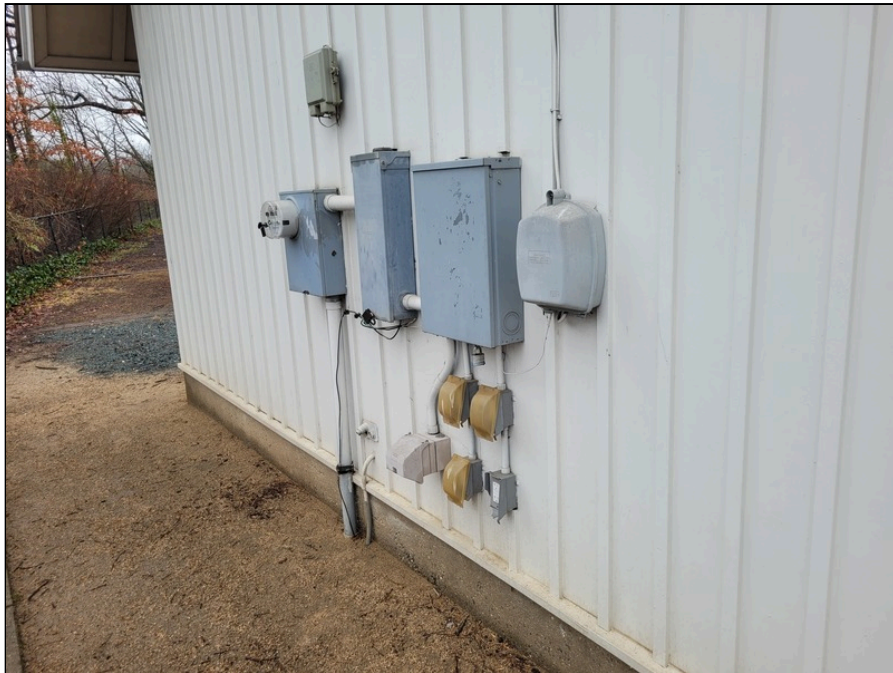
136 - Shelter electric service
