WHEELER BUILDING
401 EAST HIGH STREET
CHARLOTTESVILLE, VIRGINIA

ECS PROJECT NO. 46:6713

CITY OF CHARLOTTESVILLE - FACILITIES DEVELOPMENT

Reference: Facility Condition Assessment Report for Wheeler Building, 401 East High Street,
Charlottesville, Virginia

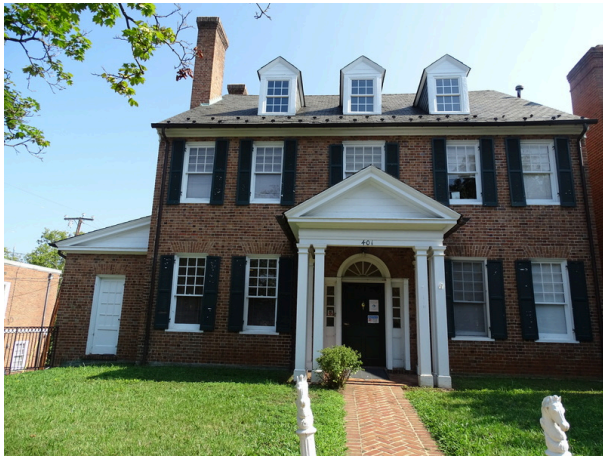
The property is generally level and slopes to the north. The adjoining properties are generally level with or located down gradient from the property.

South elevation

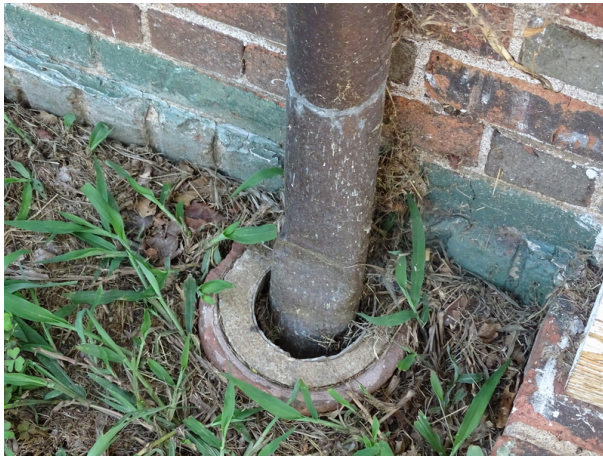
The storm water collection system includes a municipal system.

Typical downspout

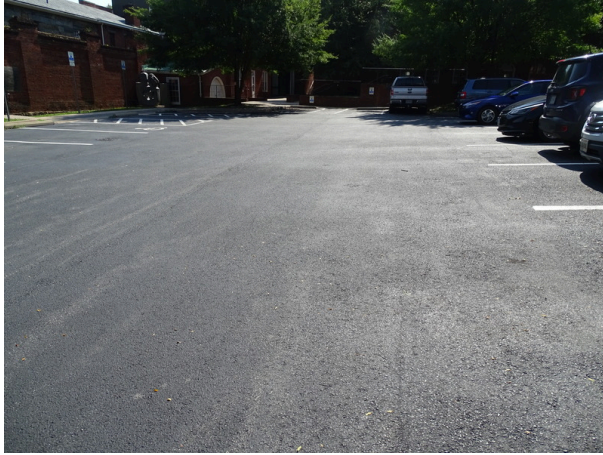
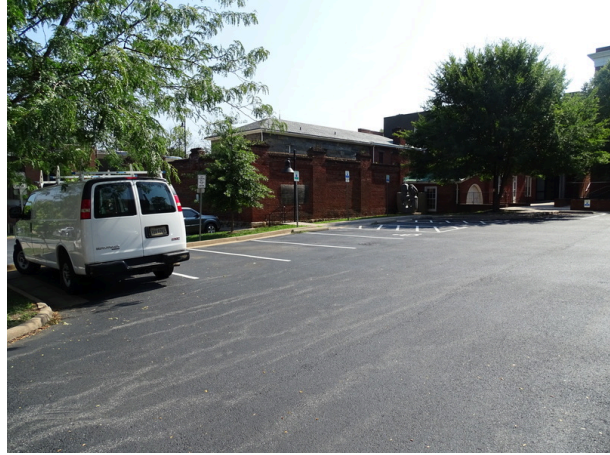
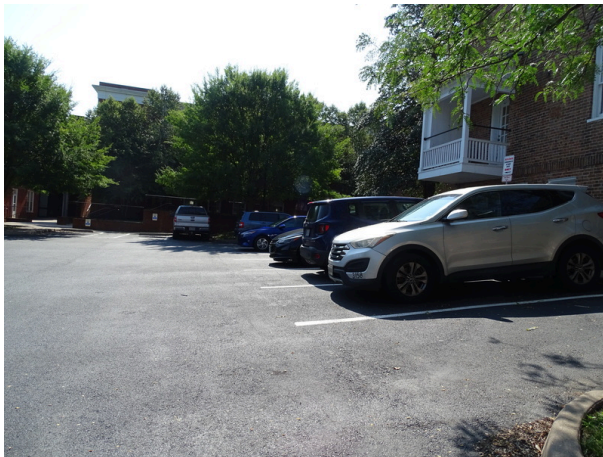
Asphalt-paved drive lanes and parking are located on the north side of the site. We observed the asphalt pavement and striping to have been recently resurfaced.. The expected useful life of asphalt pavement is 20 years. The asphalt pavement was observed to be in generally condition. arking lot is shared with Preston Morris Building next door.

Asphalt parking north side of the site

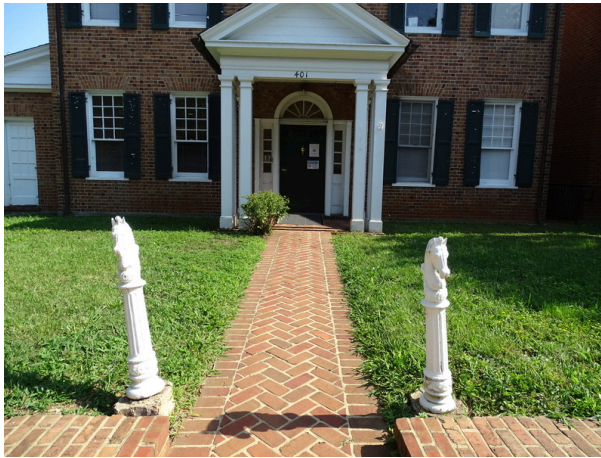
A concrete sidewalk is located at the north side of the building. A brick sidewalk is located at the south end of the site. The Concrete and brick sidewalks thickness was undetermined. Regularly spaced control joints were observed. The Concrete and brick sidewalks were generally in fair condition.

Brick sidewalk south side of the site

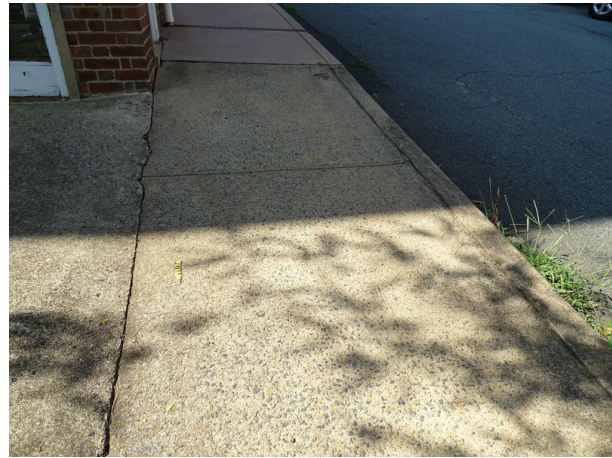
Concrete sidewalk south side of the site

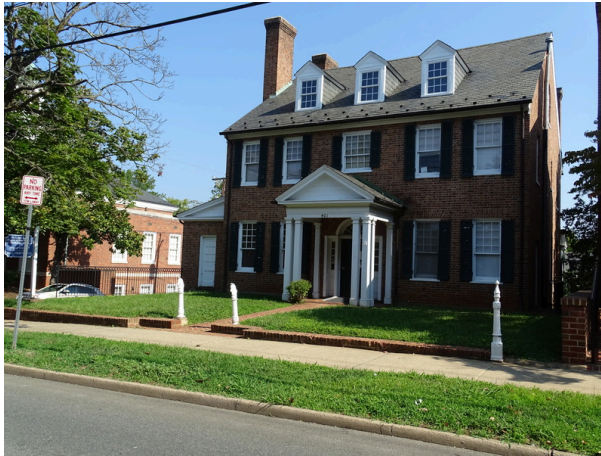
A retaining wall is located on the south and west sides of the site. The retaining wall was generally in fair condition with damage at the base in the southwest corner. This corner of the wall should be repaired in the near future to prevent further freeze/thaw damage. The vegetation should be removed from the wall/sidewalk joint and sealant installed.

Wheeler building landscape overview

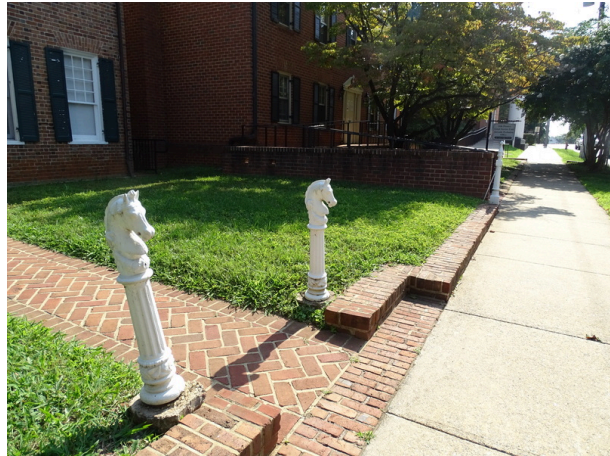
Brick sidewalk south side of the site

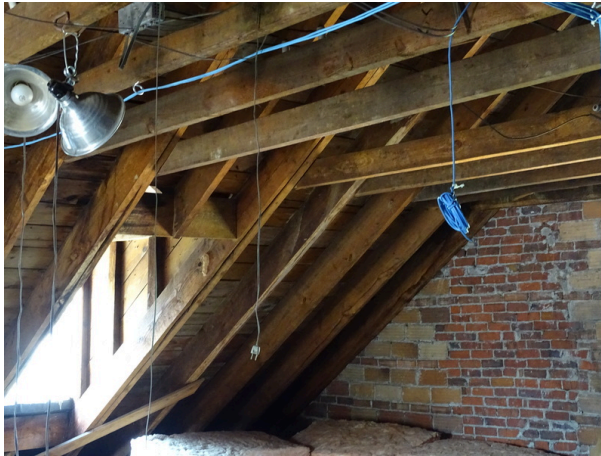
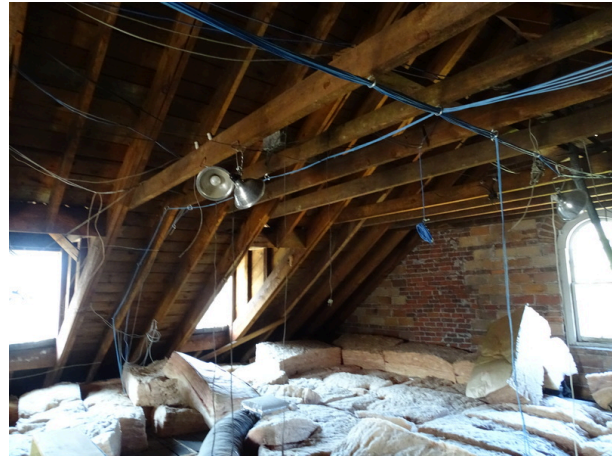
The structure of the building consists of Wood framing with brick masonry bearing exterior walls with brick masonry columns. The structural frame of the building was generally in good condition.

Structural framing

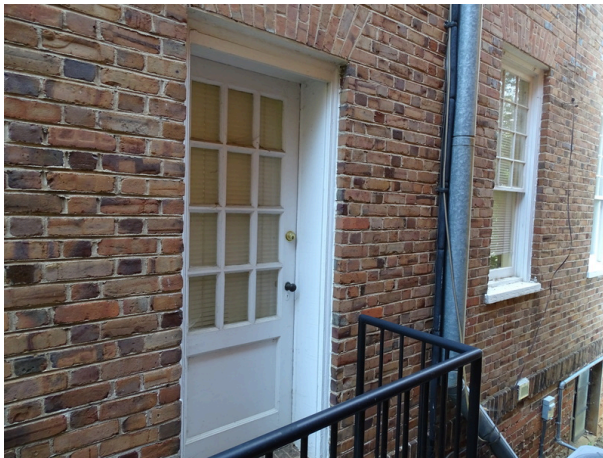
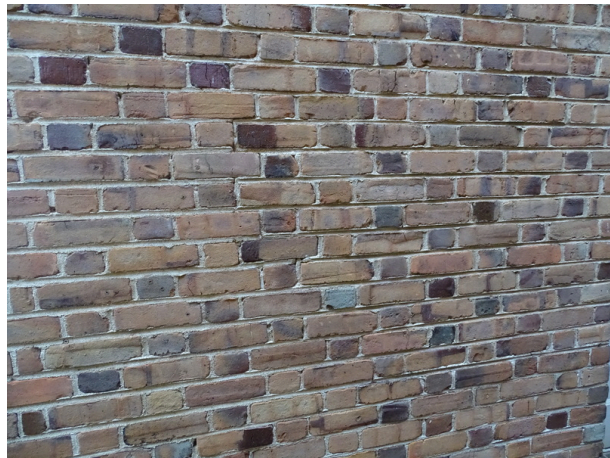
The wood trim and wood covered soffits are painted. The paint was generally in good condition with renovations completed in 2016. Painting of exterior components is typically recommended every 5 to 7 years. We recommend the wood trim and soffits be painted during the report period.

Building exterior east side of the building

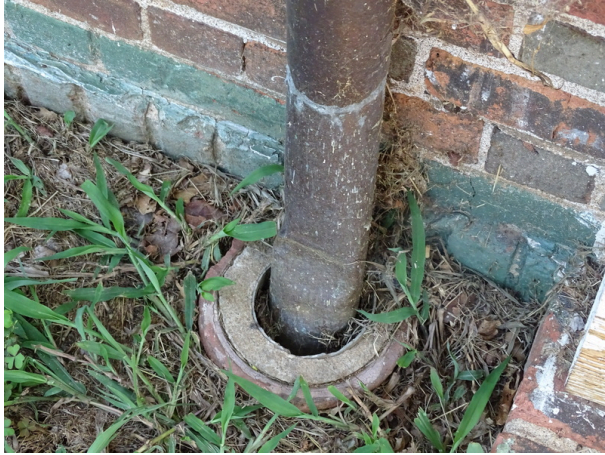
Typical downspout

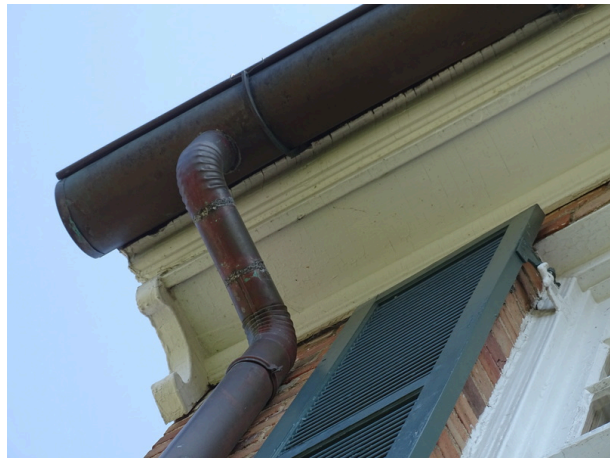
Typical gutter overview

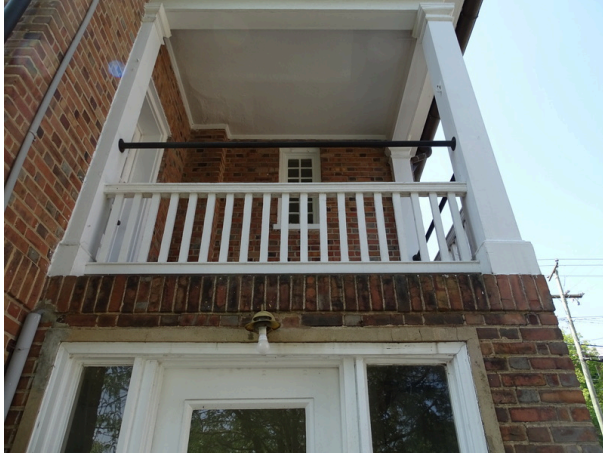
Building exterior north side of the building

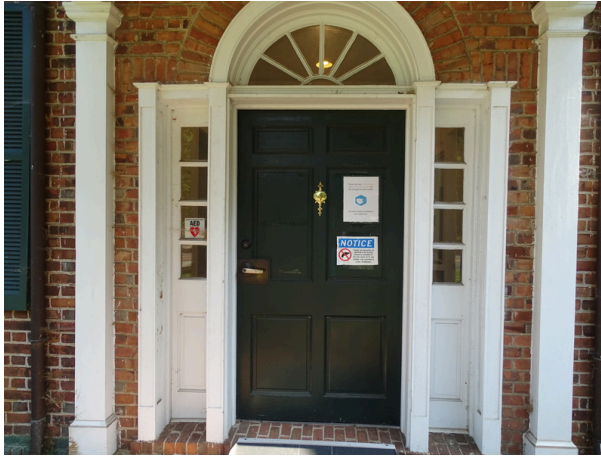
The main entrance is a Wood door. The main entrance door was generally in good condition. Exterior doors typically have an expected useful life of 20 to 30 years.

Main entrance

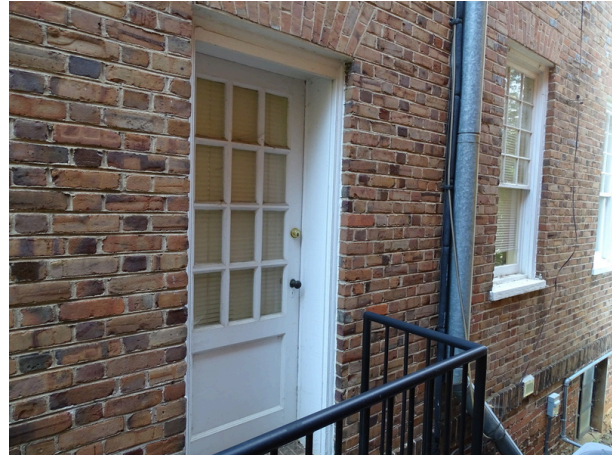
Building exterior east side of the building

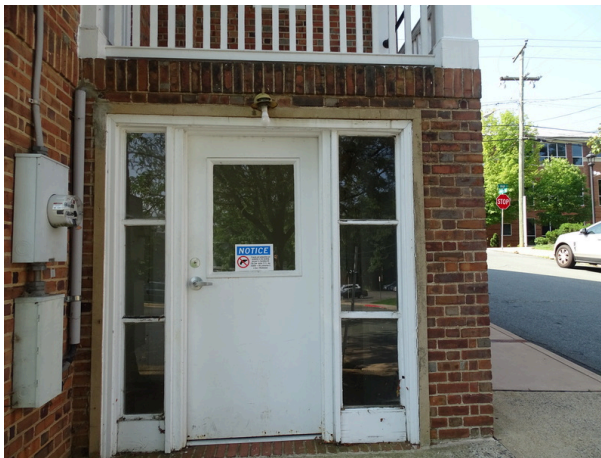
Door at north side of the building

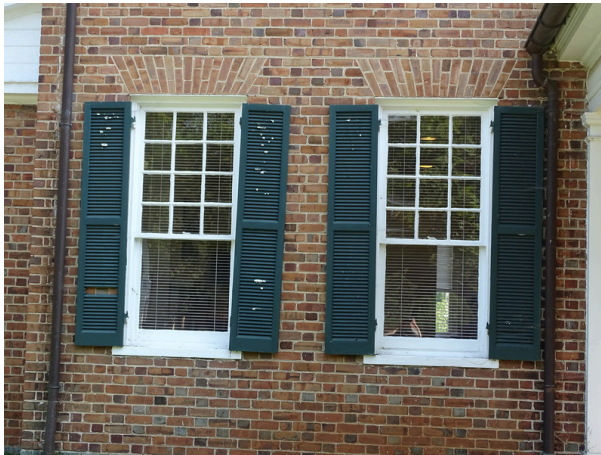
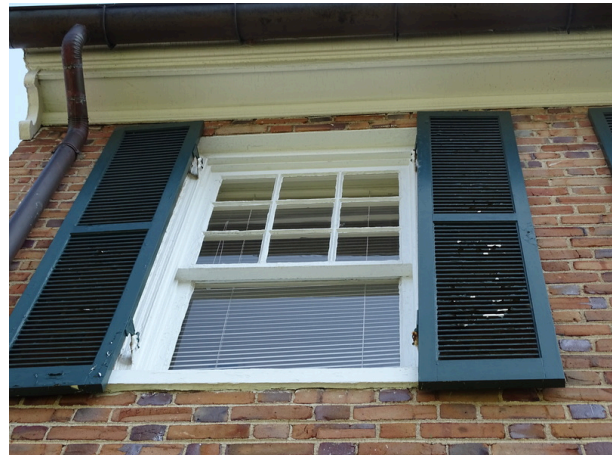
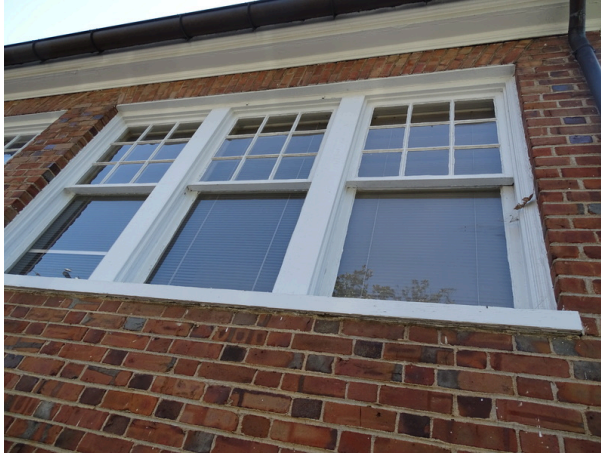
The window system for the building primarily consists of Wood frame single pane window units. The expected useful life of windows is typically 30 years. The window units were in generally in fair condition. We recommend replacing the windows during the report period.

Typical exterior window

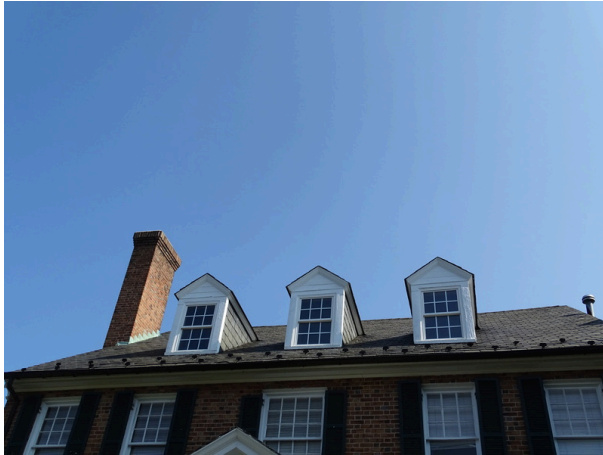
The main roofing system consists of a Slate shingle roofing system over the building. Deterioration was observed in and around the gutter on the north side of the building. Some of the slate shingles were misaligned and will need eventual repair to prevent future leakage. We recommend periodic allowance over the report period to repair misaligned slate shingles and general deterioration of the roofing system.

Slate shingle roofing system

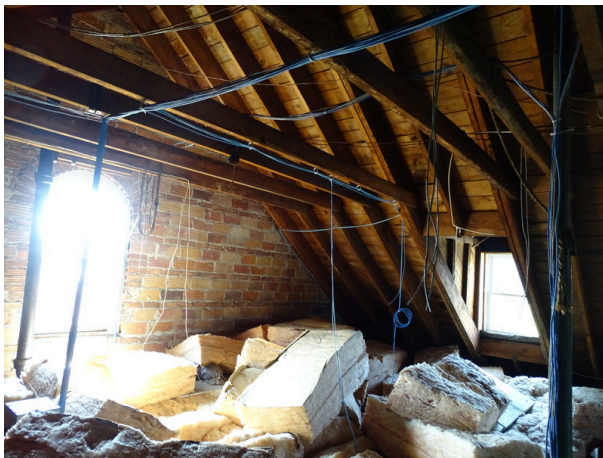
Structural framing

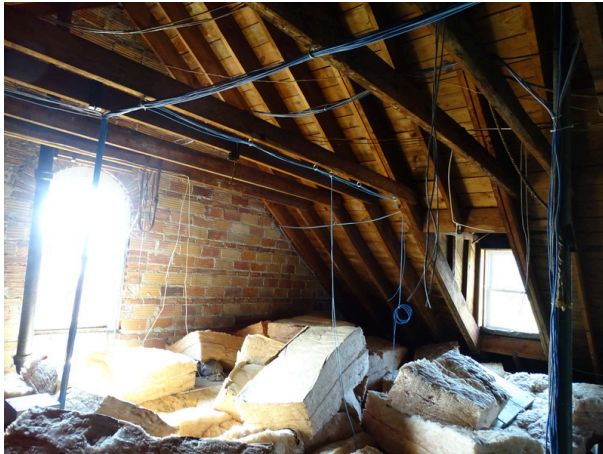
Structural framing

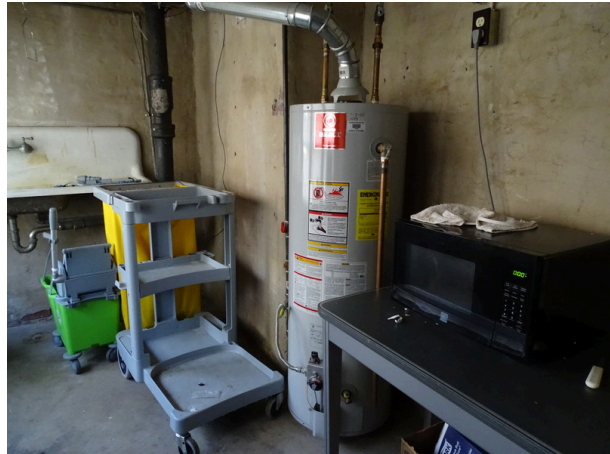
Gas domestic water heater

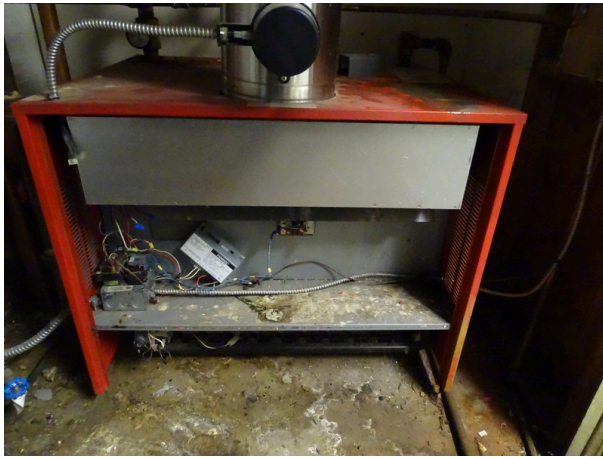
Boiler located at lower level

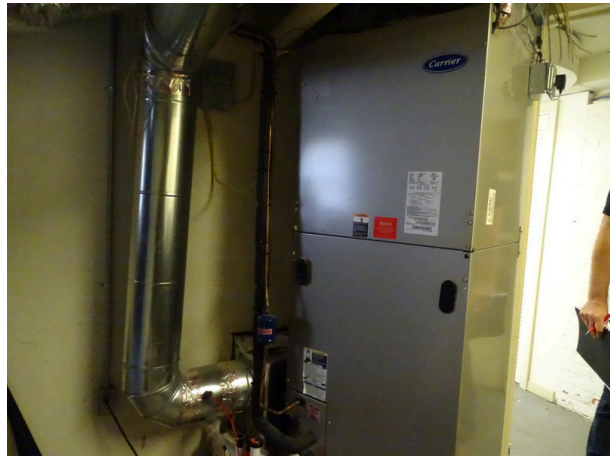
The air handler units were located at the lower level and attic areas. The combination gas furnace and air handler was manufactured by Carrier in 2013. The expected useful life of an air handler is 15 years with proper maintenance. The air handlers were observed to be in good to fair condition. We recommend that the air handlers be replaced during the later part of the report period.

Air Handler unit located in basement

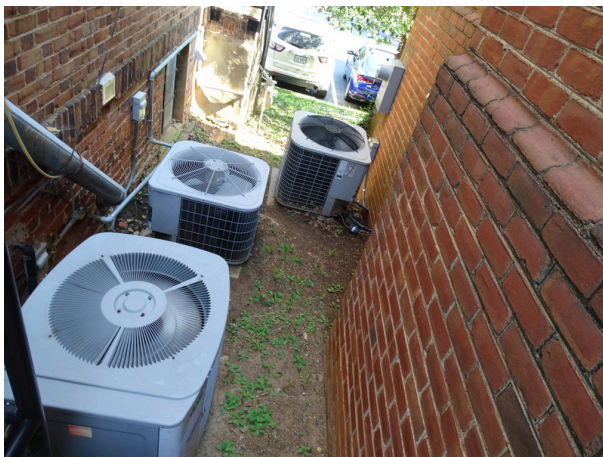
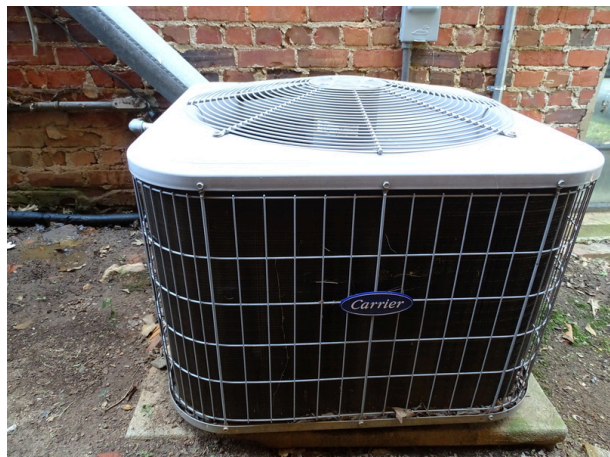
Condensers located on east side of the building

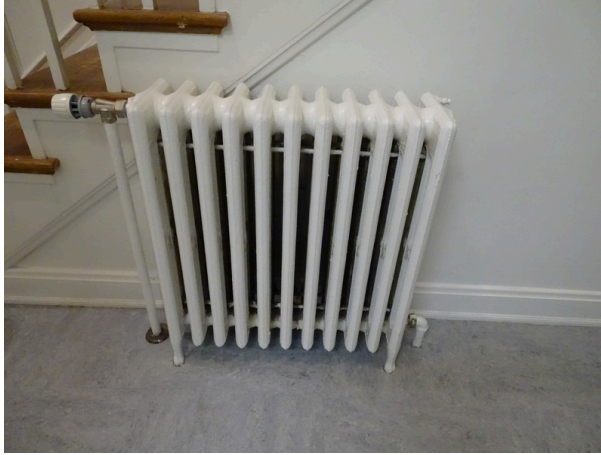
Typical radiator unit with manual control

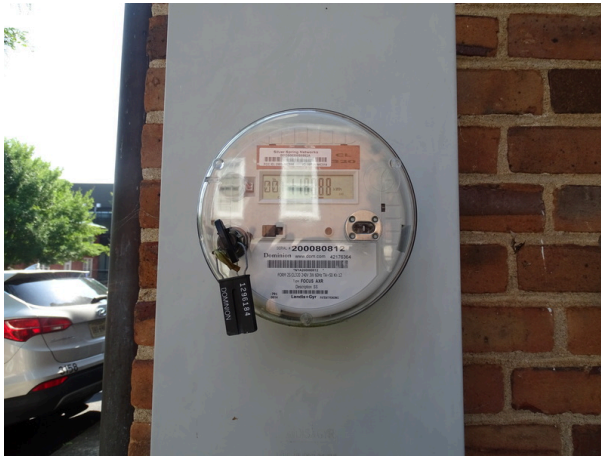
Electricity is provided to the building by Dominion Virginia Power through a pole mounted transformer. The main electrical entrance is located on the north side of the building and provides 120/240-volt, single-phase, 3-wire, 200 amps service.

Electric meter

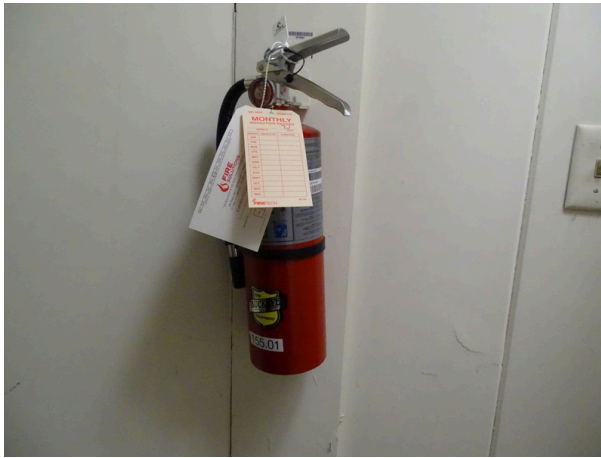
The fire suppression system consists of Fire extinguishers. The fire suppression system was observed but not tested. Fire extinguishers were observed throughout the building. The fire extinguishers were observed to have inspection tags issued by Fire Solutions in June 2021 . These devices are required to be inspected annually.

Typical fire extinguisher

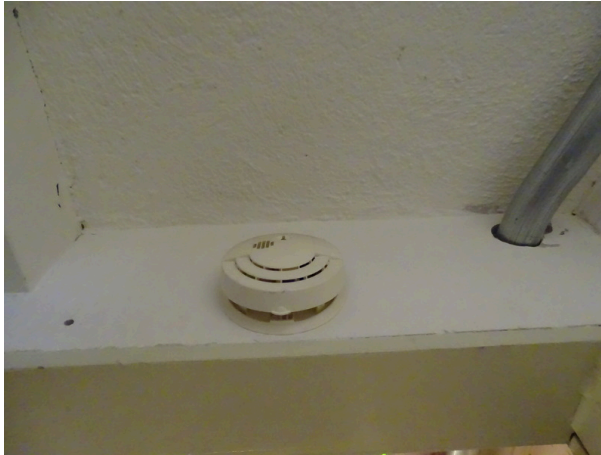
The fire alarm system was observed but not tested. Smoke detectors, exit signs, and emergency lighting are located throughout the building. The smoke alarms were generally in good condition.

Typical smoke detector

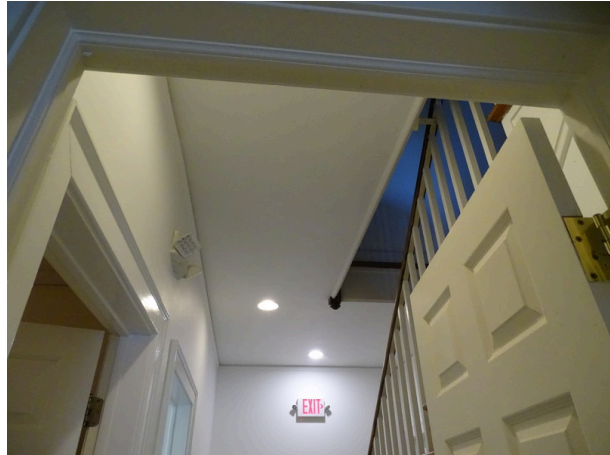
Exit and emergency lights sign

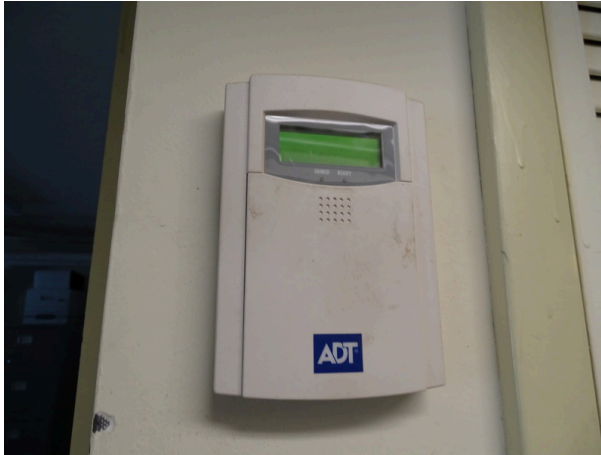
The building has an electronic alarm system and secure access with hardware locks. The security system was generally in good condition.

Security system electronics

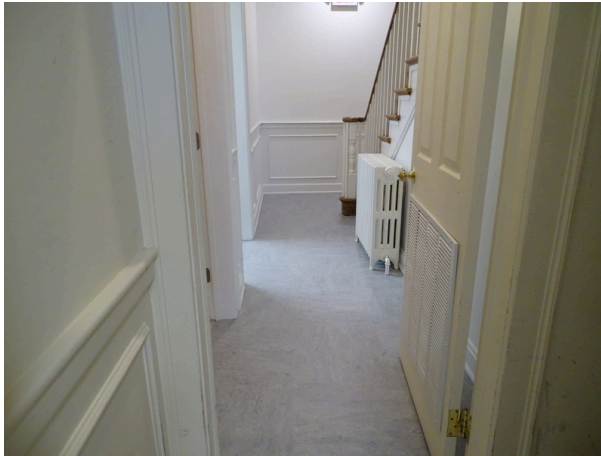
Typical corridor

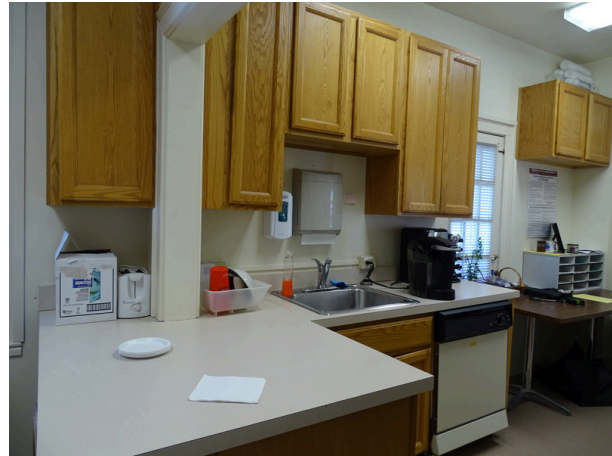
Interior finishes of kitchen area

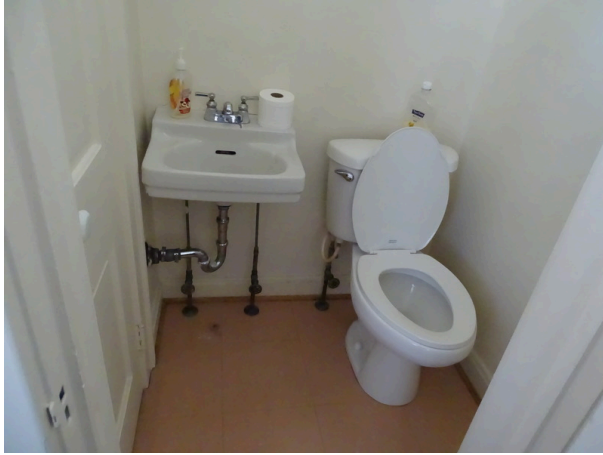
Interior finishes of restroom area

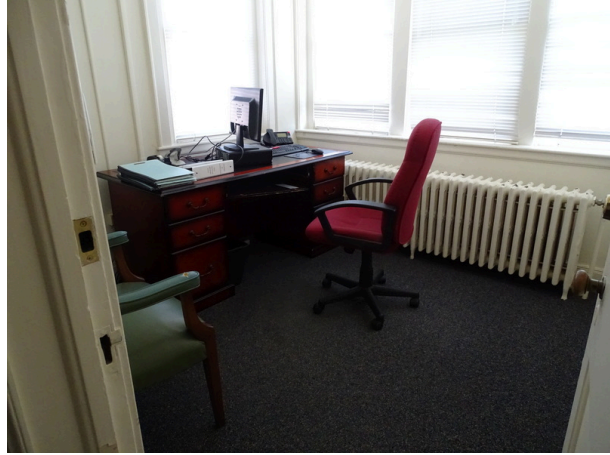
Interior finishes of office area

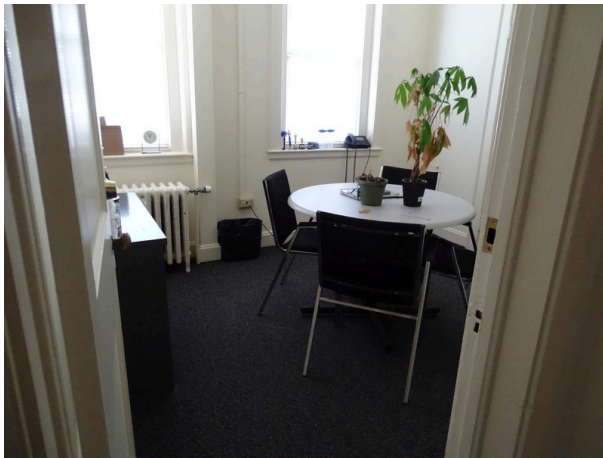
Interior finishes of meeting room area

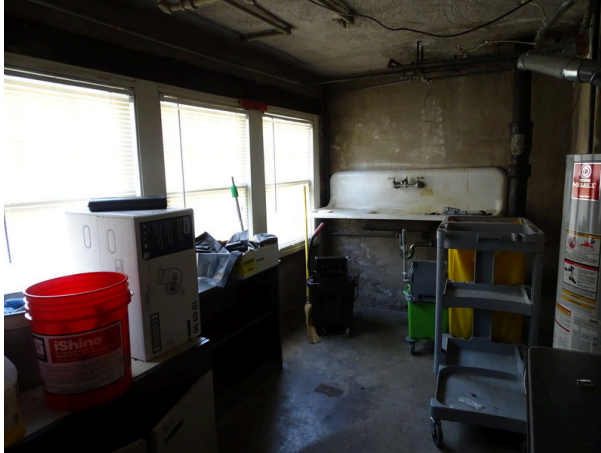
Utility room

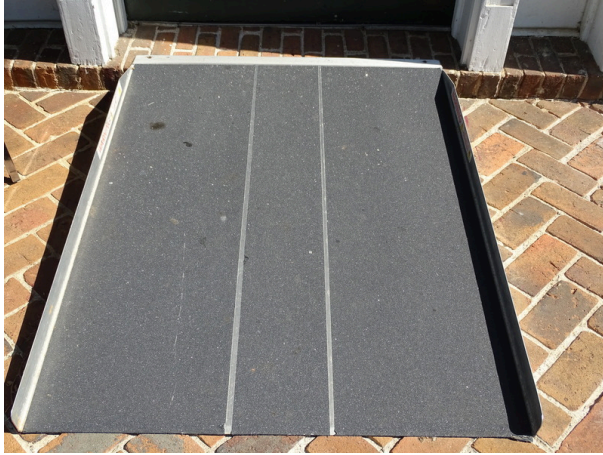
Accessible ramp at main entrance

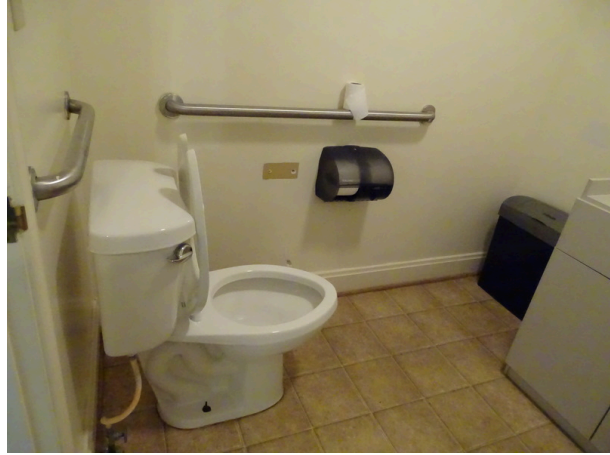
Accessible toilet

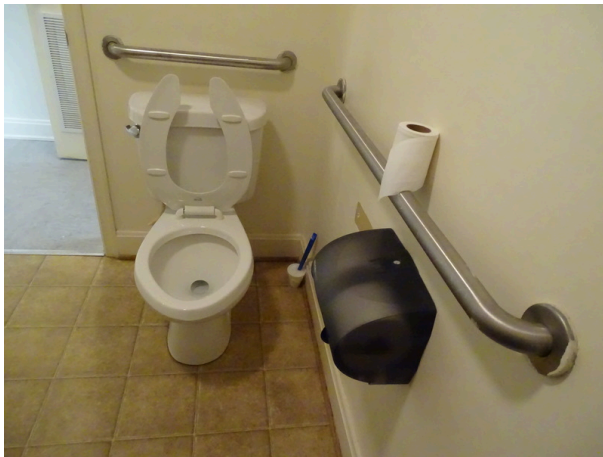
Accessible toilet

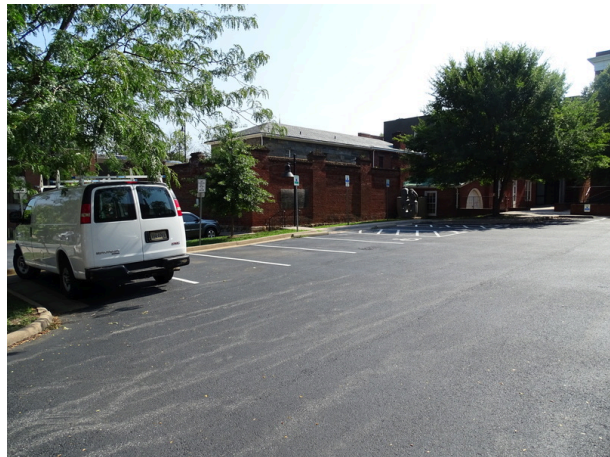
Asphalt parking north side of the site

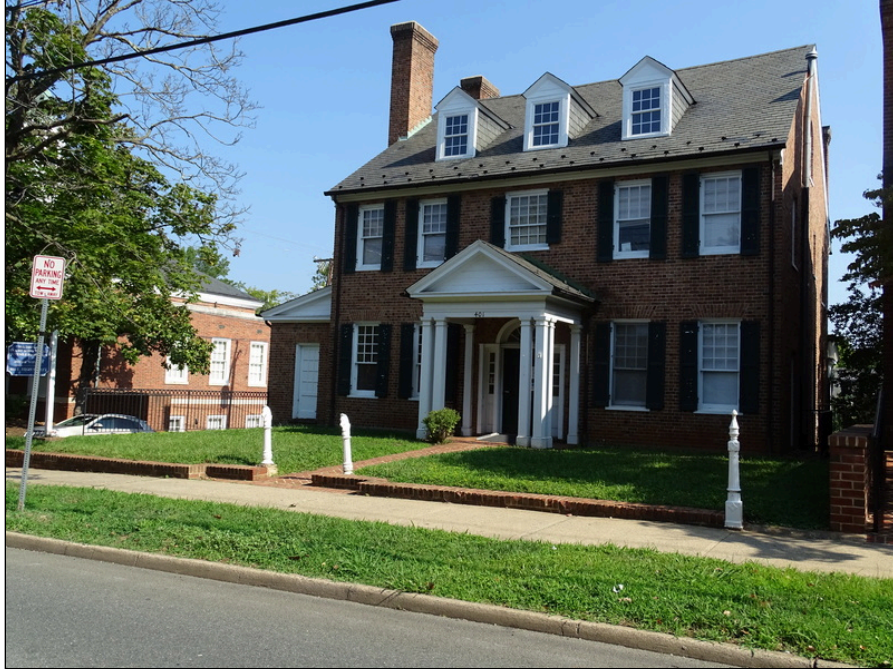
1 - Wheeler building overview

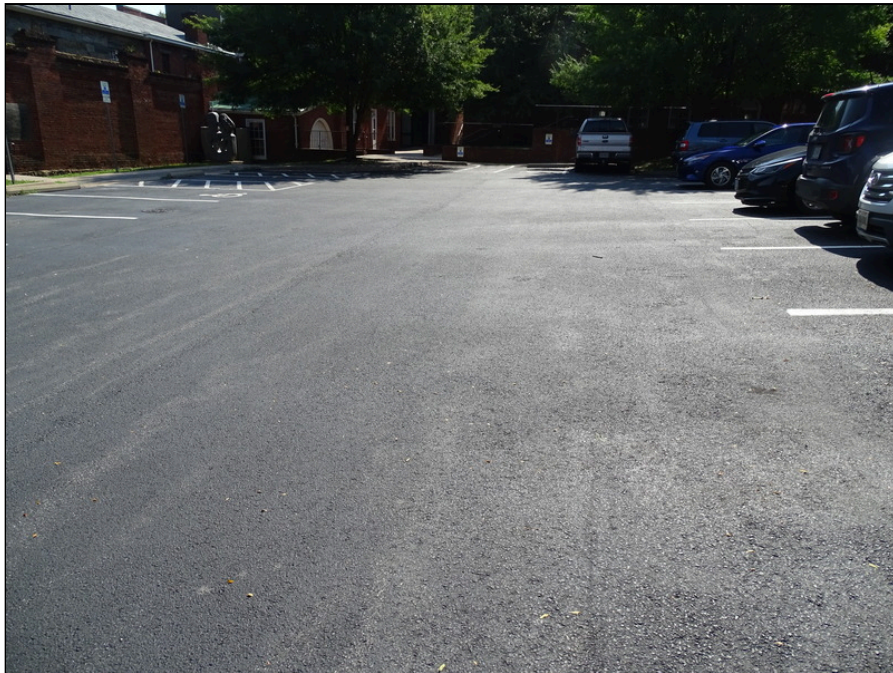
2 - Asphalt parking north side of the site

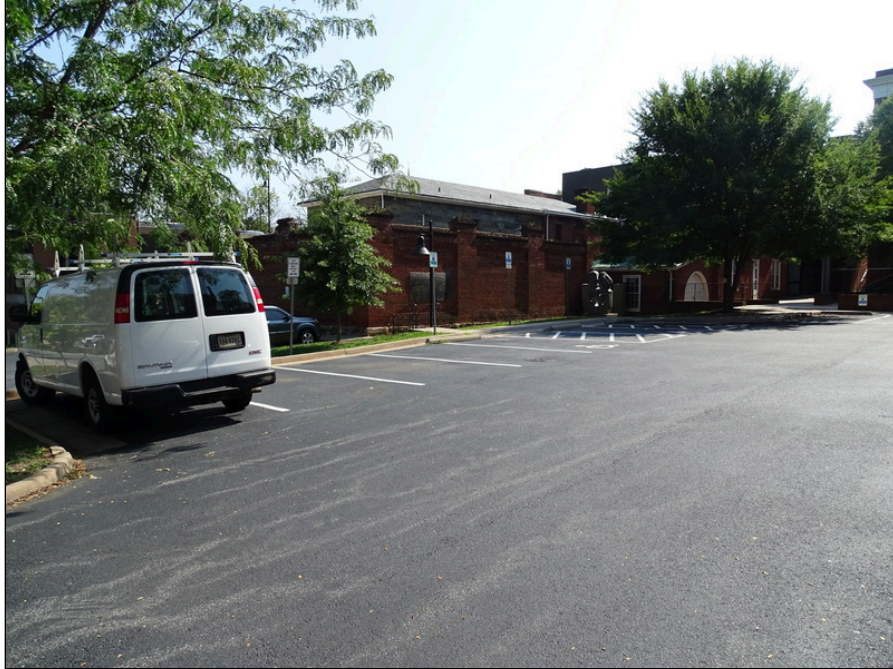
3 - Asphalt parking north side of the site

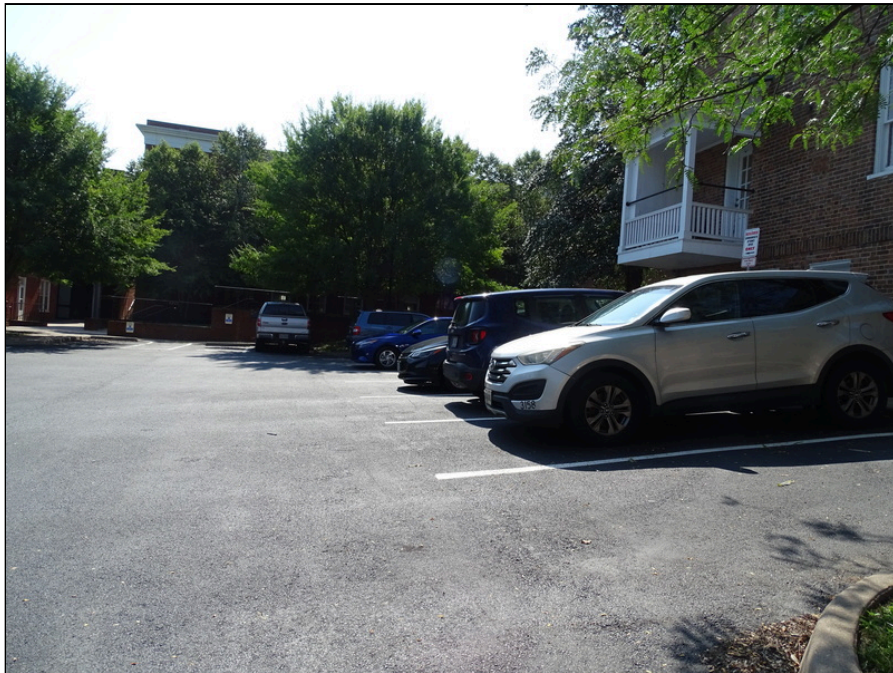
4 - Asphalt parking north side of the site

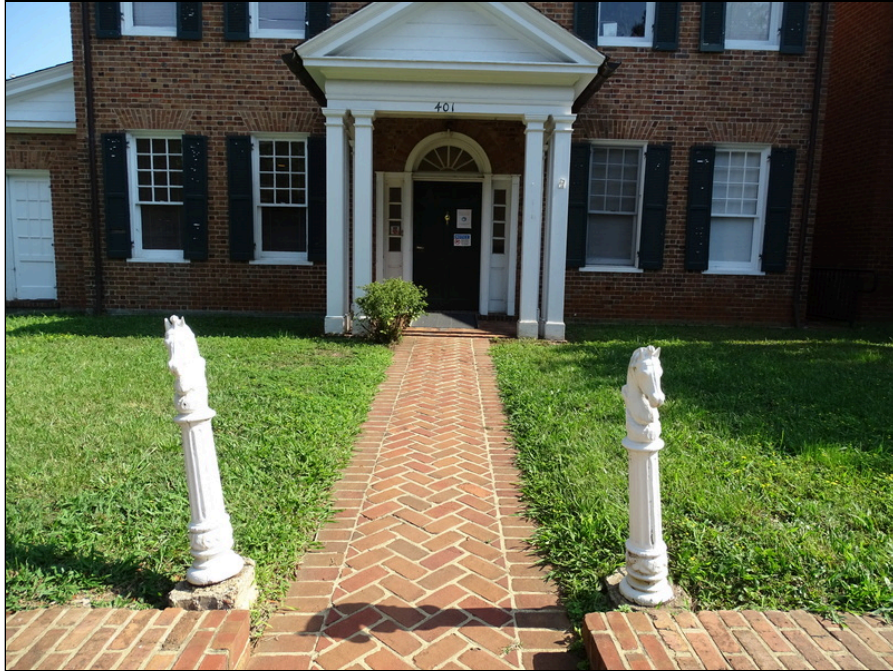
5 - Brick sidewalk south side of the site

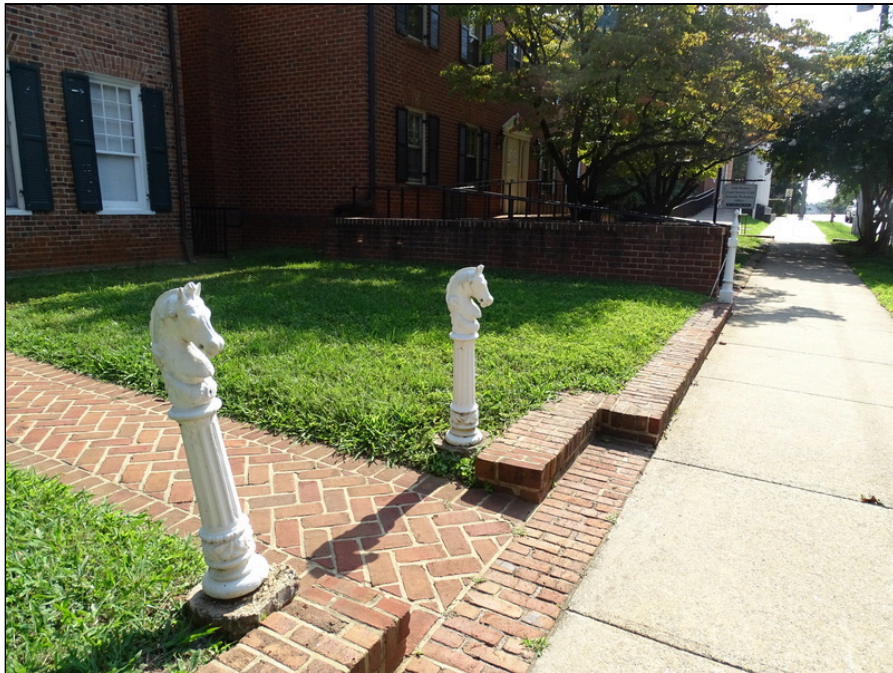
6 - Brick sidewalk south side of the site

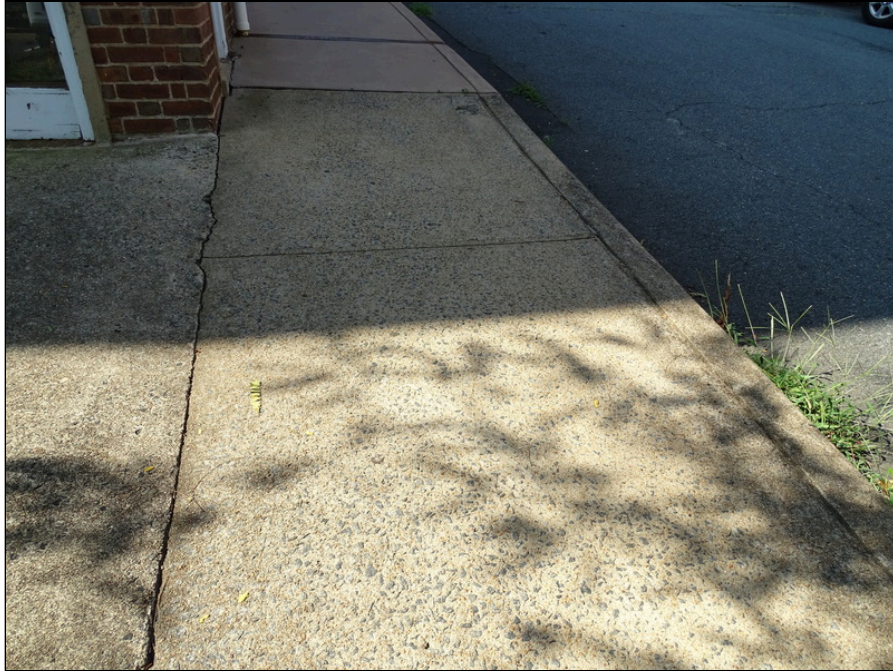
7 - Concrete sidewalk south side of the site

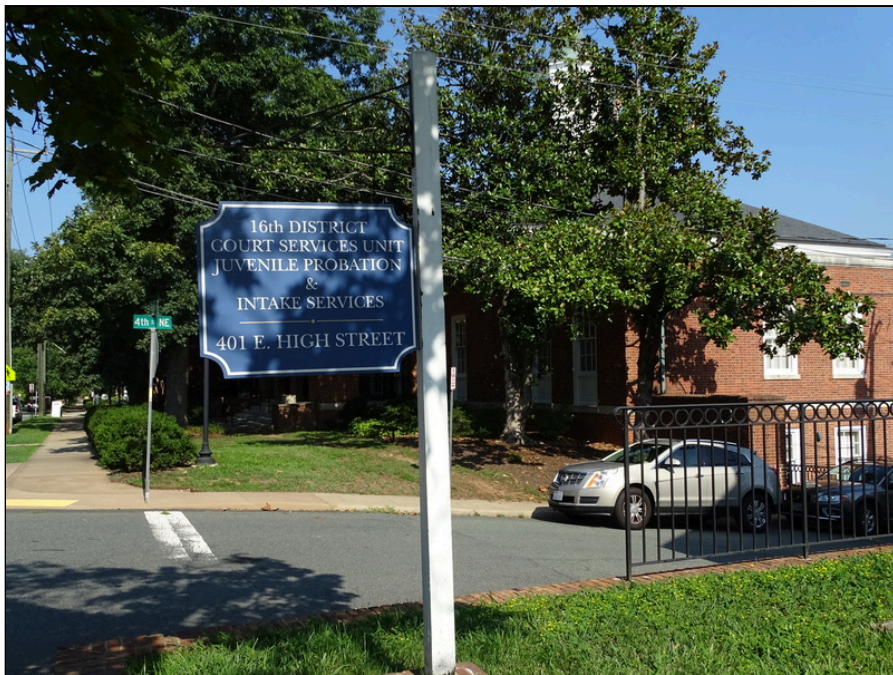
8 - Building signage

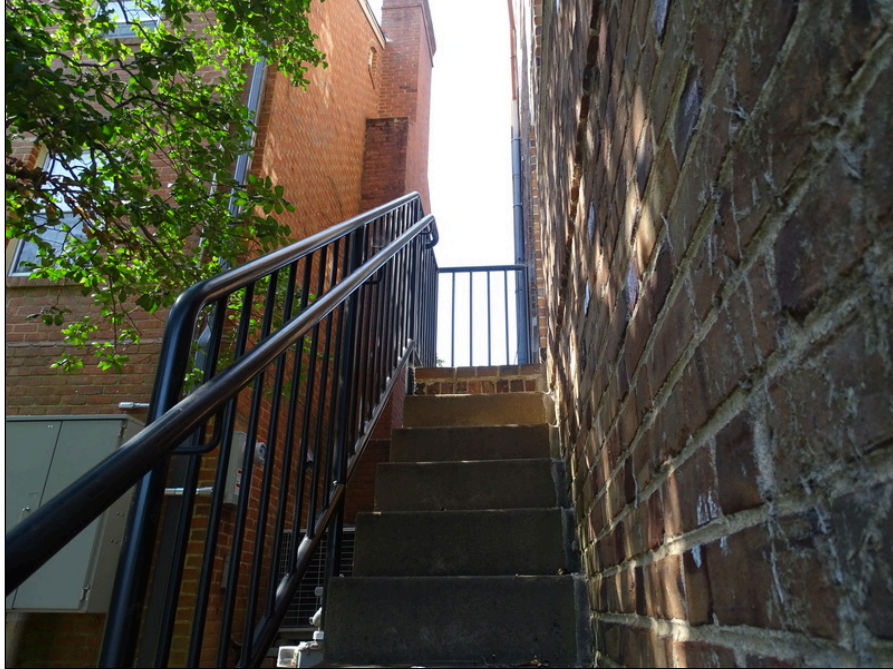
9 - Stair at west side of the building

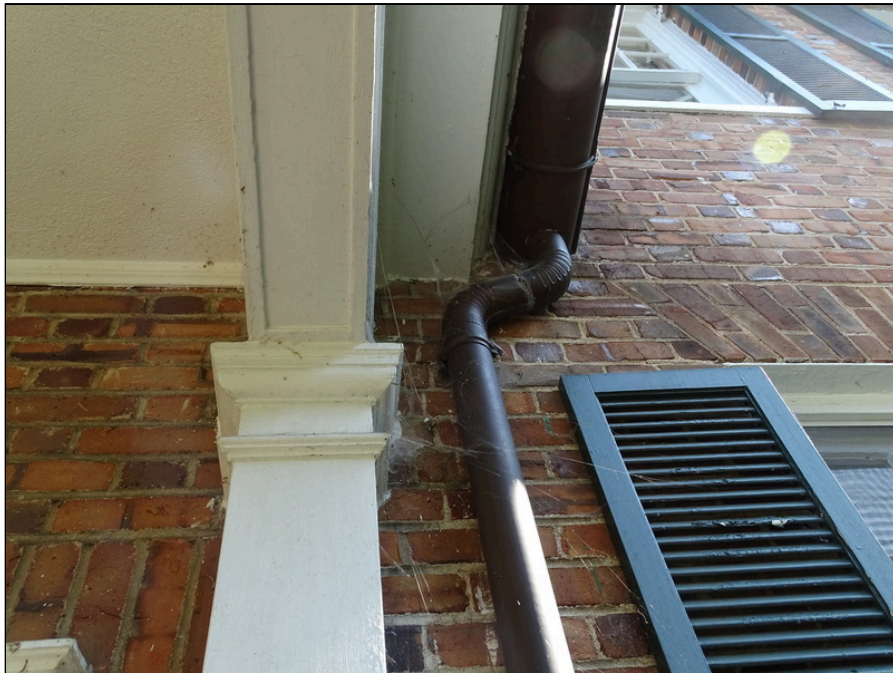
12 - Typical gutter overview

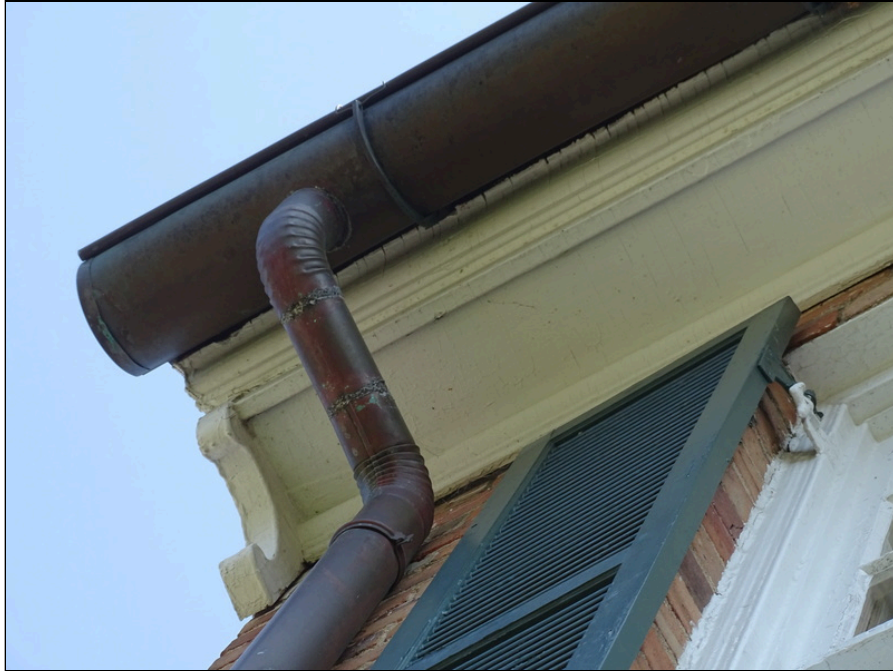
13 - Typical gutter overview

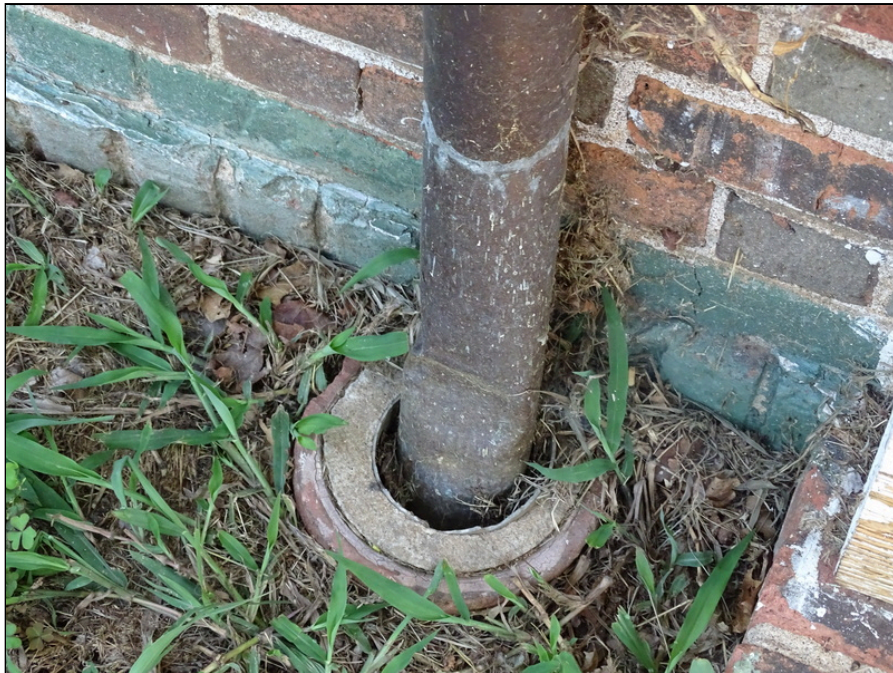
14 - Typical downspout

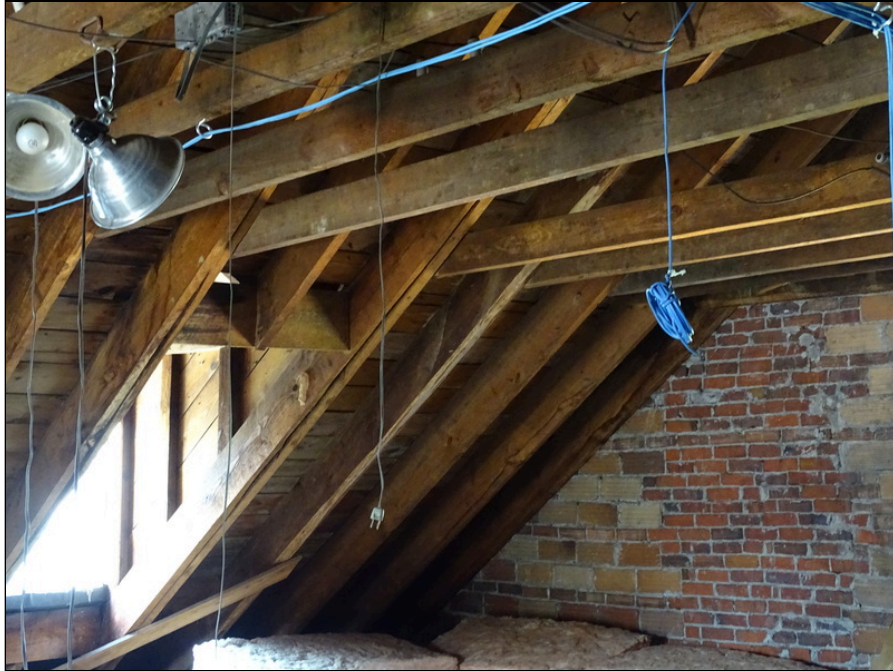
15 - Structural framing

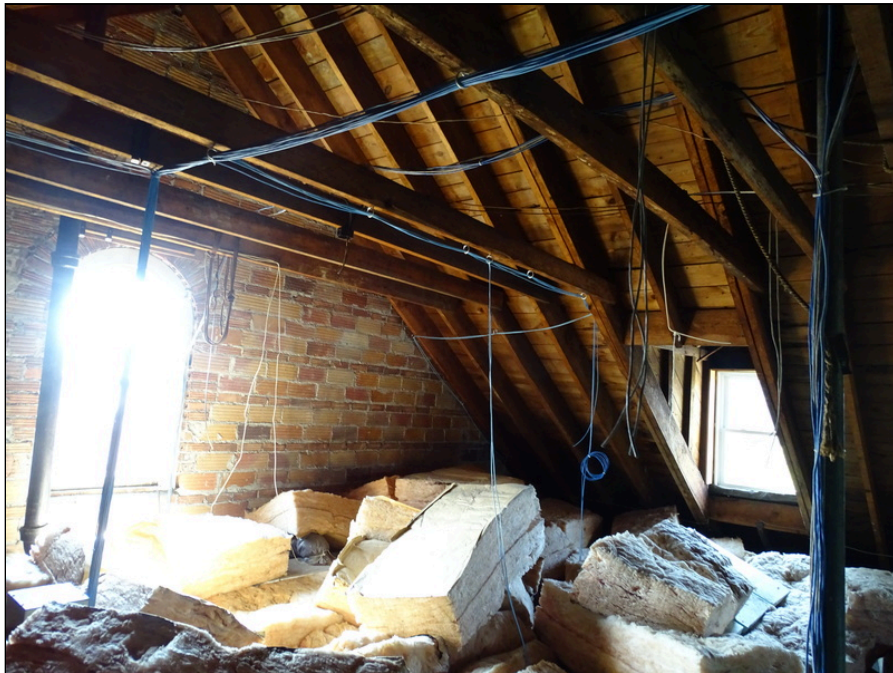
16 - Structural framing
