WHEELER BUILDING
401 EAST HIGH STREET
CHARLOTTESVILLE, VIRGINIA

ECS PROJECT NO. 46:6713

CITY OF CHARLOTTESVILLE - FACILITIES DEVELOPMENT

Reference: Facility Condition Assessment Report for Wheeler Building, 401 East High Street,
Charlottesville, Virginia

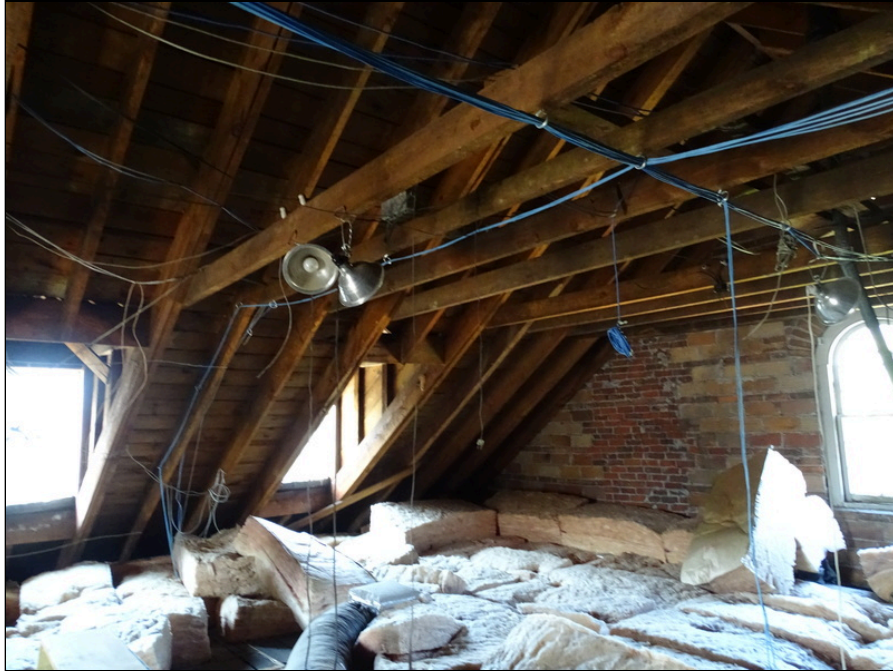
17 - Structural framing

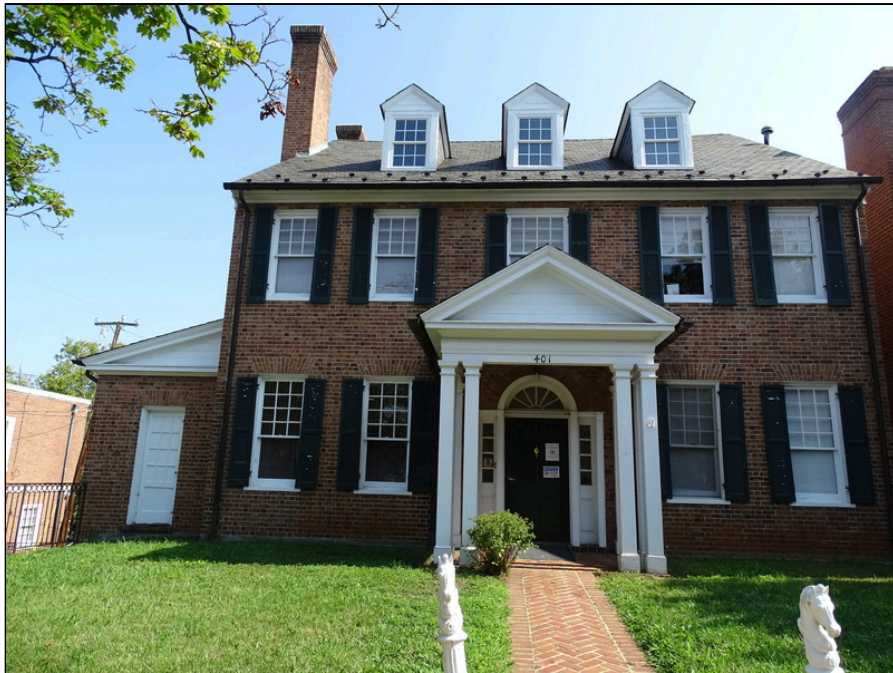
18 - South elevation

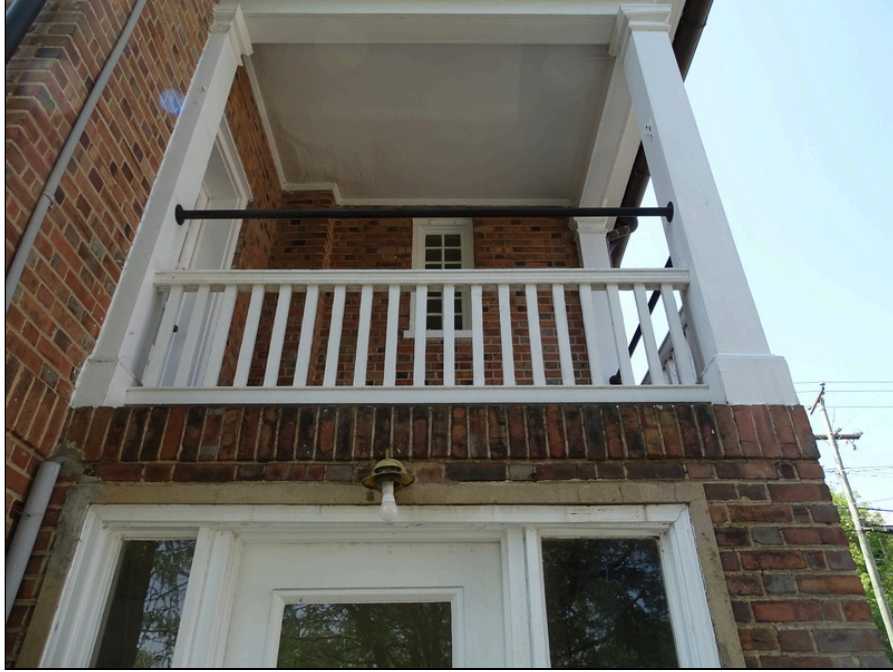
19 - Building exterior north side of the building

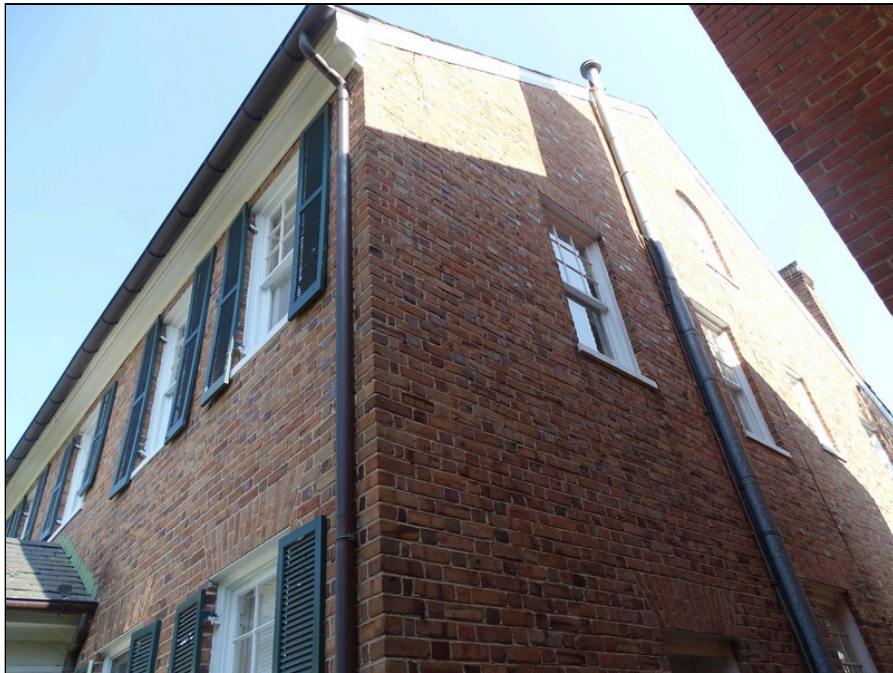
20 - Building exterior east side of the building

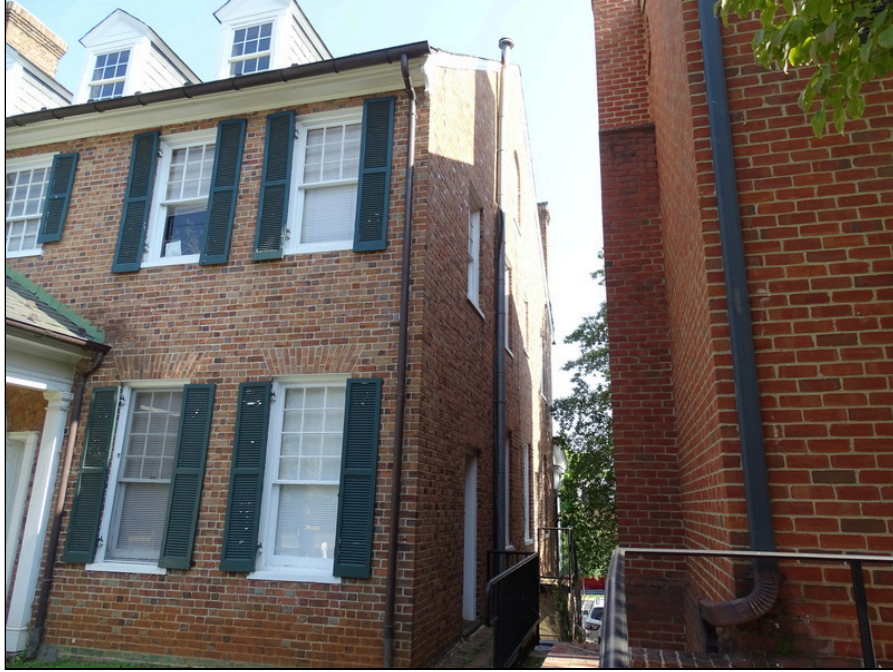
21 - Building exterior east side of the building

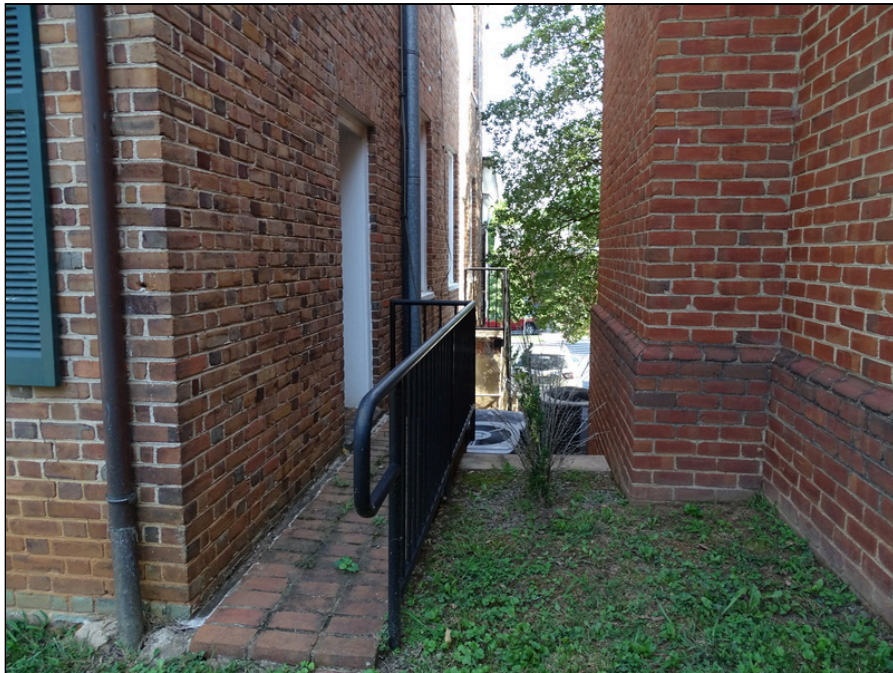
22 - Building exterior east side of the building

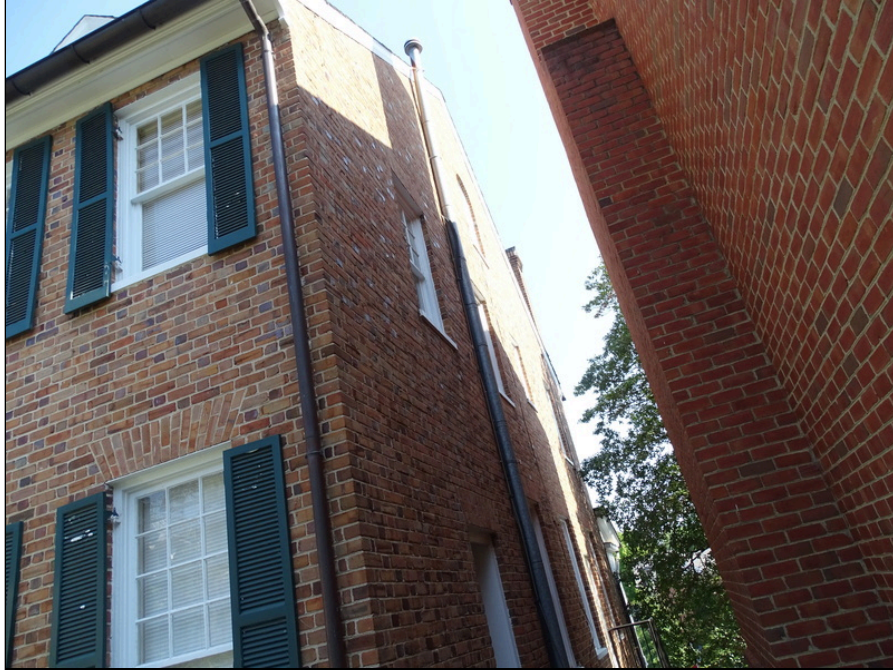
23 - Building exterior east side of the building

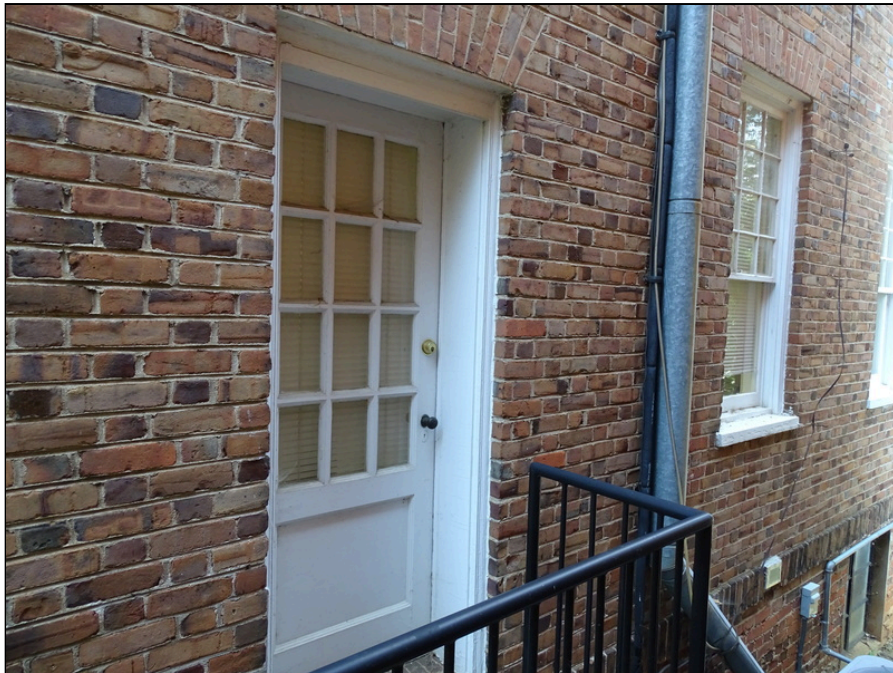
24 - Building exterior east side of the building

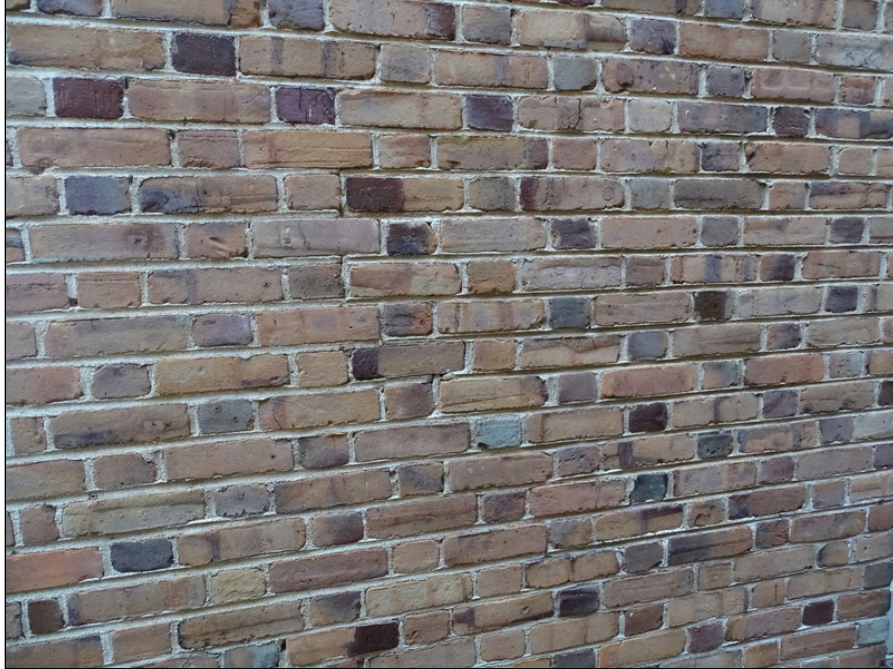
25 - Building exterior east side of the building

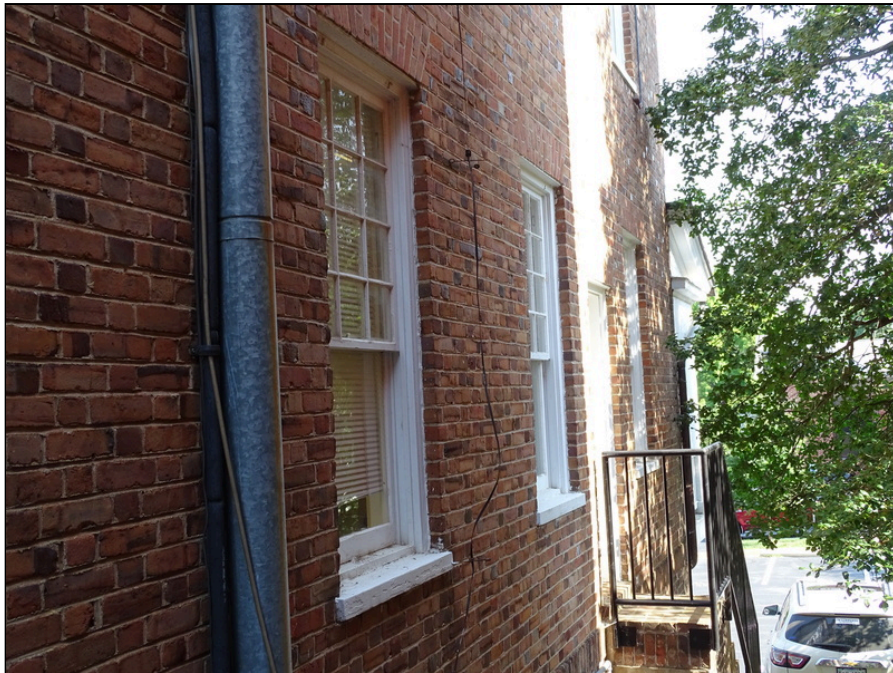
26 - Building exterior east side of the building

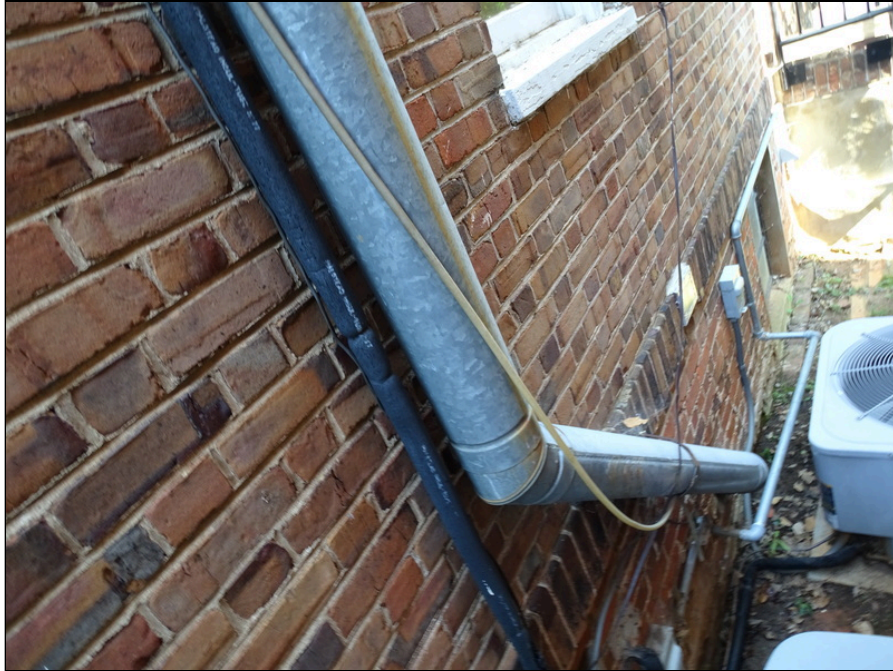
27 - Building exterior east side of the building

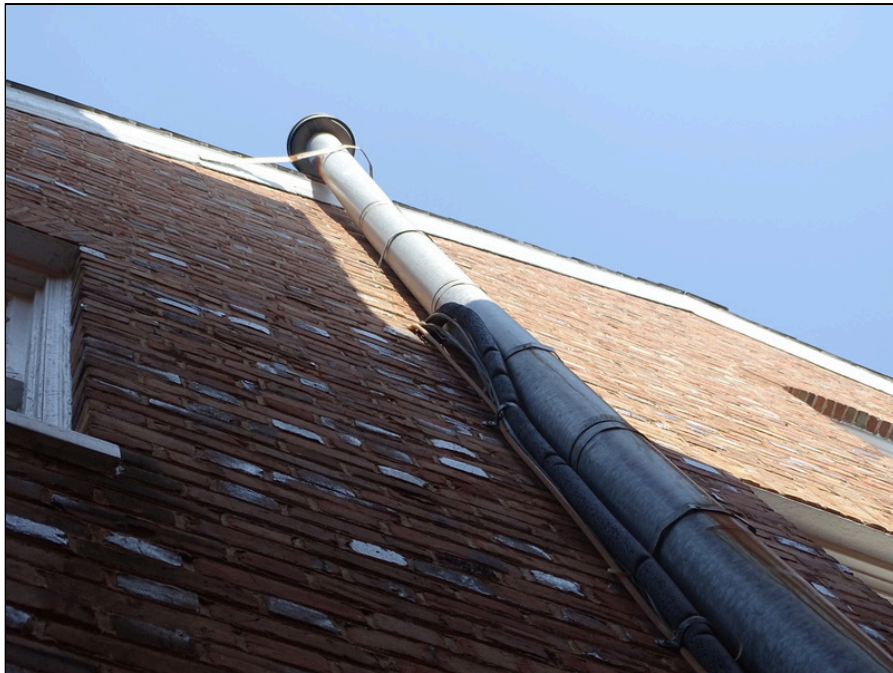
28 - Building exterior east side of the building

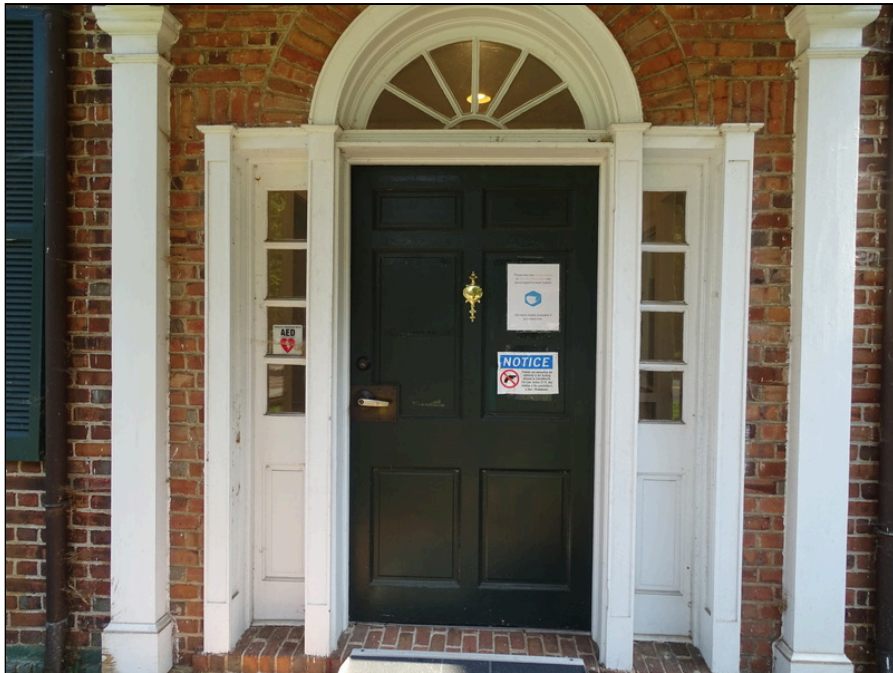
32 - Main entrance

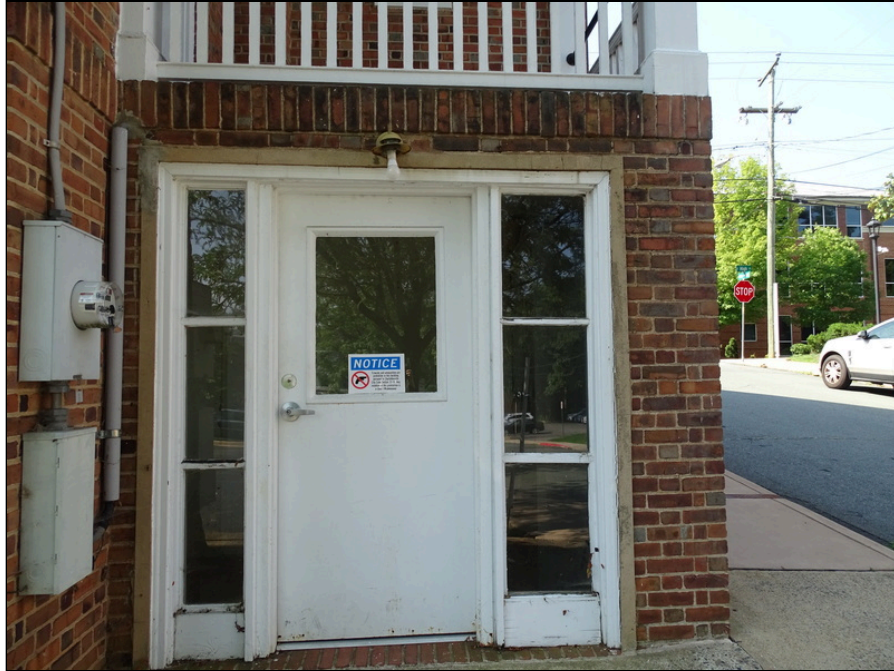
33 - Door at north side of the building

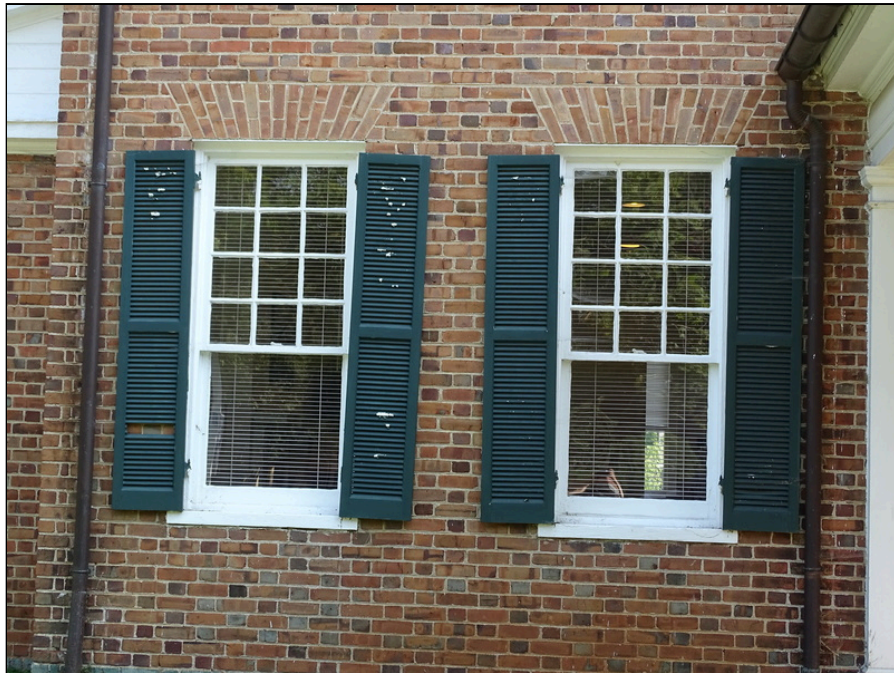
34 - Typical exterior window

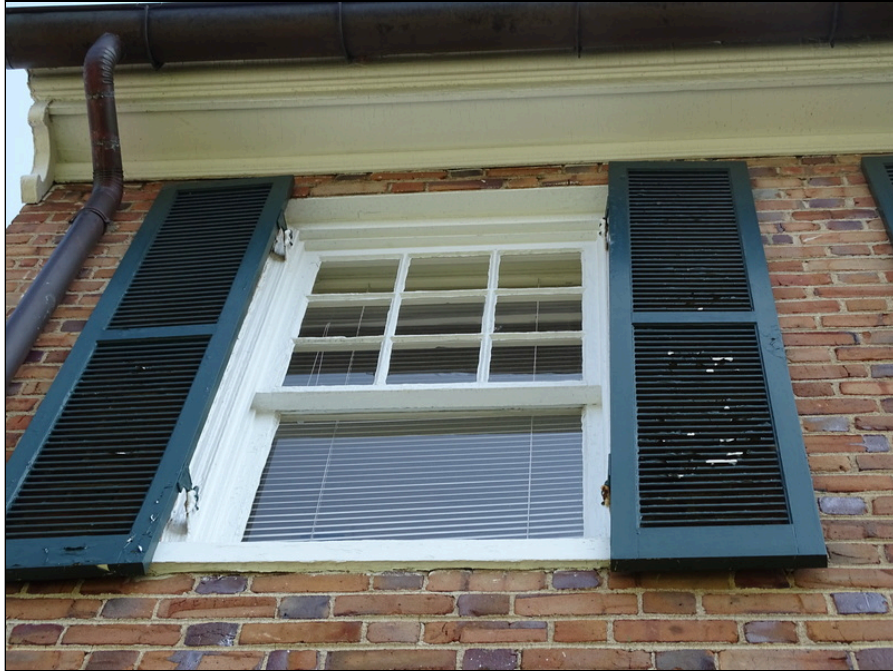
35 - Typical exterior window

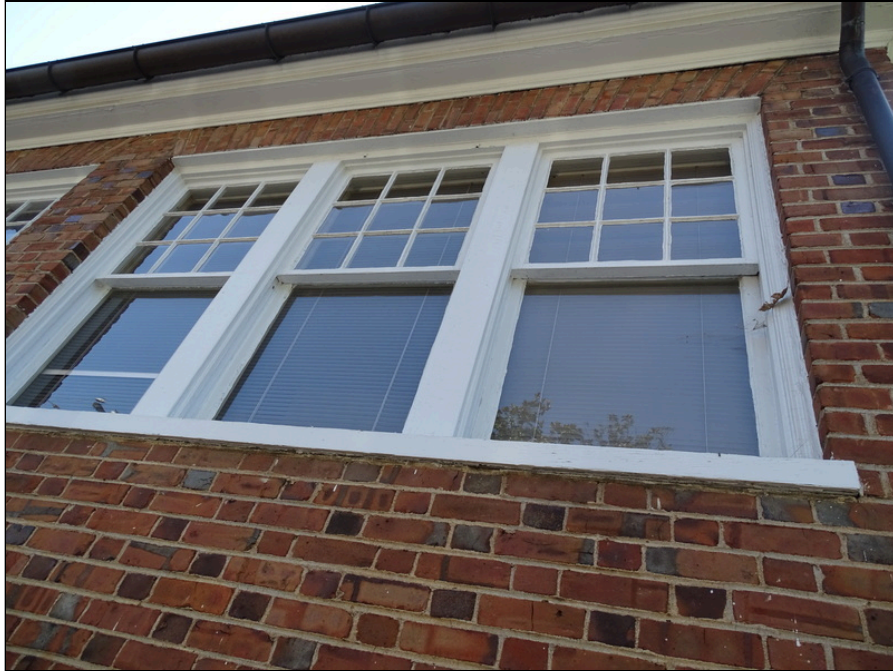
37 - Typical window on west side

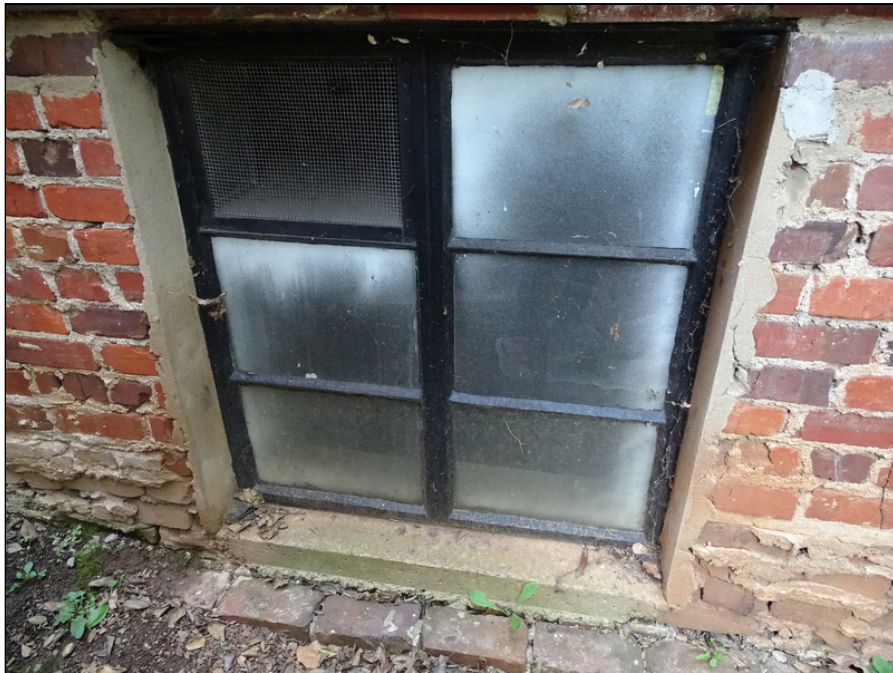
38 - Exterior basement window

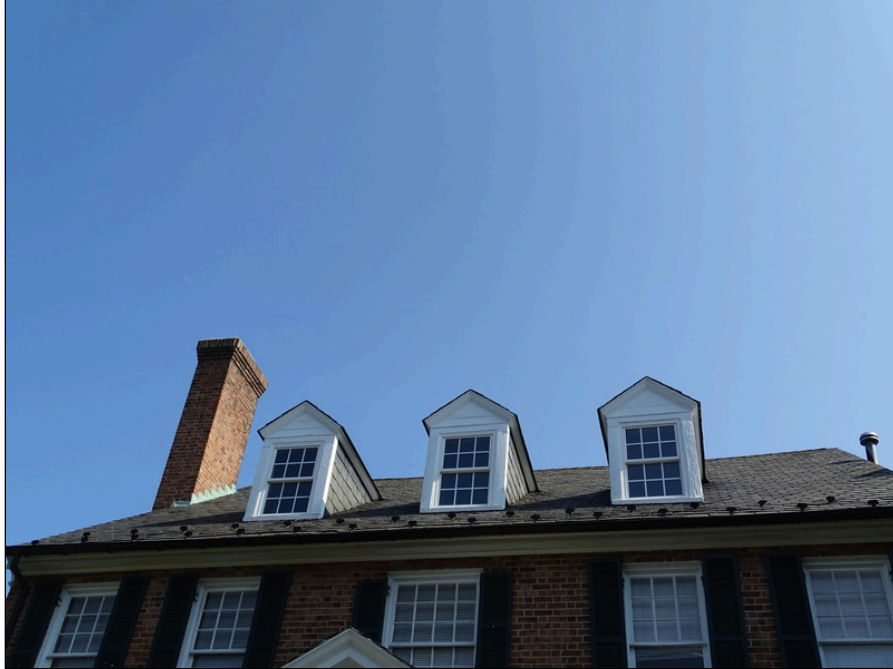
39 - Slate shingle roofing system

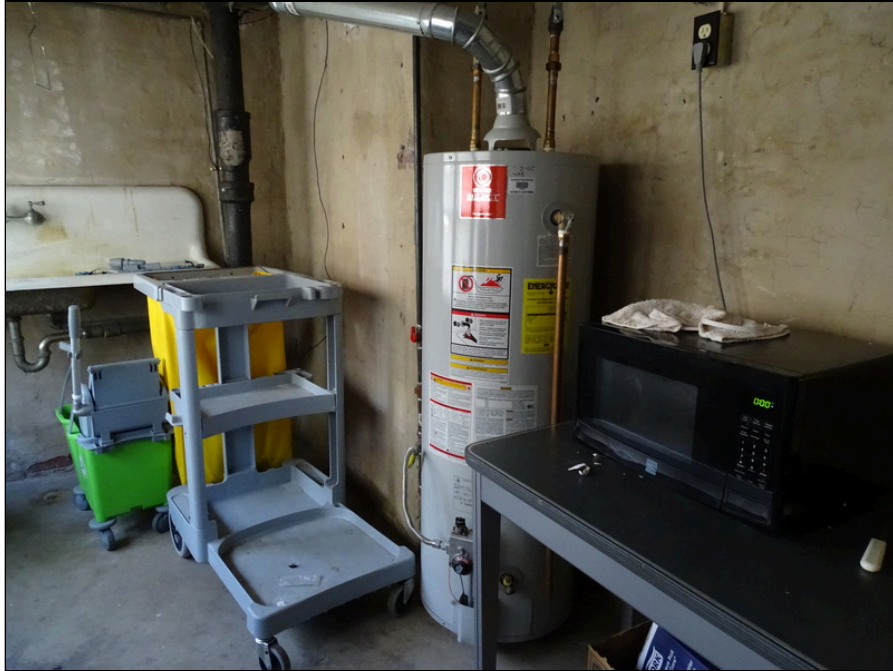
41 - Gas domestic water heater

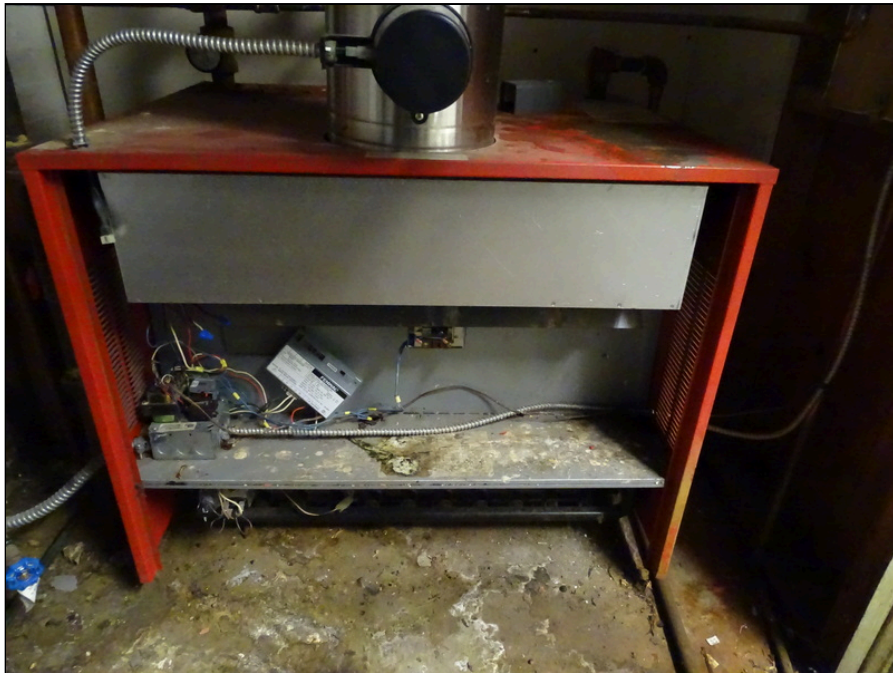
42 - Boiler located at lower level

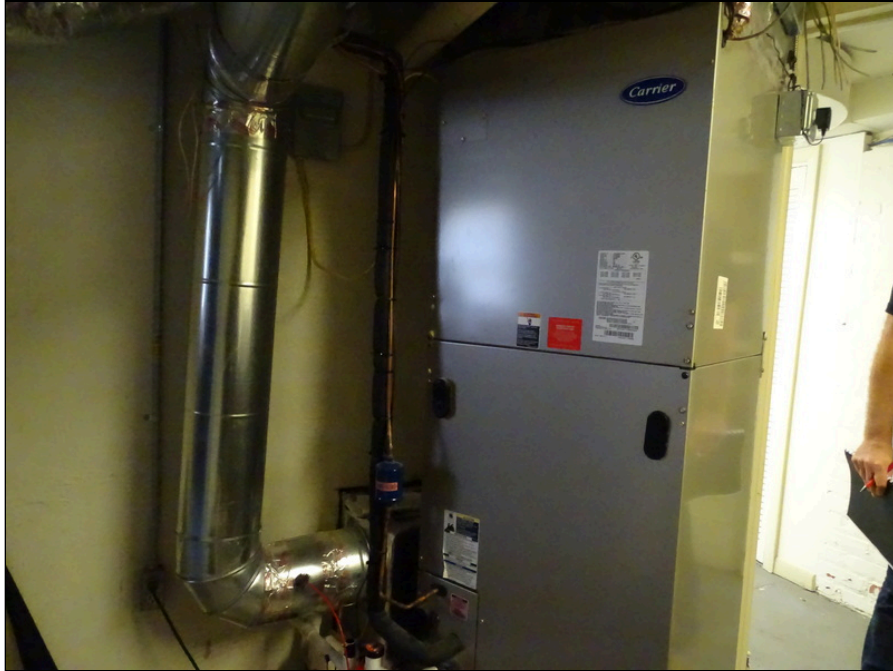
43 - Air Handler unit located in basement

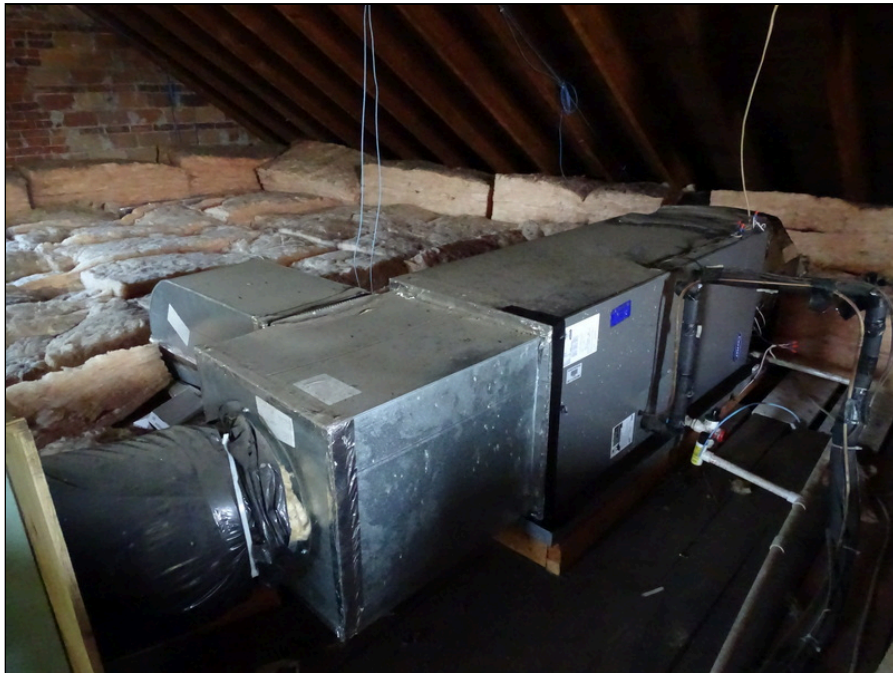
44 - Carrier air Handler unit located in attic

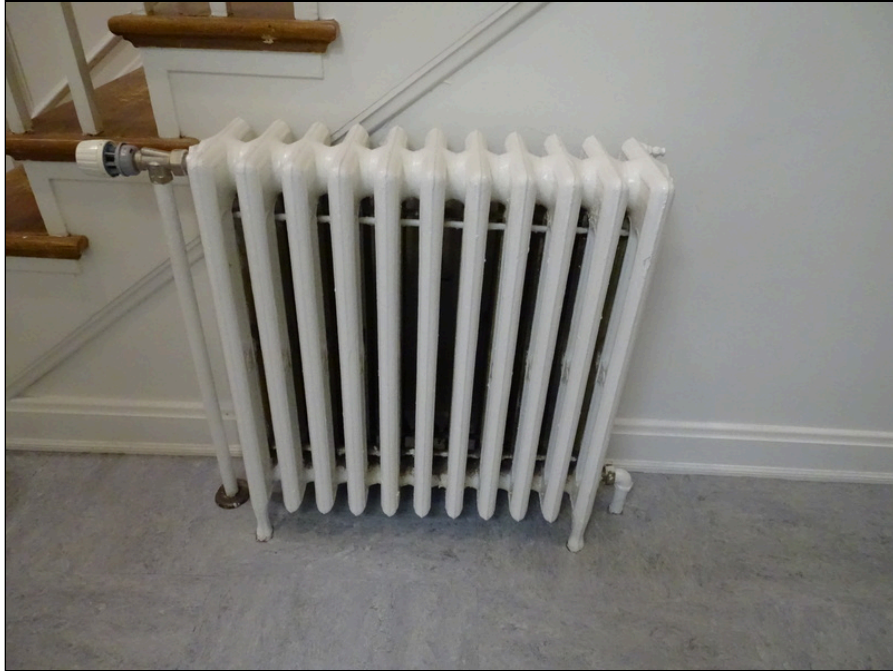
45 - Typical radiator unit with manual control

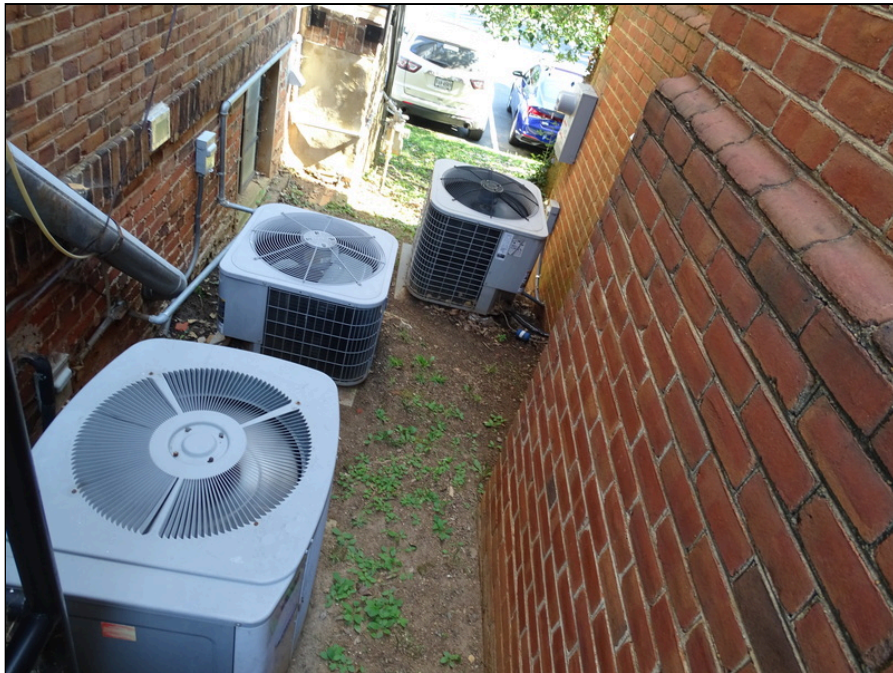
46 - Condensers located on east side of the building

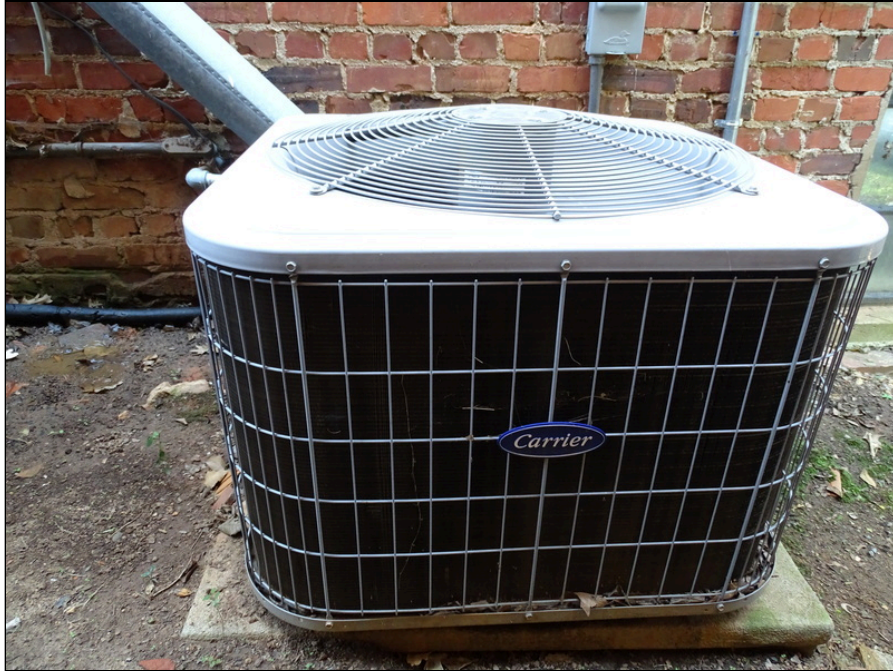
47 - Condensers located on east side of the building

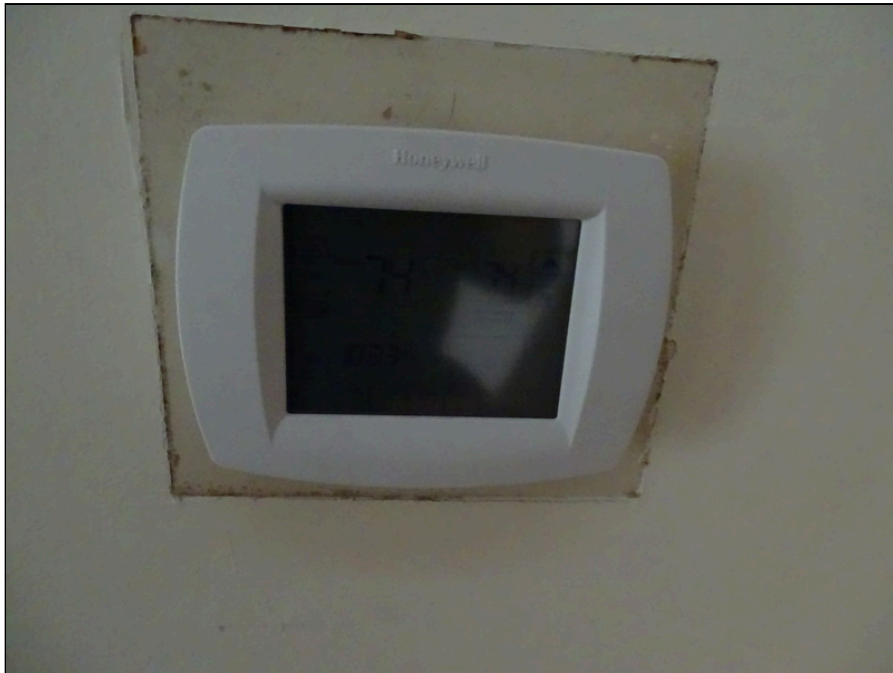
48 - Typical thermostat

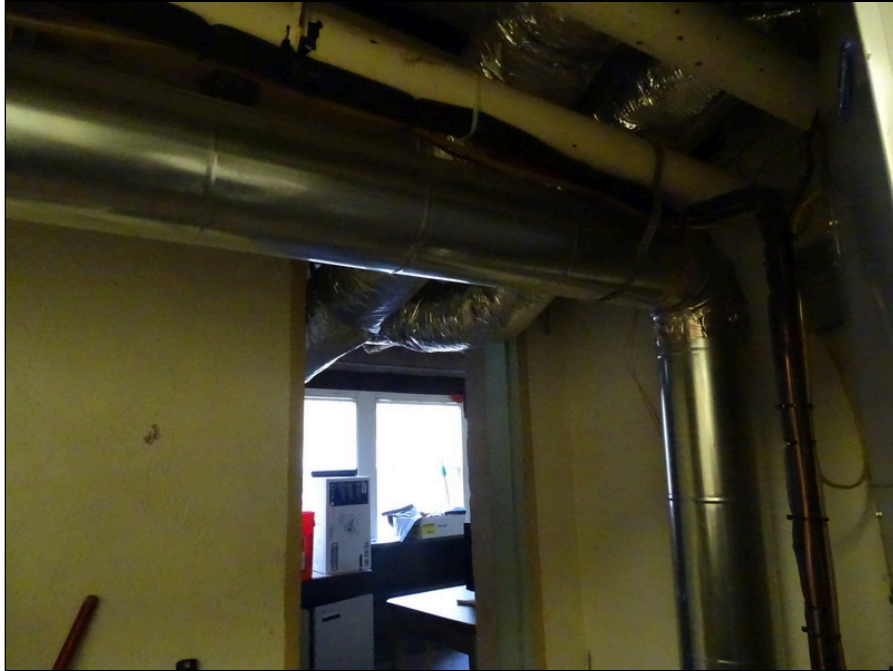
49 - Typical mechanical duct

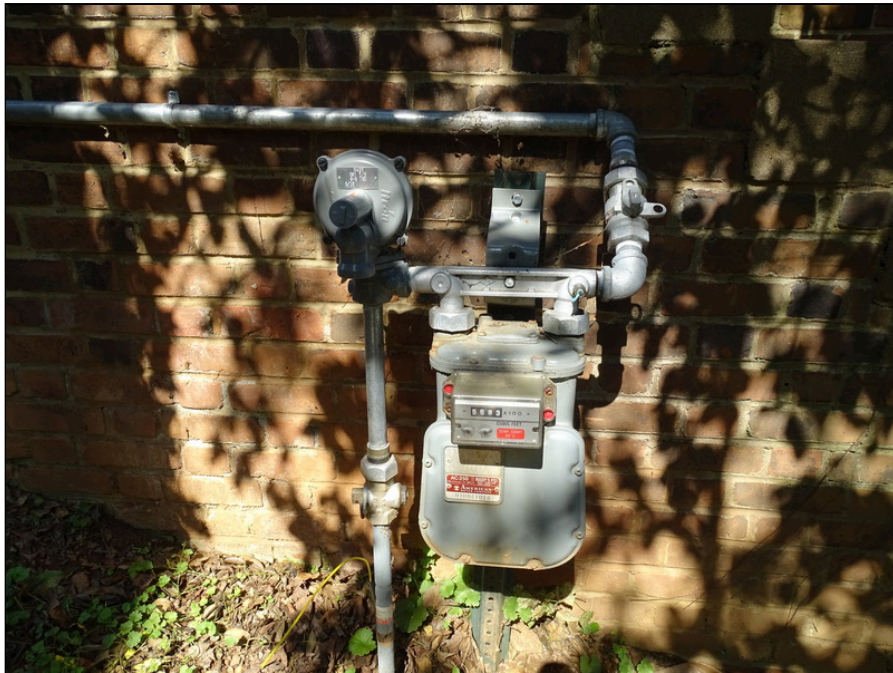
50 - Typical gas meter

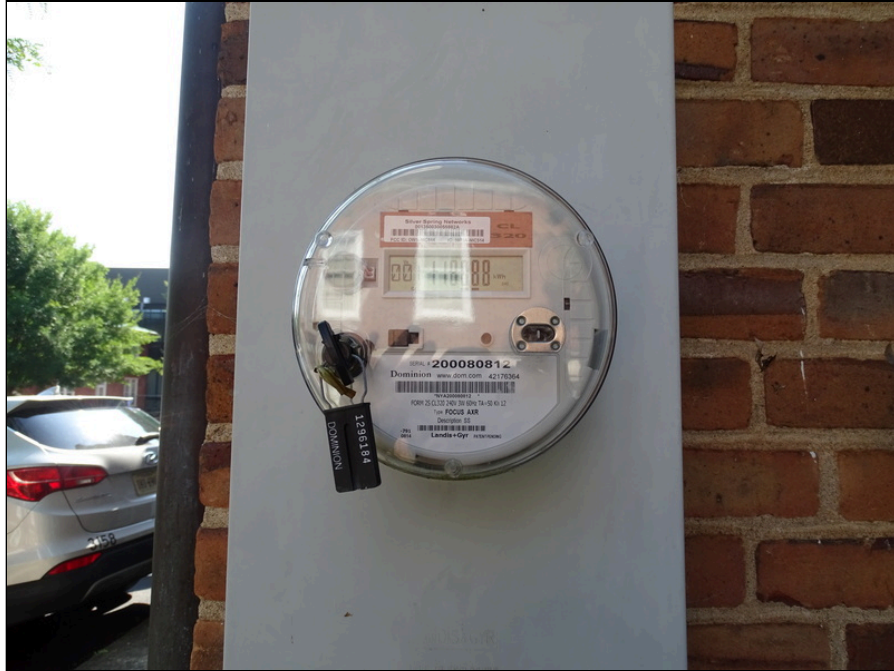
51 - Electric meter

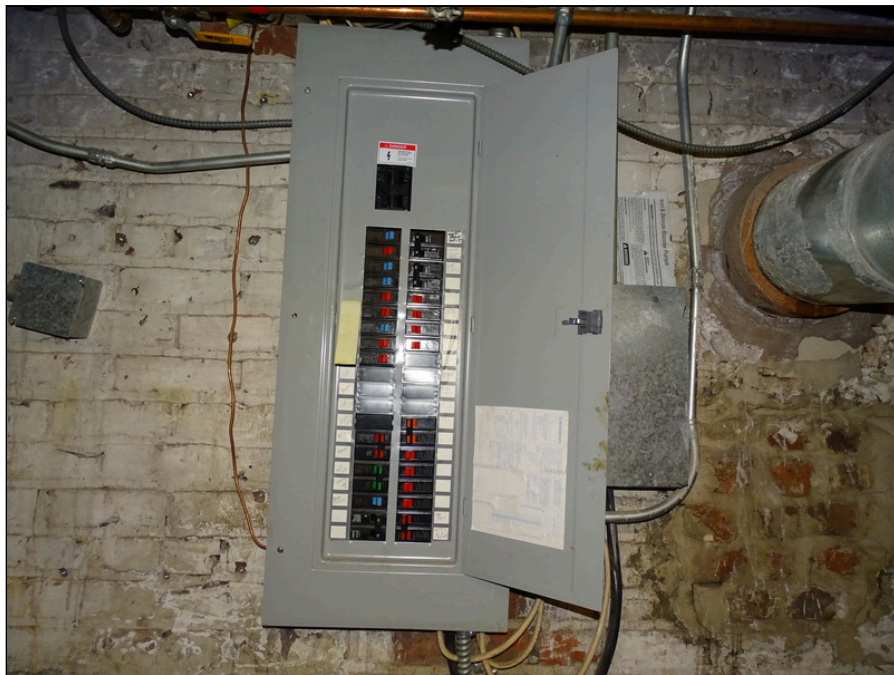
52 - Typical circuit breaker panel

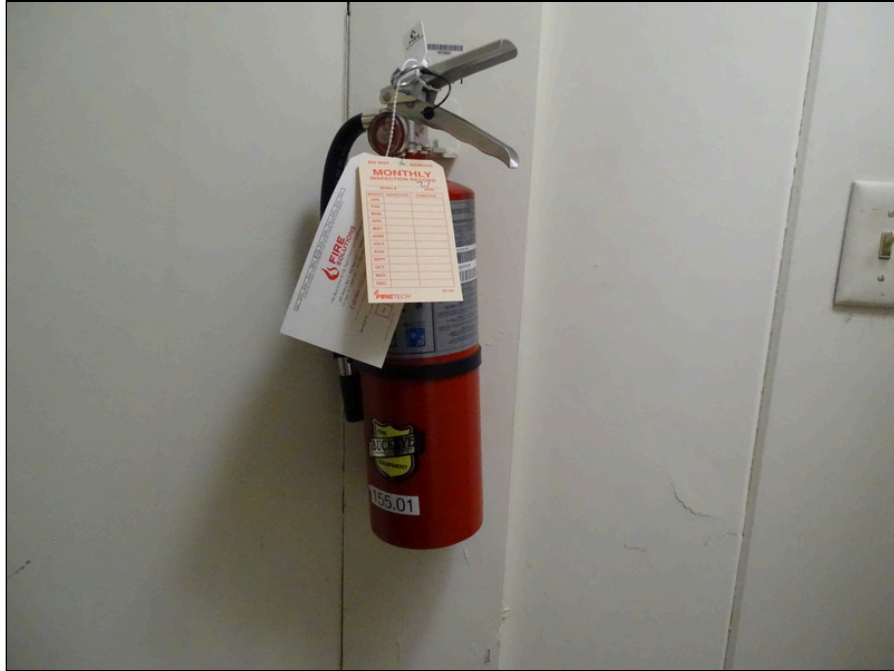
53 - Typical fire extinguisher

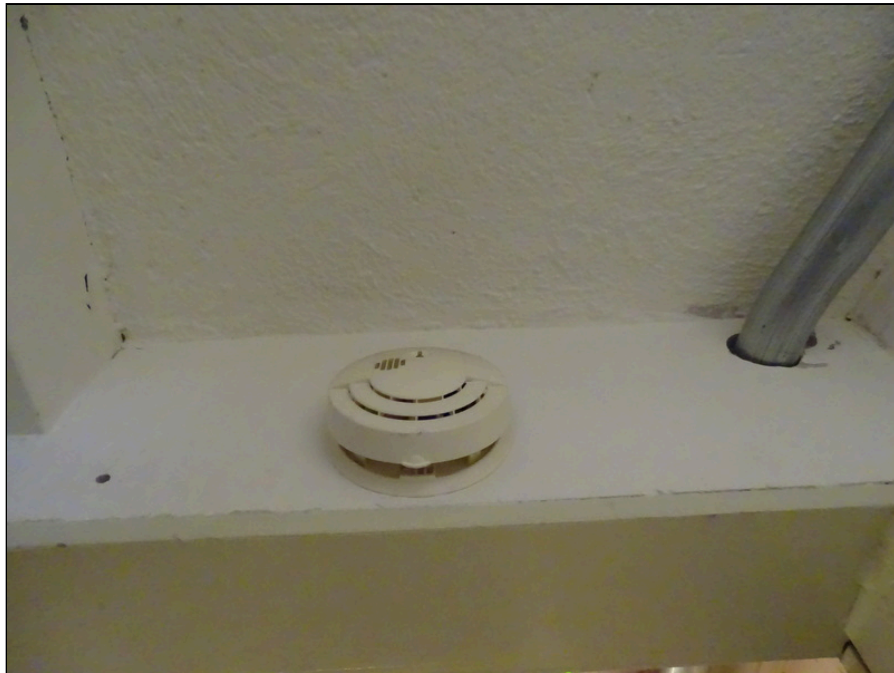
54 - Typical smoke detector

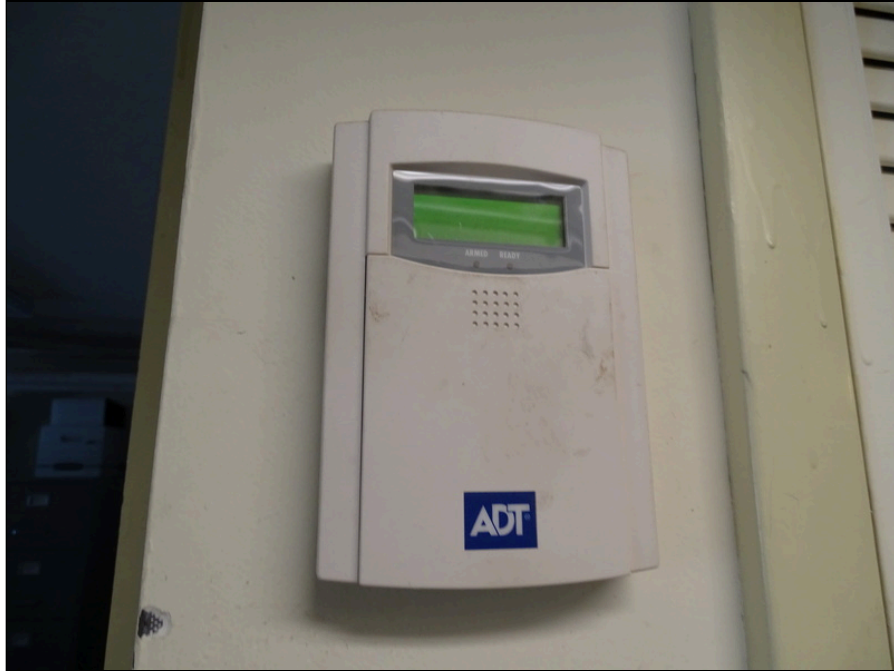
57 - Security system electronics

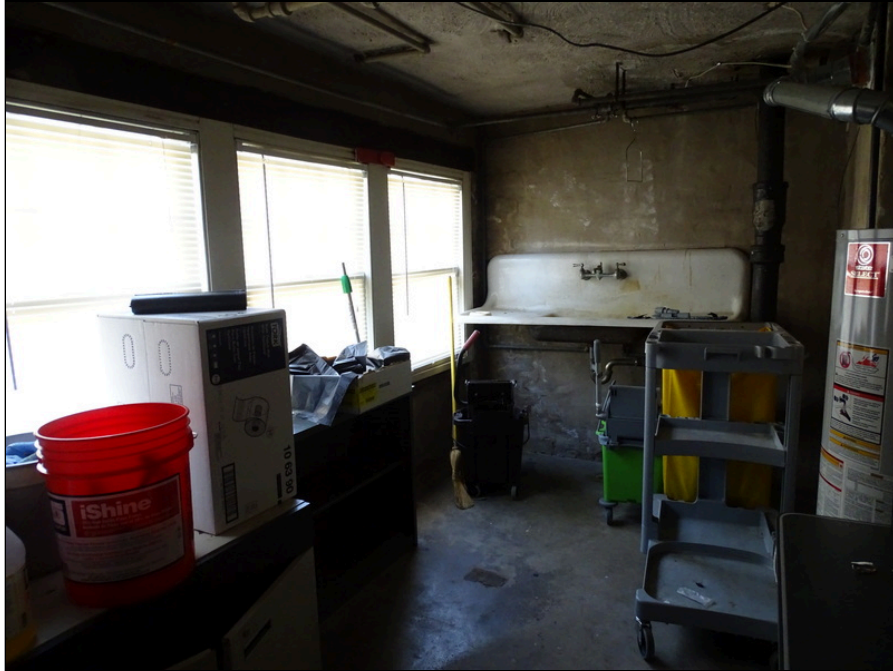
59 - Utility room

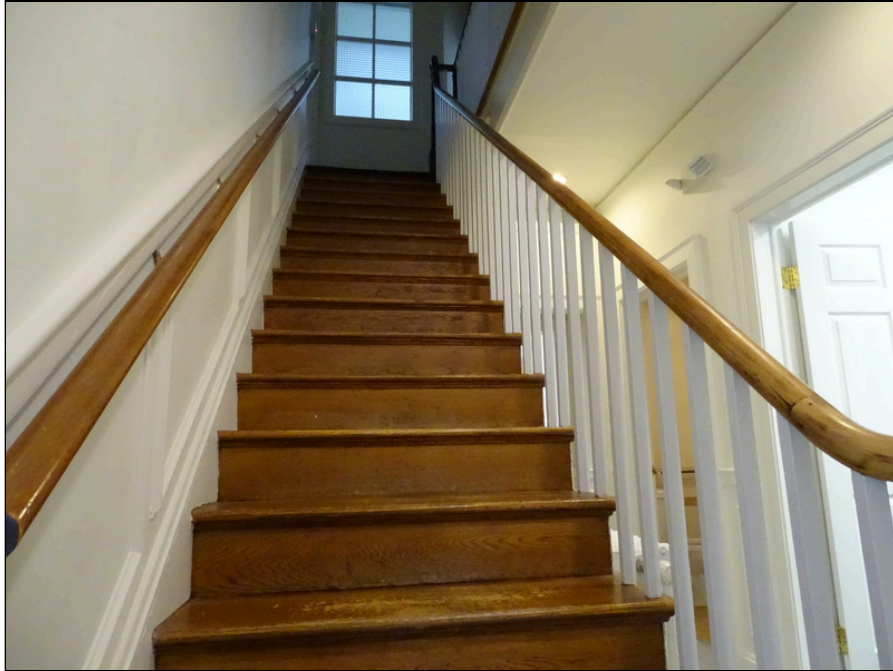
61 - Interior finishes of entrance area and stairs

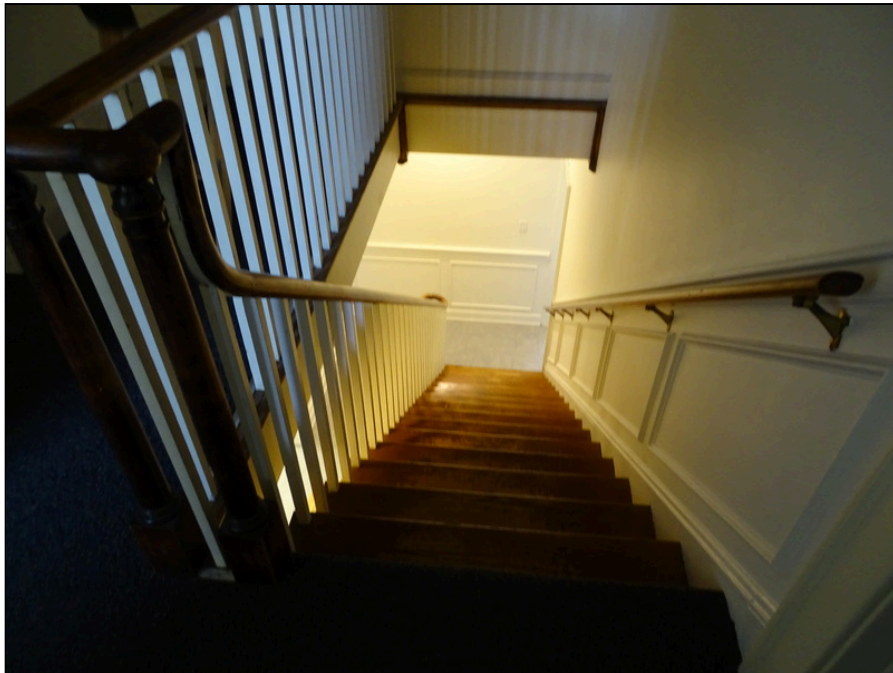
62 - Interior finishes of entrance area and stairs

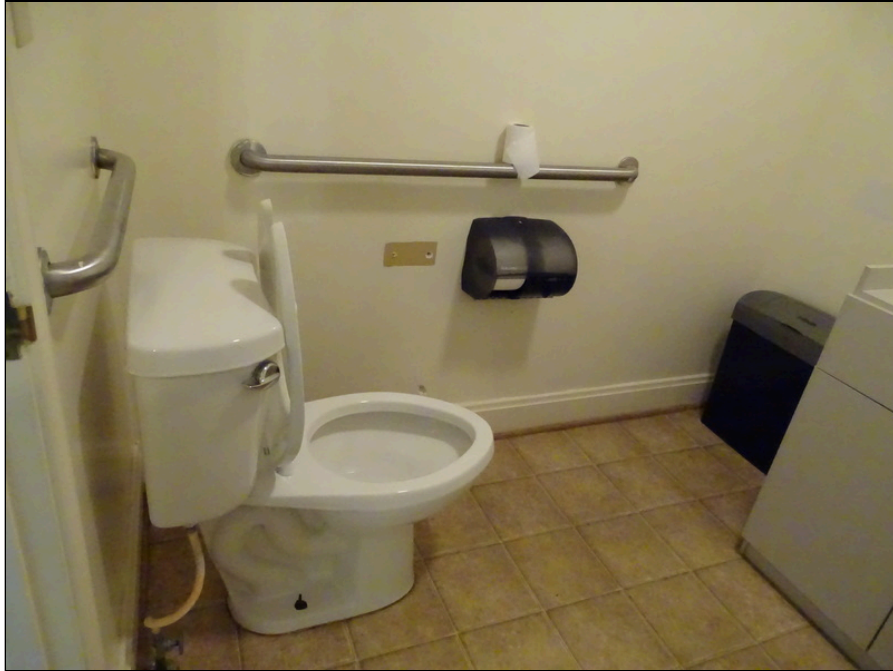
63 - Accessible toilet
