WHEELER BUILDING
401 EAST HIGH STREET
CHARLOTTESVILLE, VIRGINIA

ECS PROJECT NO. 46:6713

CITY OF CHARLOTTESVILLE - FACILITIES DEVELOPMENT

Reference: Facility Condition Assessment Report for Wheeler Building, 401 East High Street,
Charlottesville, Virginia

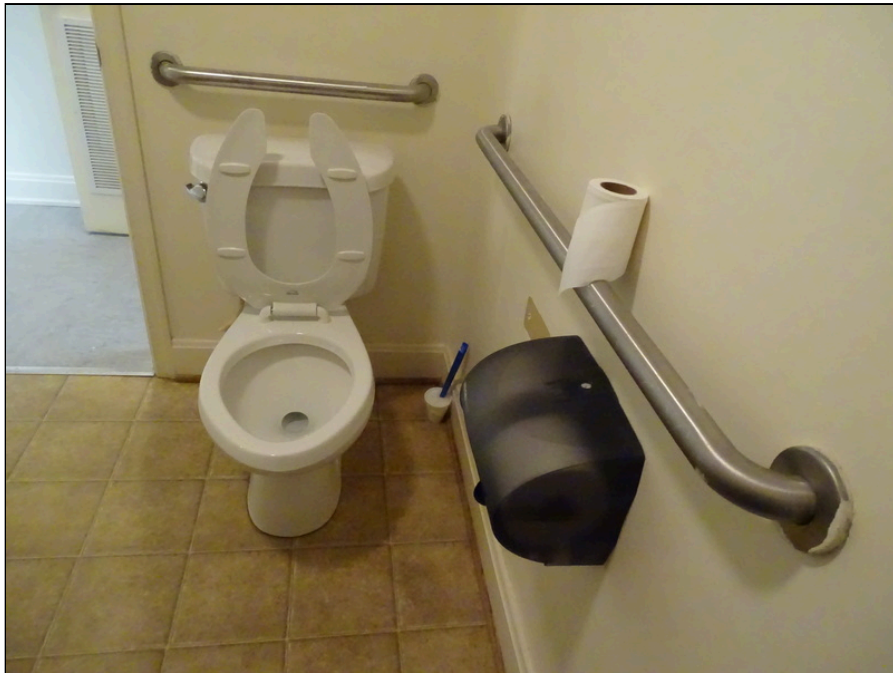
64 - Accessible toilet

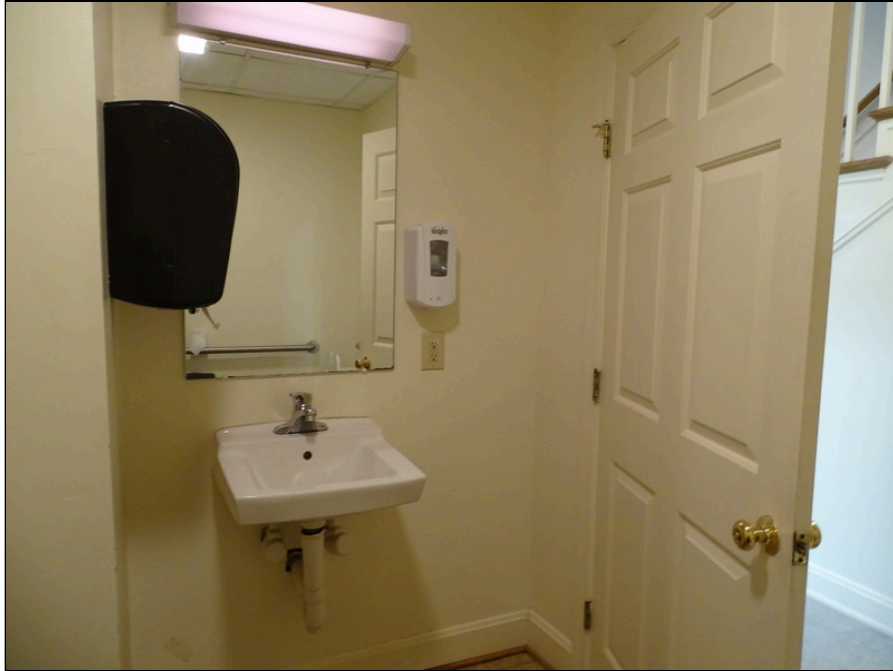
65 - Accessible lavatory

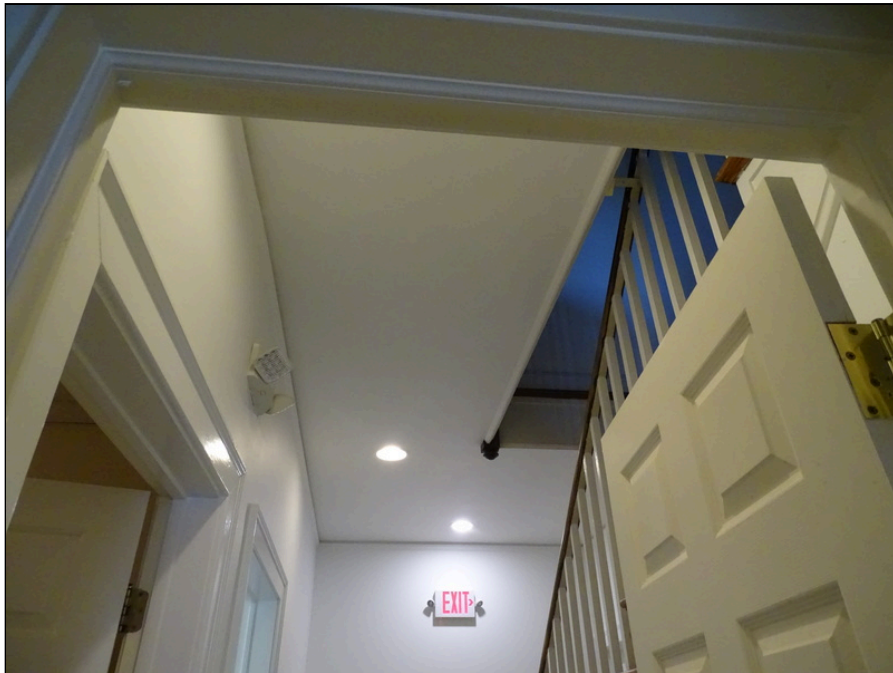
66 - Exit and emergency lights sign

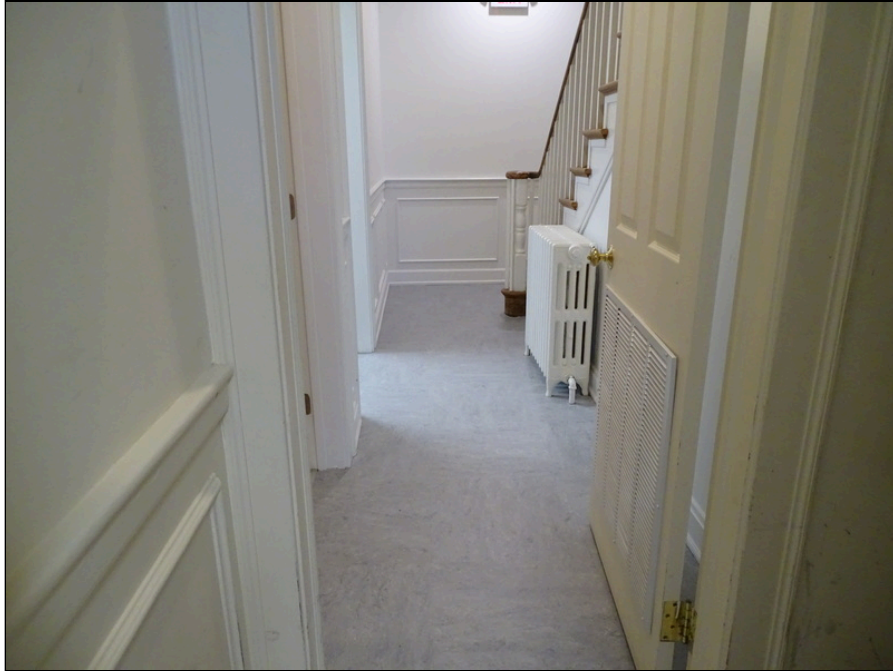
67 - Typical corridor

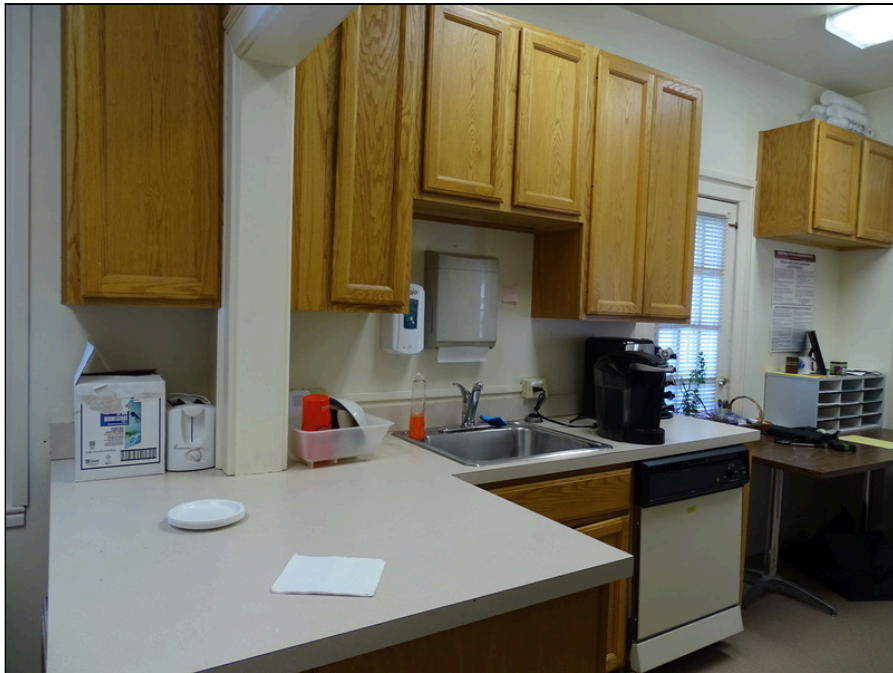
68 - Interior finishes of kitchen area

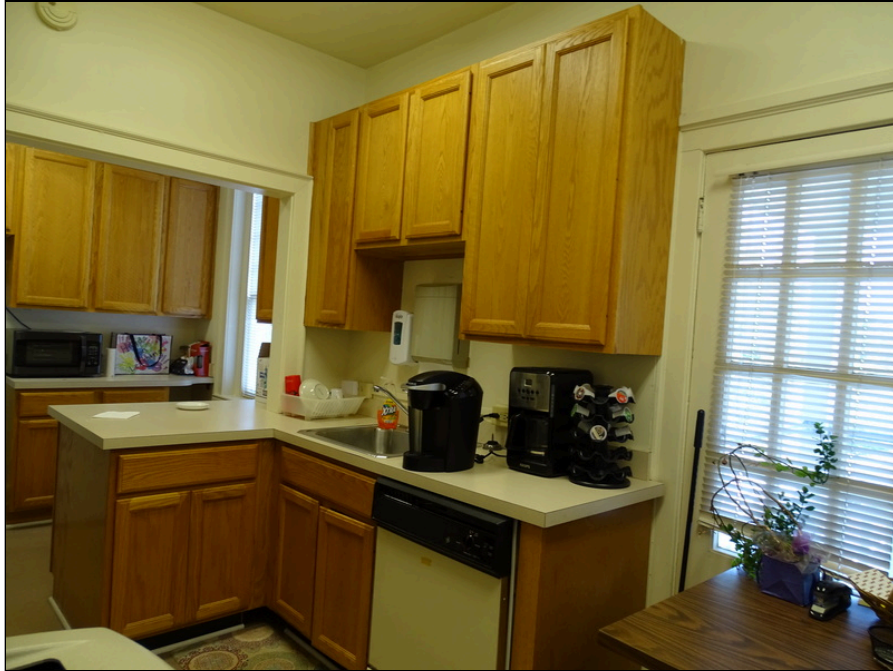
69 - Interior finishes of kitchen area

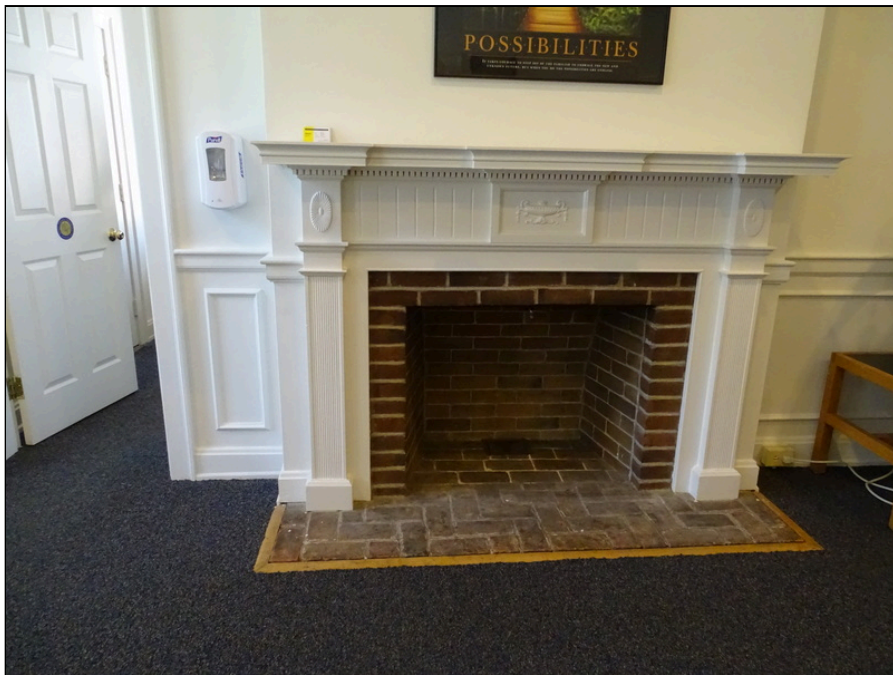
70 - Typical fire place

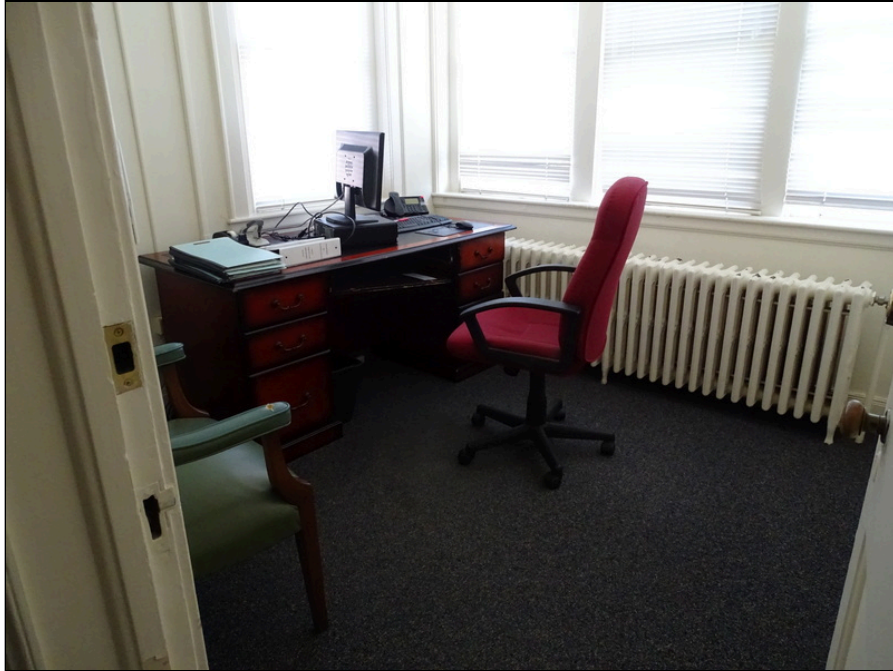
71 - Interior finishes of office area

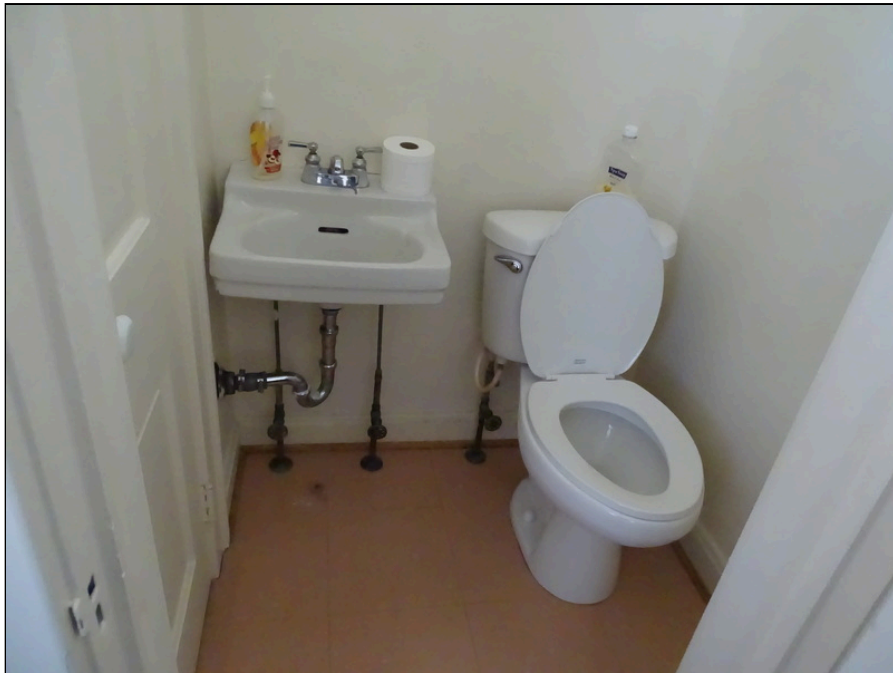
72 - Interior finishes of restroom area

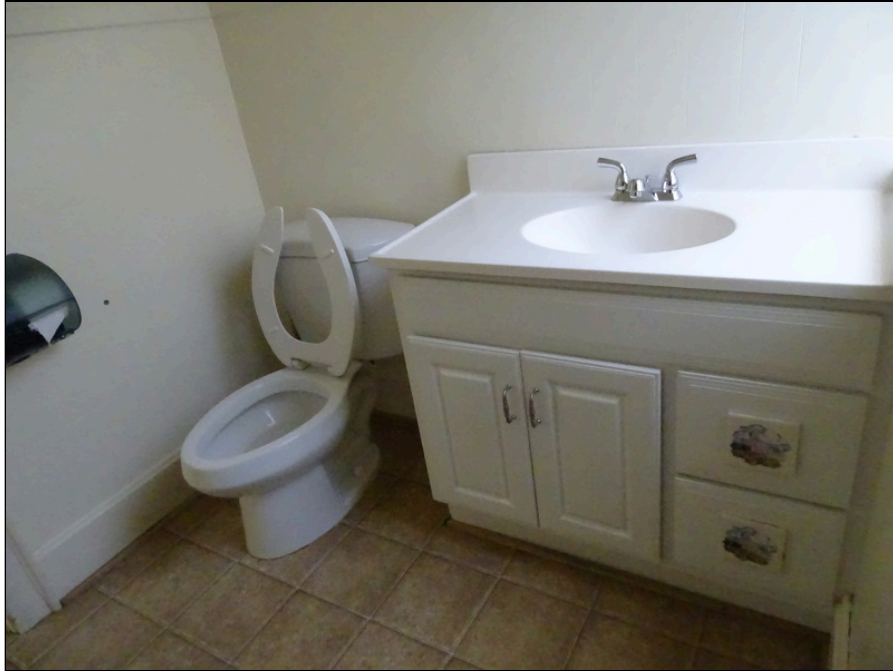
73 - Interior finishes of restroom area

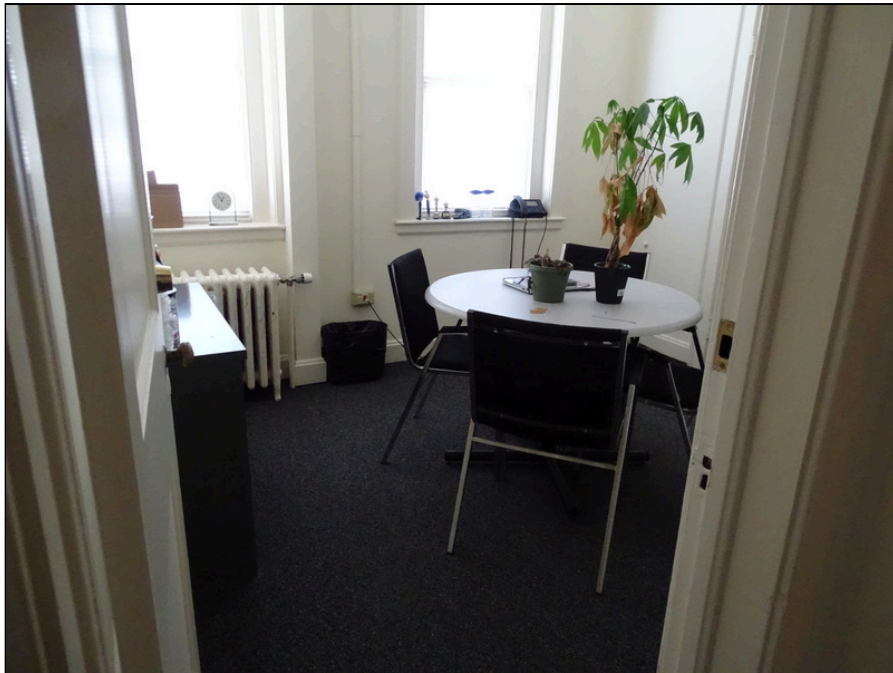
74 - Interior finishes of meeting room area

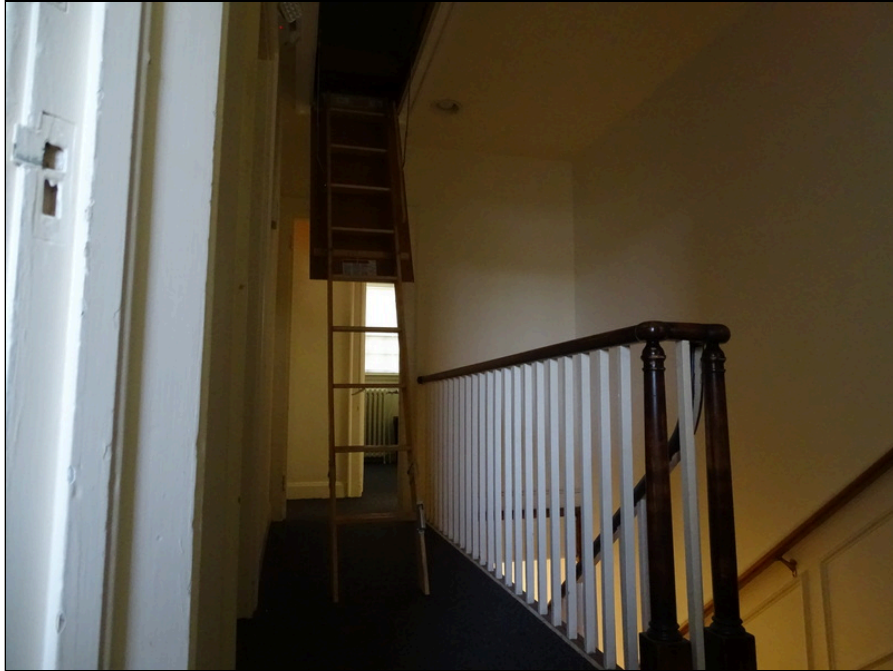
75 - Attic access

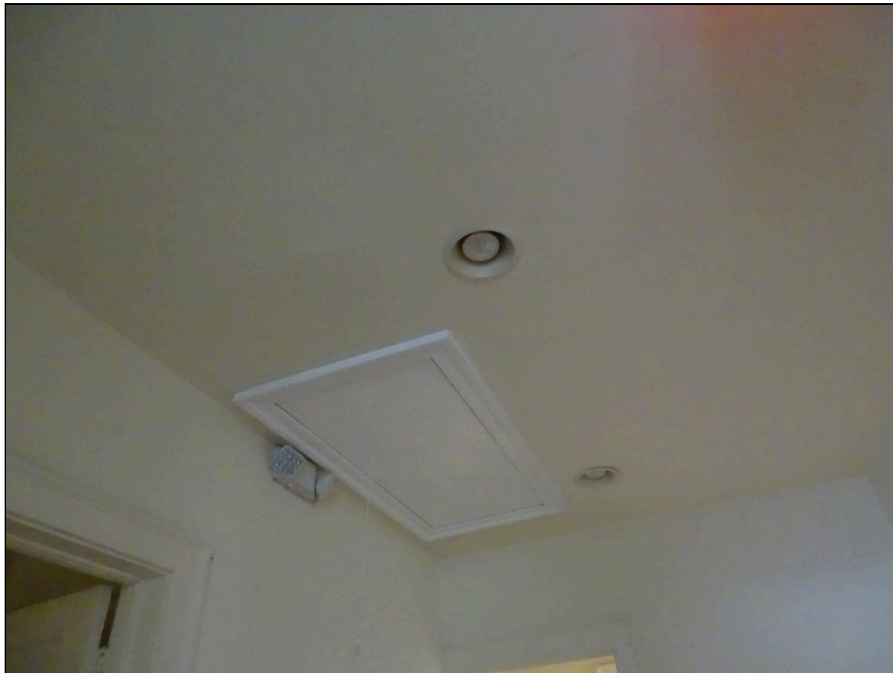
76 - Attic access

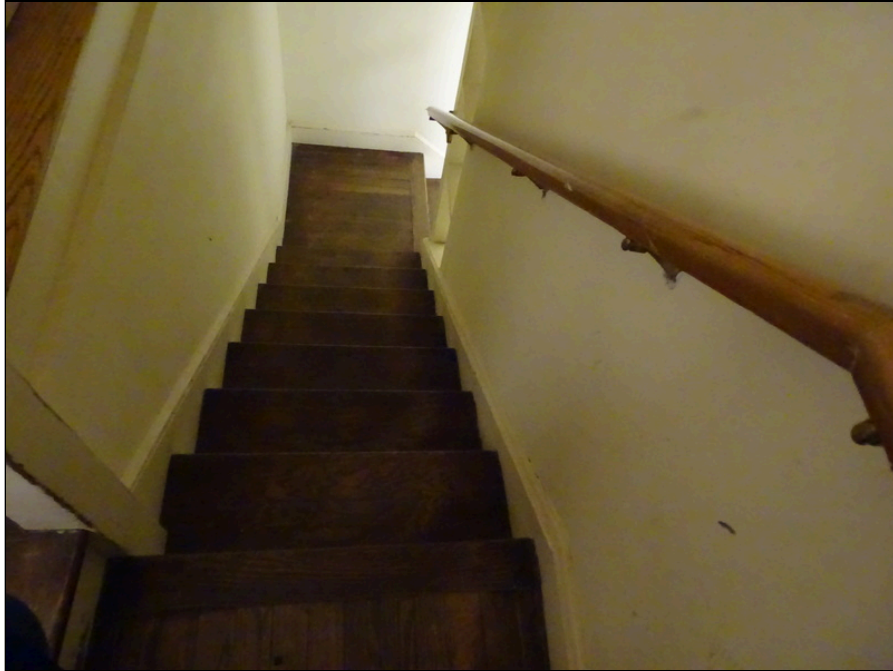
77 - Interior stair and handrail

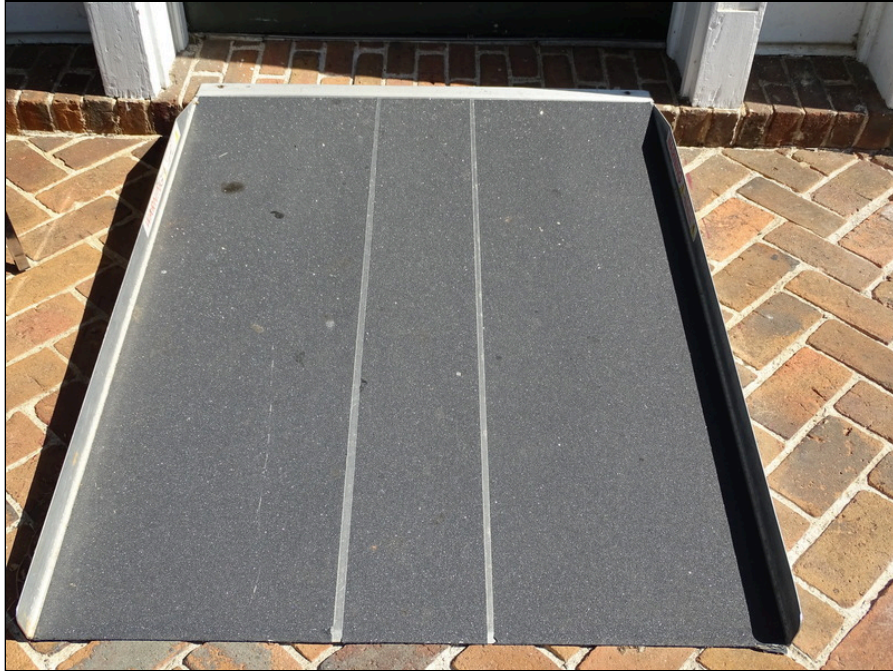
79 - Accessible ramp at main entrance
